Technical Memorandum

To	Ridgefield WPCA	Page	1 of 22
CC	C. Fisher, J. O'Brien, J. Pennell		
Subject	Town of Ridgefield, CT Phase 2 Wastewater Facilities Plan Technical Memorandum No. 1 – Dyed Water Testing and Tracing		
From	Jon Pearson/Alberto Angles		
Date	October 27, 2016

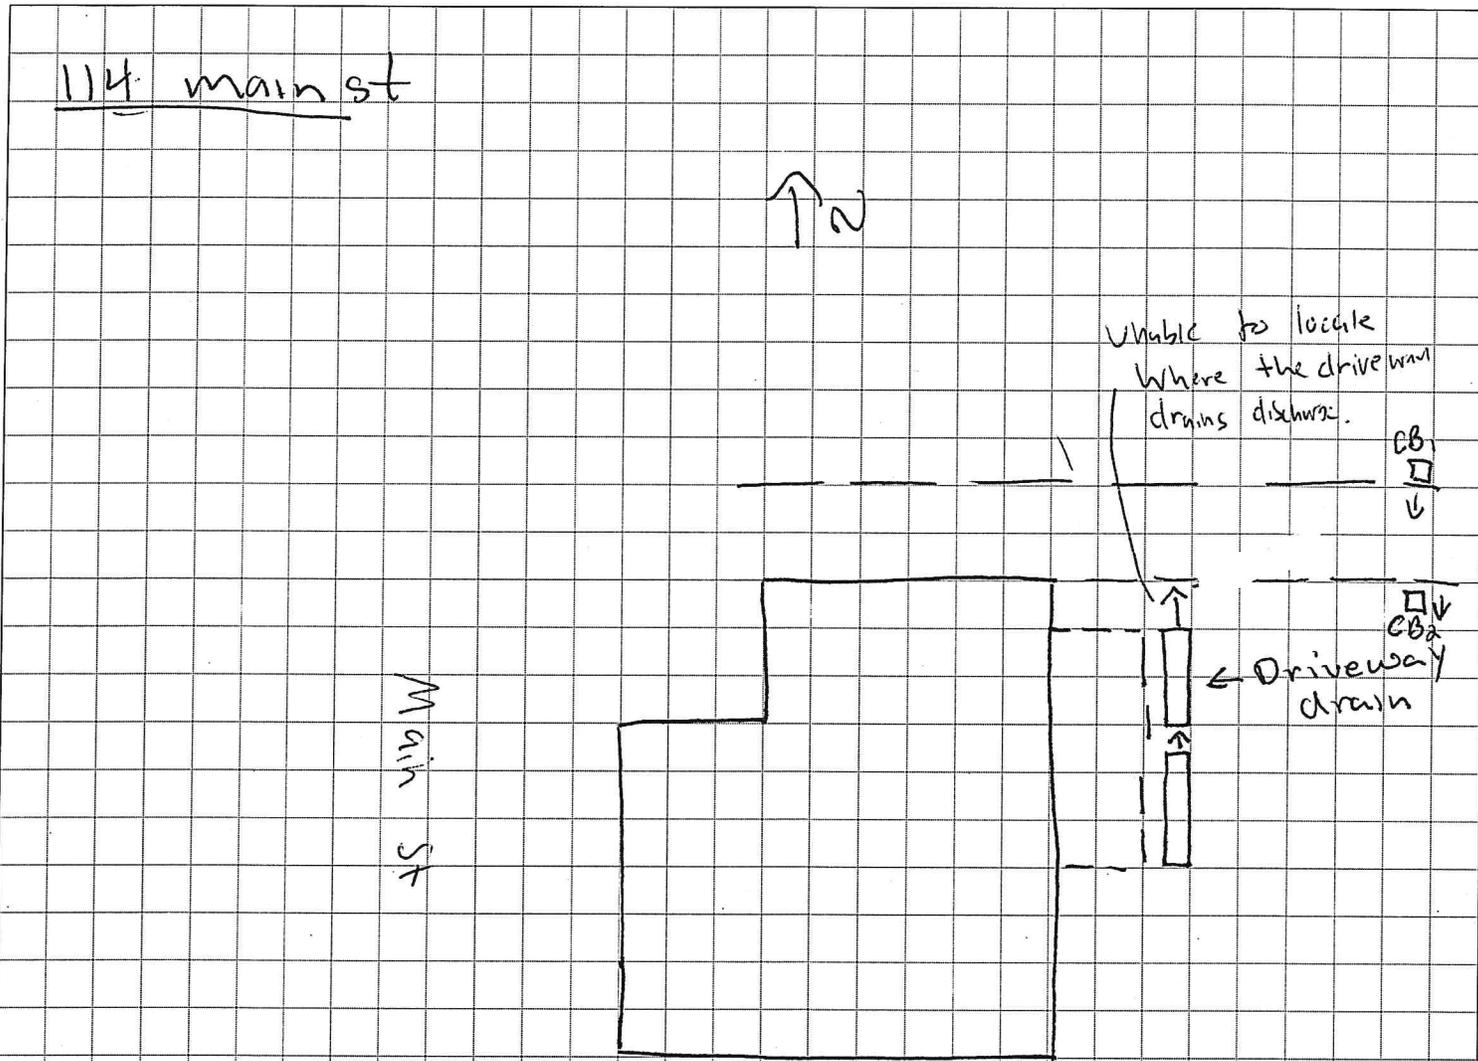
Crew poured 60 gallons of water into drain and waited roughly 1 hour. Homeowner told crew that the driveway drains go to the ground surface. Multiple discharge pipes seen but no dye observed.

- Crew poured about 60 gal of water into driveway drain
- Homeowner claimed that all the yard drains discharge on to surface. Crew found multiple discharge pipes but no dye observed.

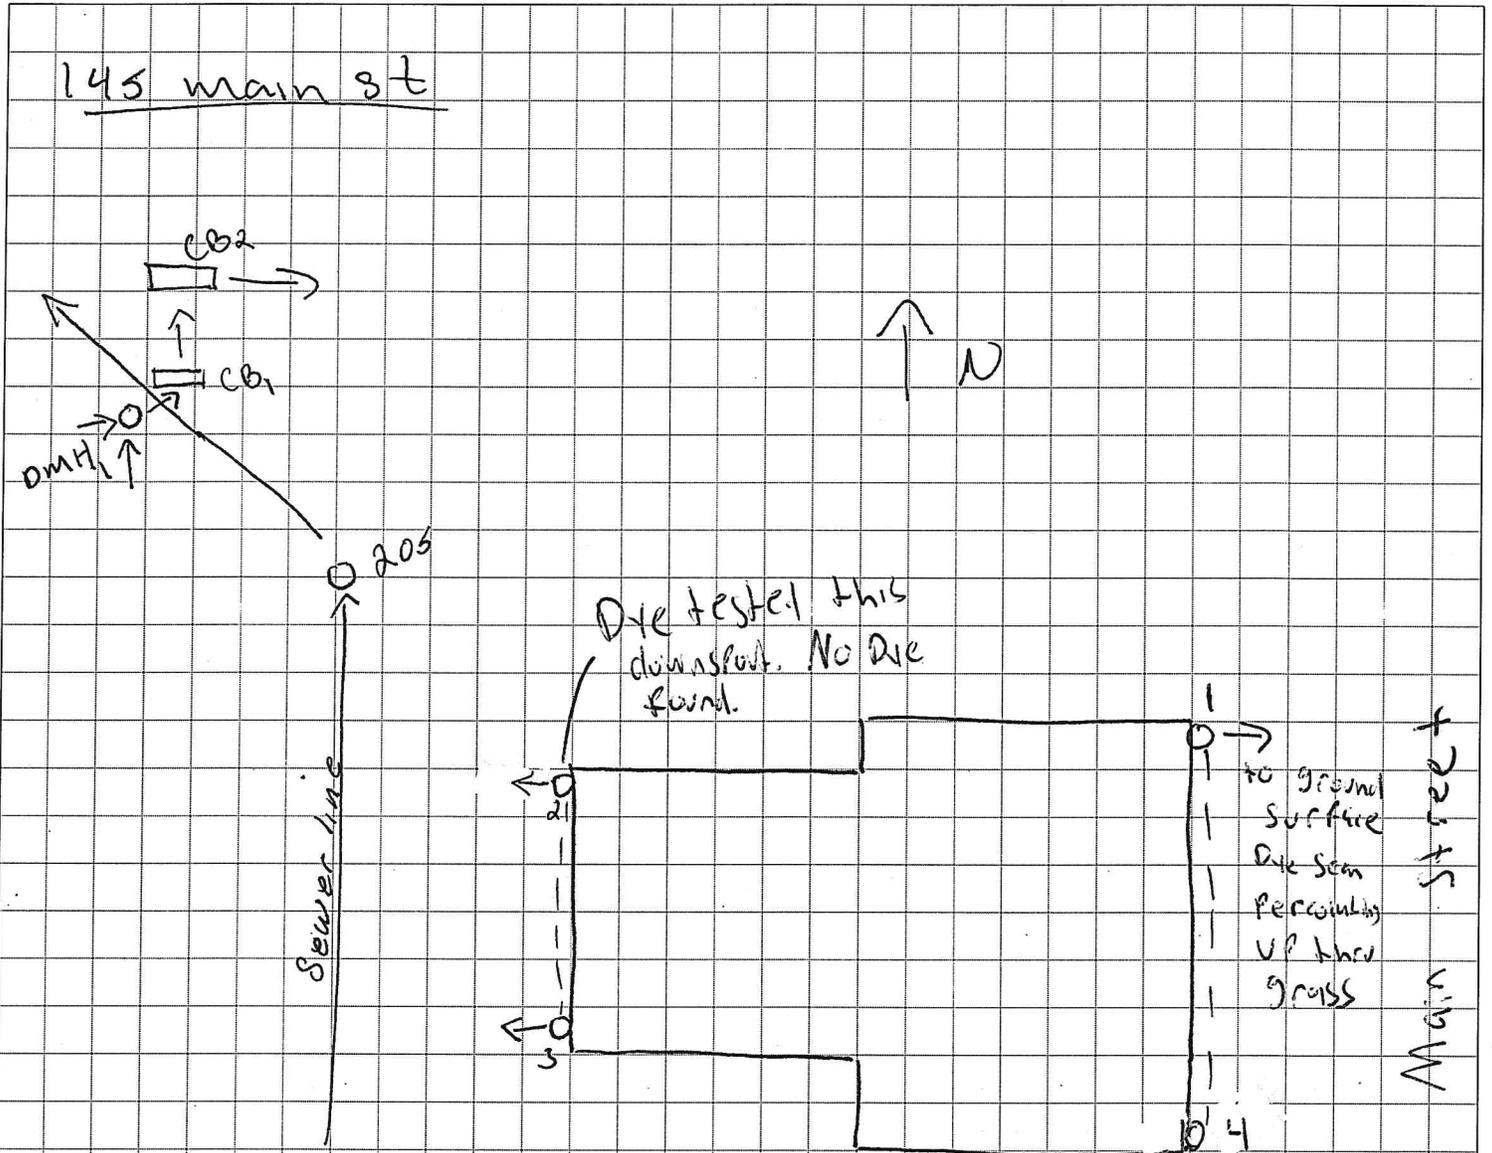
Tested downspout 2 from sketch. Crew added roughly 60 gallons of water and waited for over 1 hour. No dye found in sewer, drain or discharging to ground surface.

- Downspouts 3 and 2 connect, sand tested
- Crew poured about 60 gal of water into downspout 2 and waited at the sewer MH 205 and drain MH1 for about an hour. Crew noticed a wetland area behind the property with small amount of flow but no dye seen after an hour.
- Downspout 1 discharges onto surface

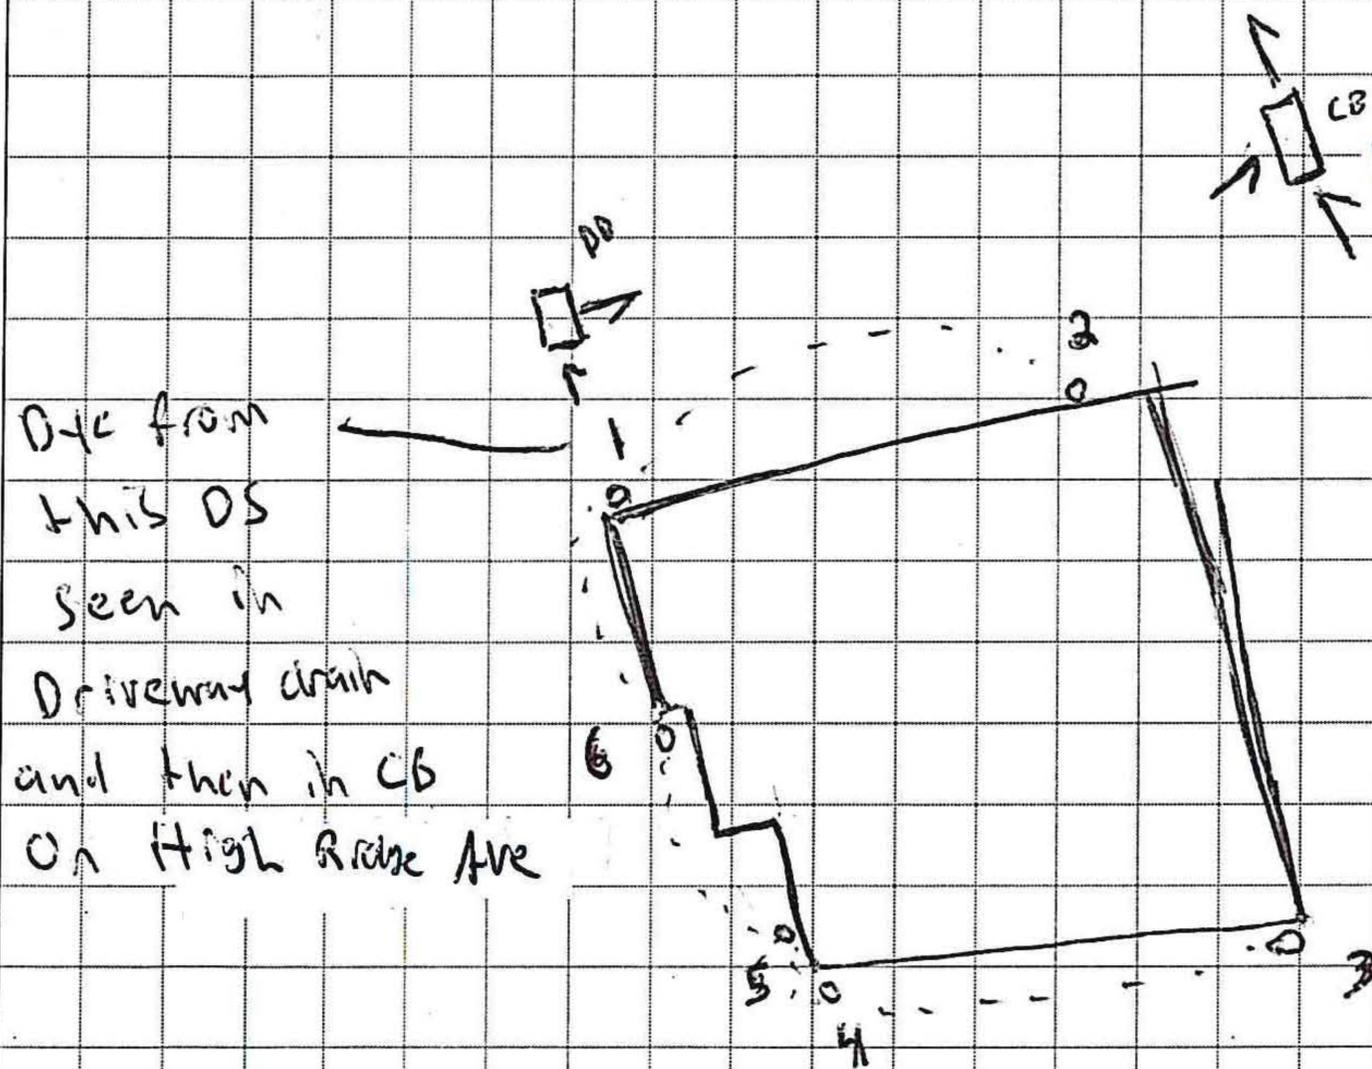
114 HIGH RIDGE AVENUE

All downspouts are connected
via sound test.

Dye tested downspout 1,
observed discharging in
Driveway drain catch basin
from SE inlet, observed
emptying into catch
basin on street from SW inlet.

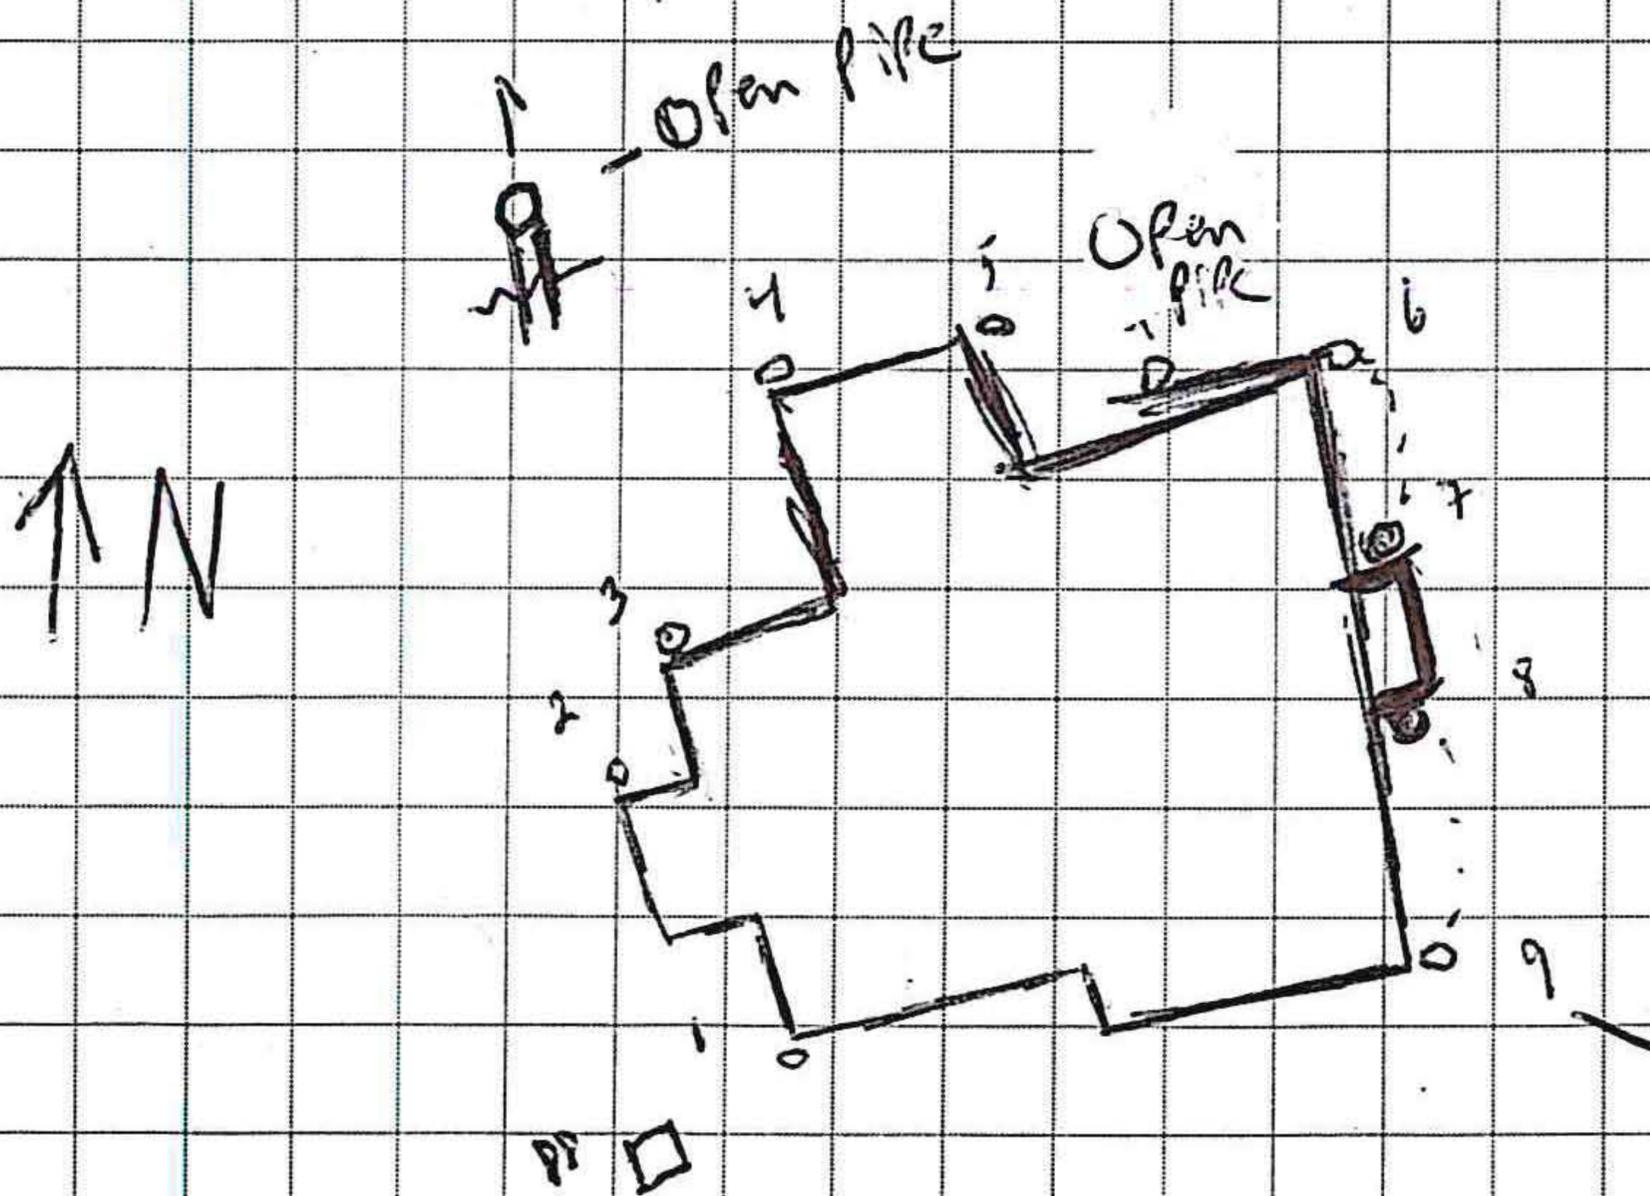
125 HIGH RIDGE

Dye tested downspout 7, observed discharging to surface in yard.

dye tested this downspout. Dye seen discharging from open pipe.

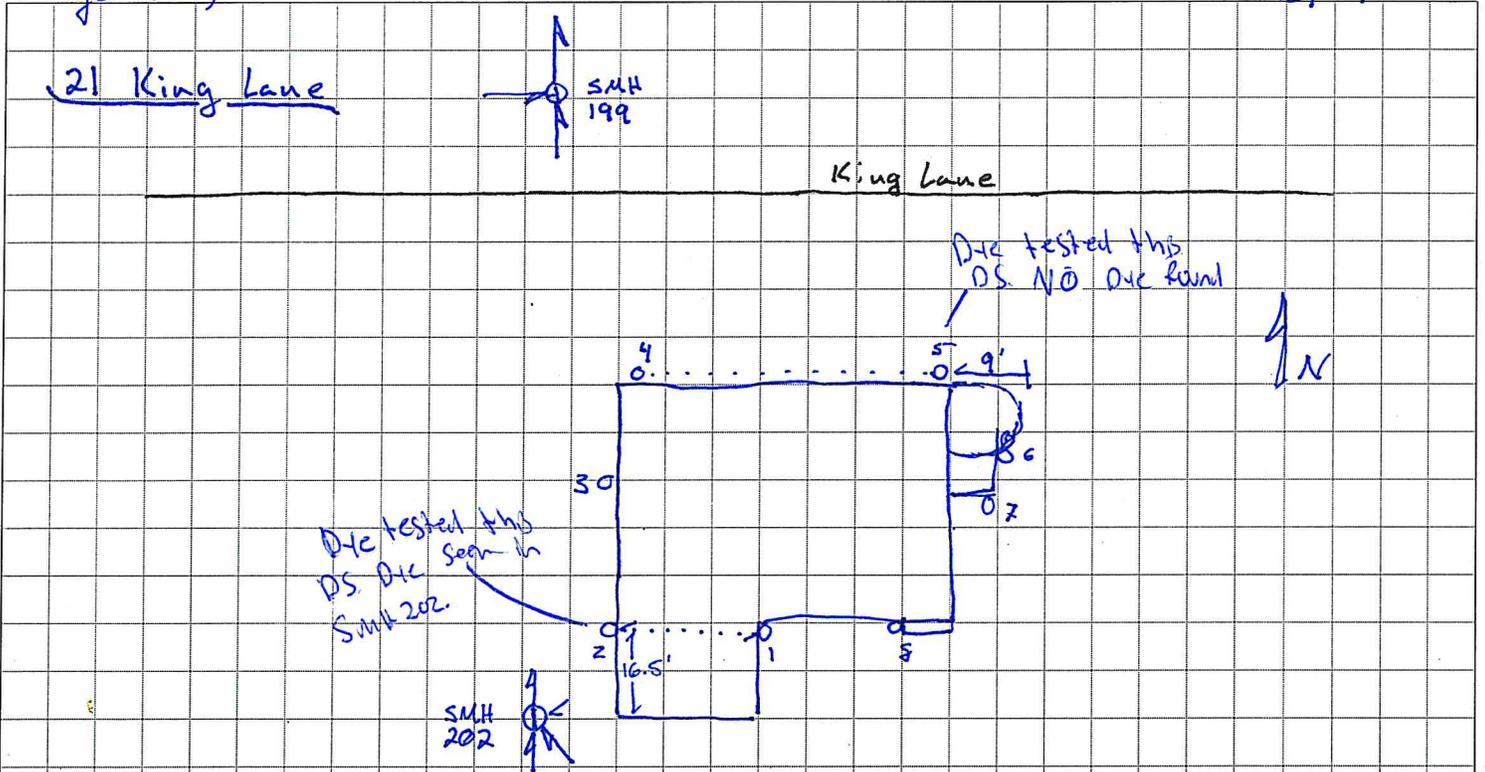
- Downspout 1 sound tested to Downspout 2. Downspout 2 dye tested to SMH 202 from the S.E. inlet. Dye seen in this inlet.
- Downspout 4 sound tested to Downspout 5. Downspout 5 was dye tested with 20gal H₂O and was waited on for 1.25hr, No dye was observed.
- Downspout 8 did not sound test to any other downspouts and was dye tested with 20gal H₂O and waited on for 1.5hr, No dye was seen.
- Downspouts 3 and 7 were found to be clogged and would overflow when filled with water.
- Downspout 6 was seen discharging to ground surface.

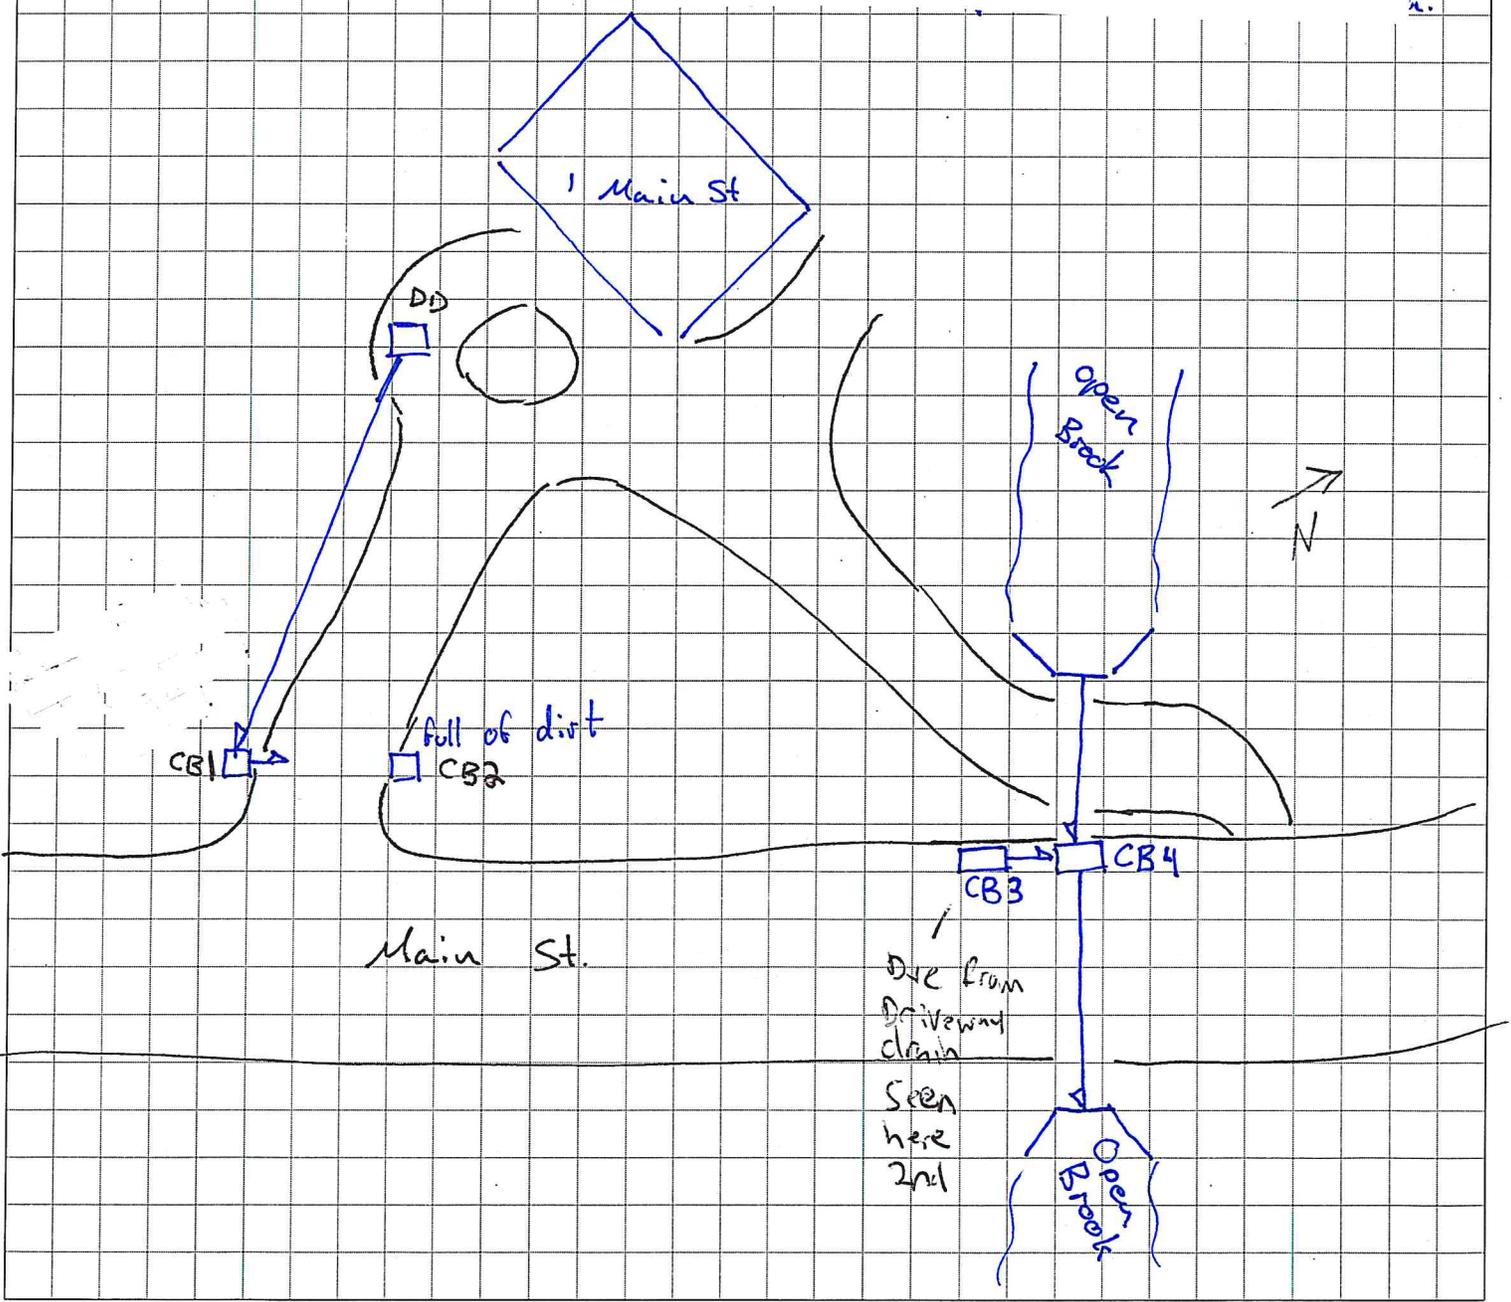
- Driveway drain marked DD sound tested to Drain marked CB1.
- Dye test at CB1 was observed in catch basin marked CB3.

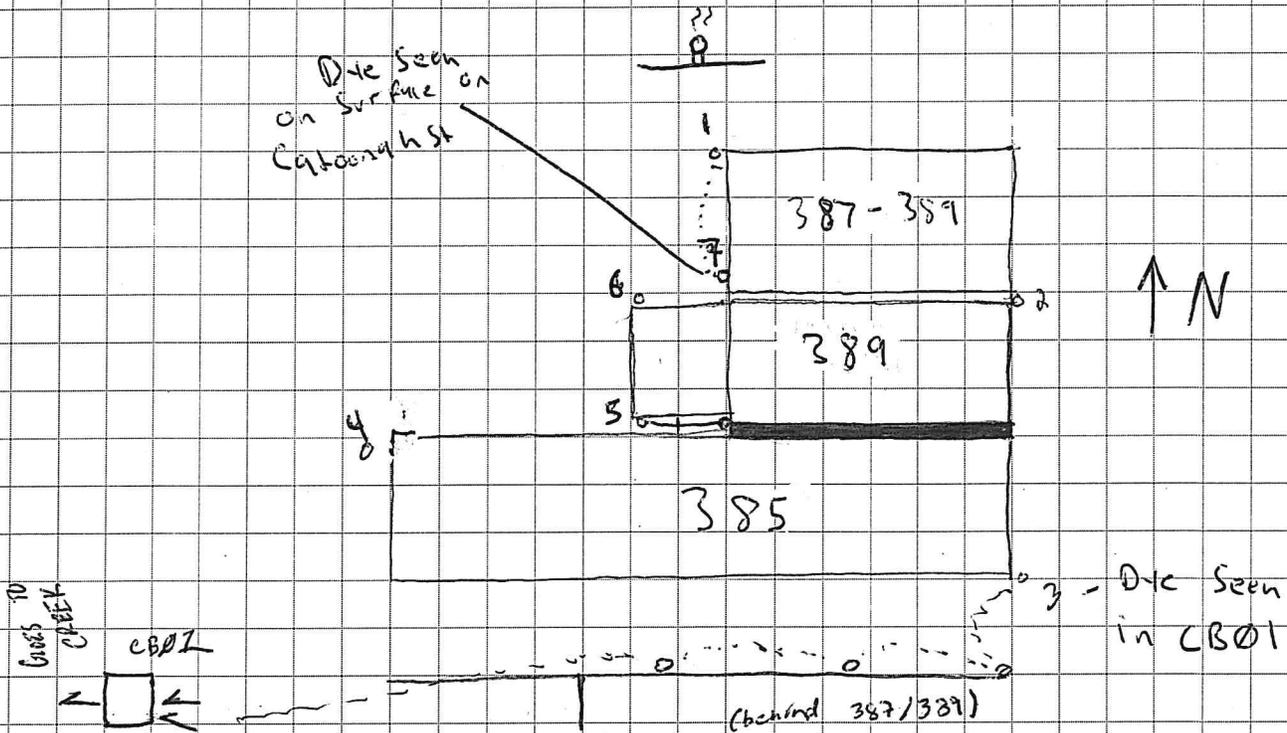
Dye tested at 7, observed discharging to surface on Catoona Street. Green dye abundant on street surface.

Dye tested downspout 3, dye observed discharging to catch basin CB01

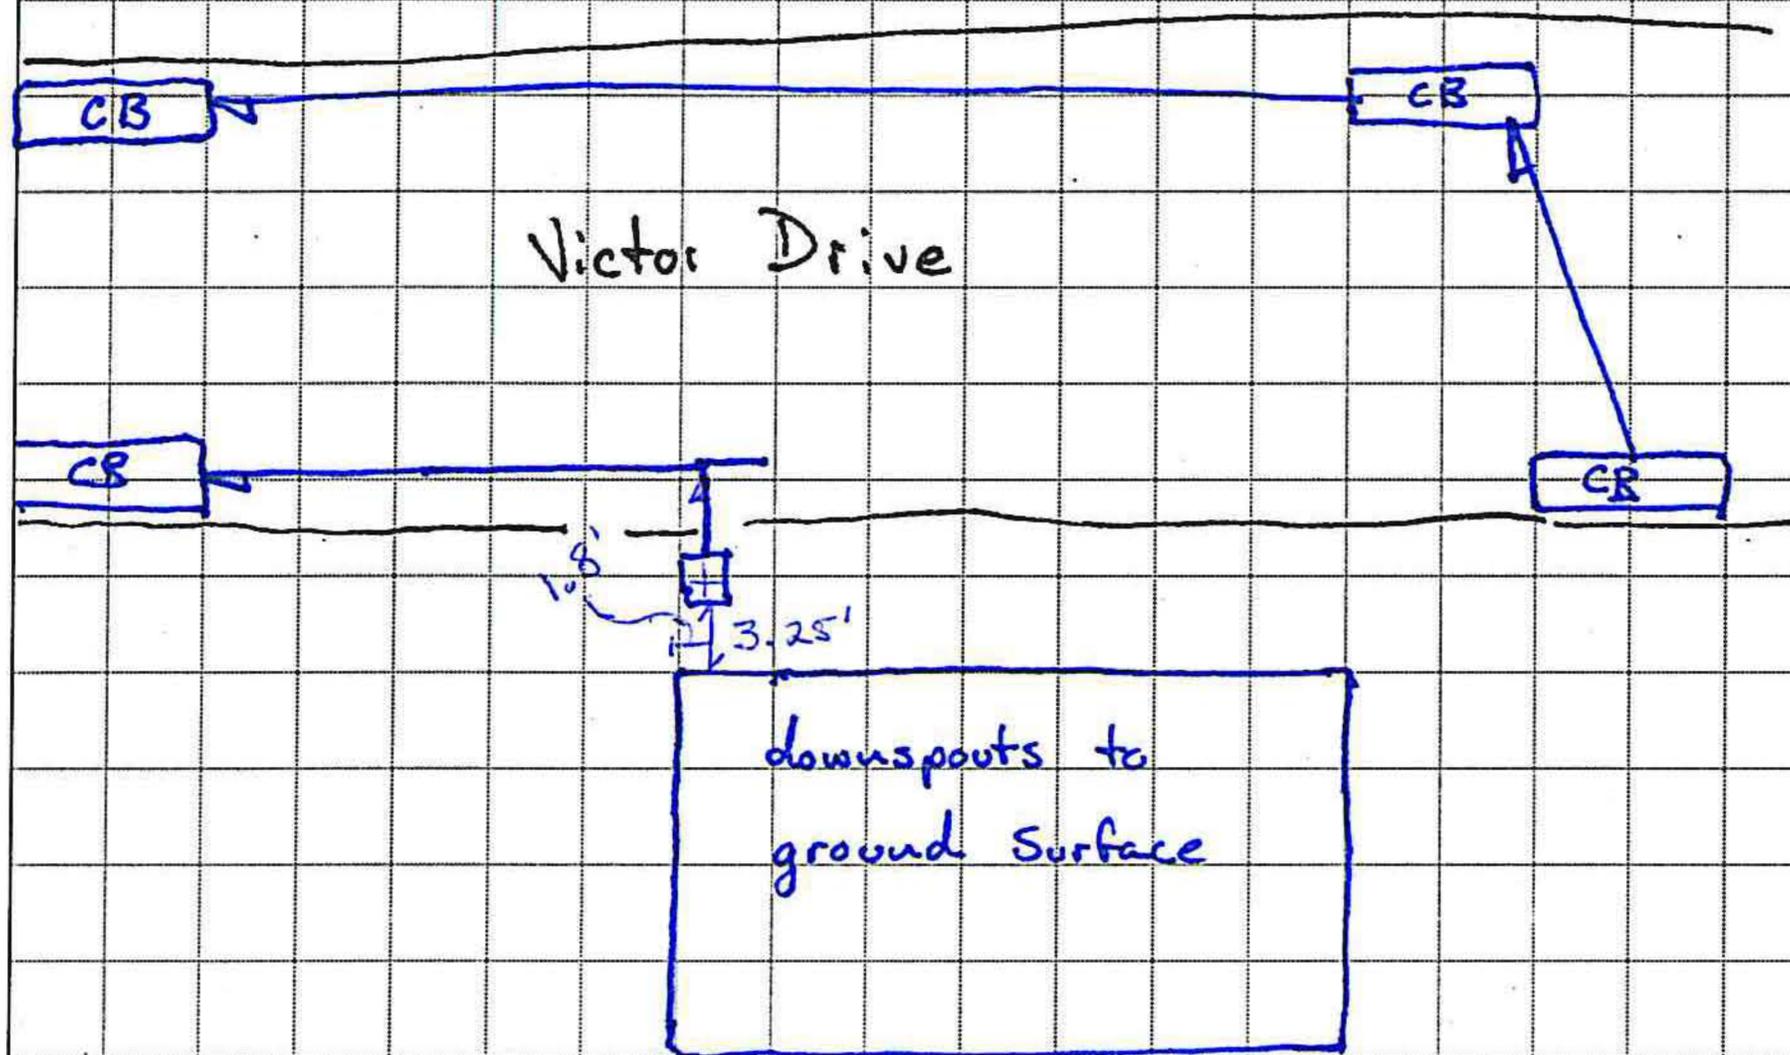
8 Victor Drive

⊙ driveway drain was tested and dye was observed in a catch basin in front of #2 Victor Drive.

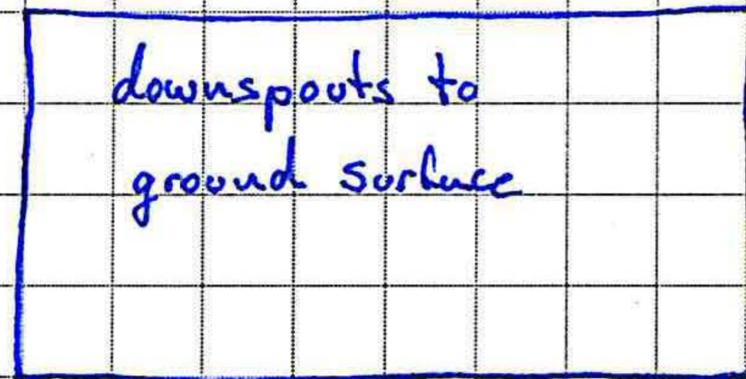
11 Victor Drive

⊙ dye was put in driveway drain and flushed with 40 gal H₂O. dye was observed in a catch basin in front of #7 Victor Dr.

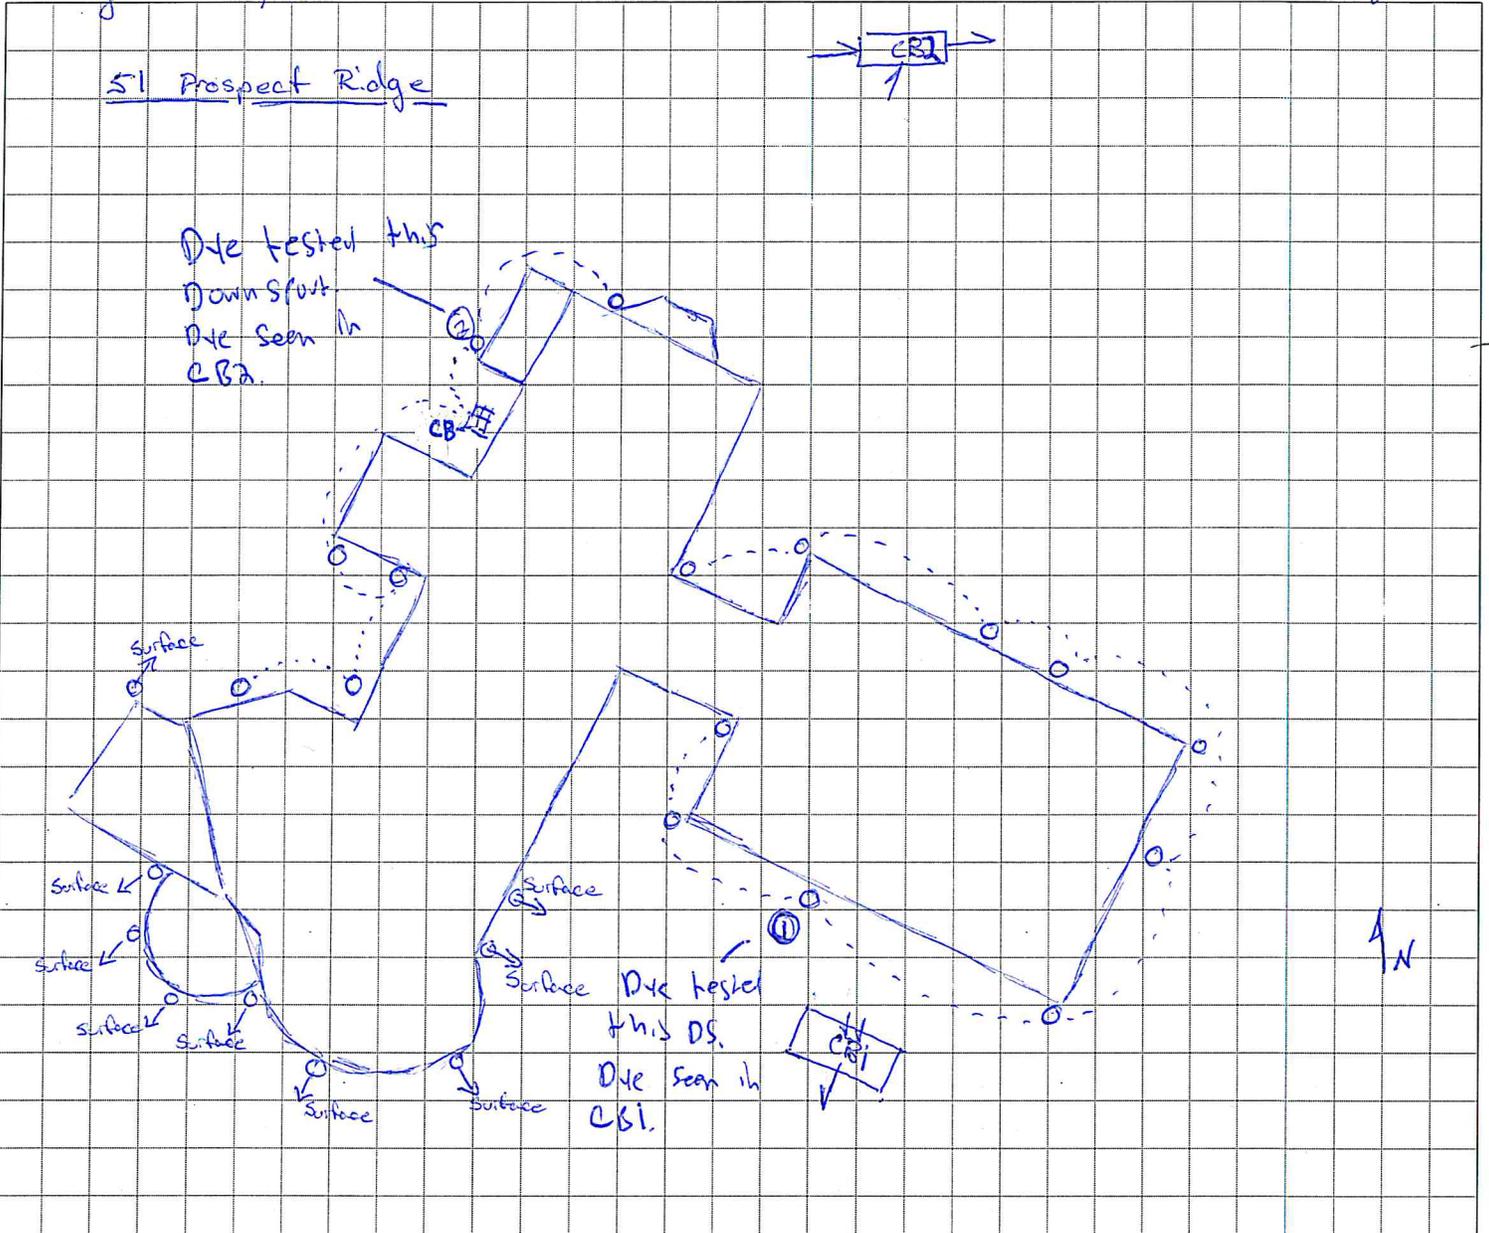
Dye tested this
Down Spout
Dye seen in
C.B.

Dye tested
this DS.
Dye seen in
C.B.

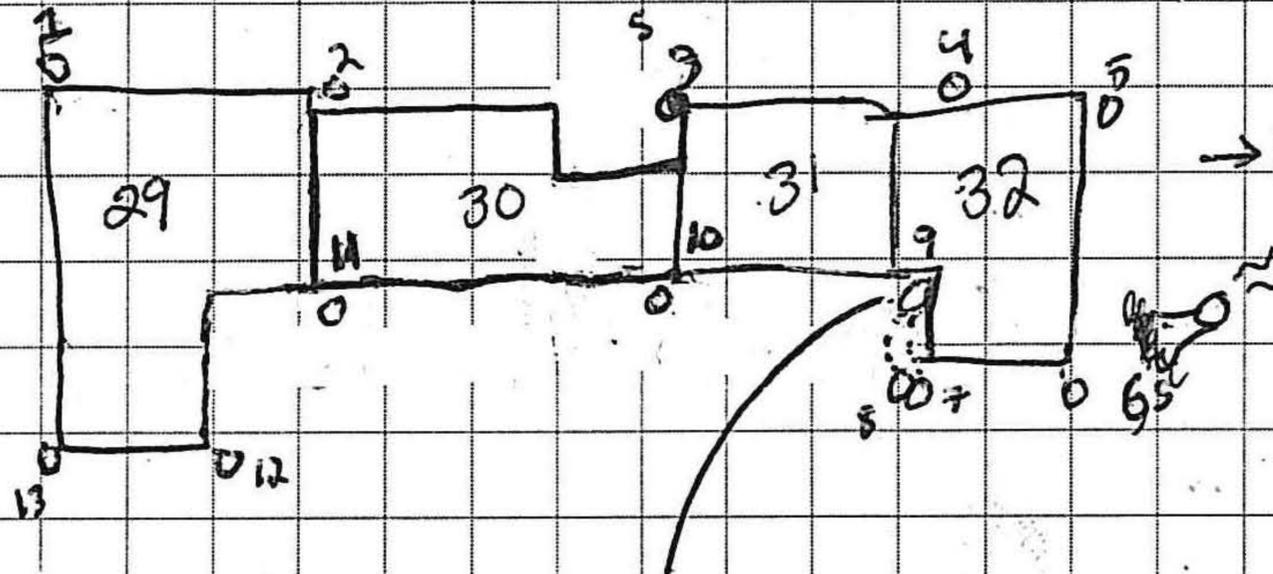
Quail Ridge I

→ Downspouts 3, 6 were observed discharging to surface.

→ Downspouts 7, 8, 9 connected via sound test

Dye tested downspout 9, observed discharging to surface, next to man hole on side of driveway.

Dye tested this downspout. Discharges to surface.

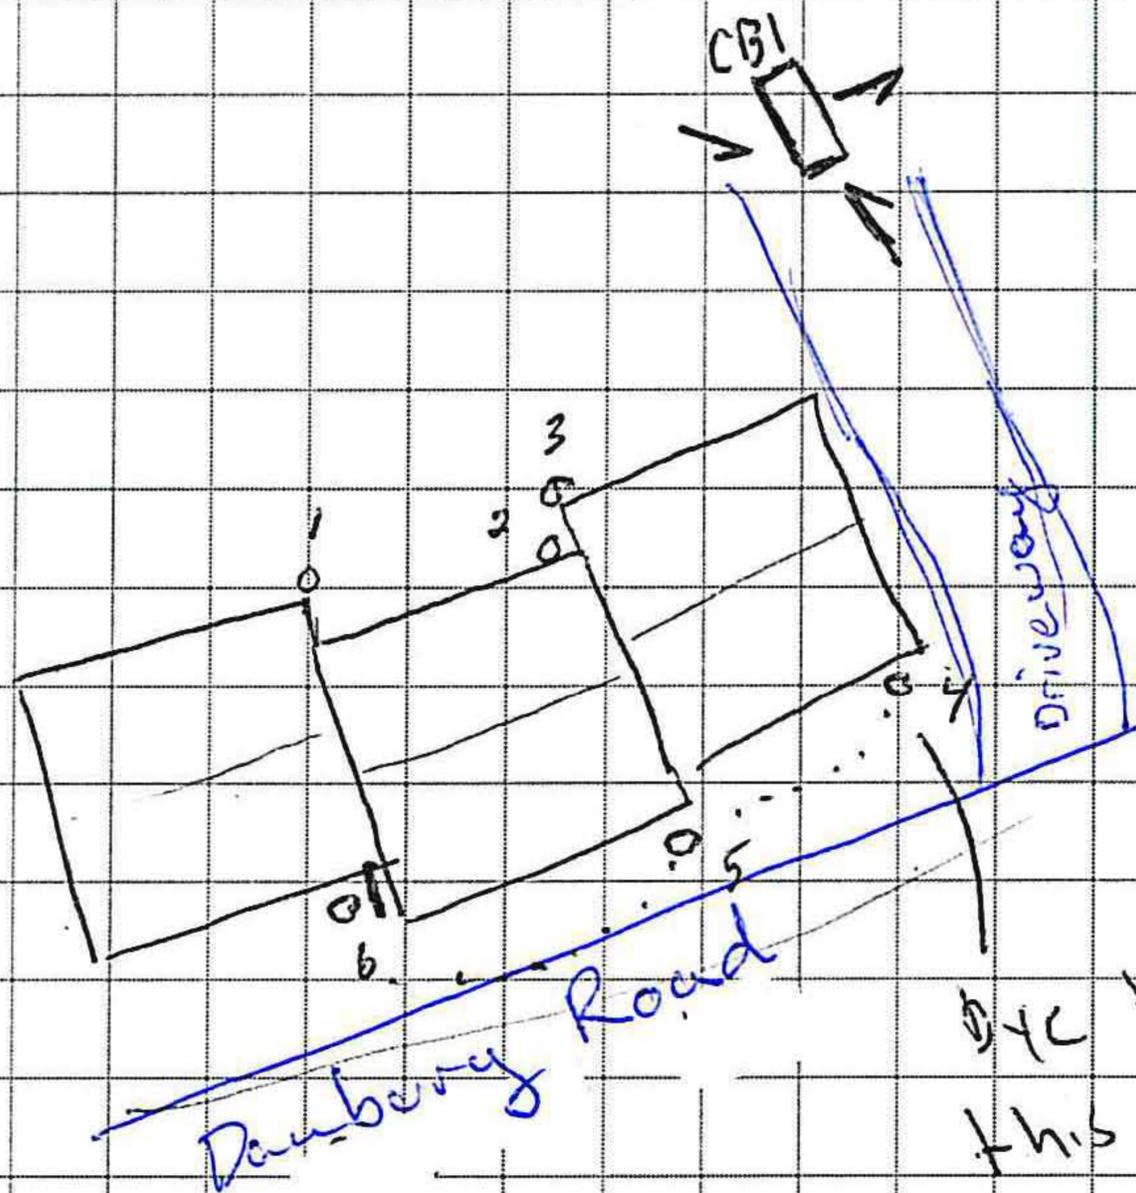
Downspouts 4, 5, 6 connect
via sound test

Dye tested downspout 4,
observed discharges in CBI
from SE inlet.

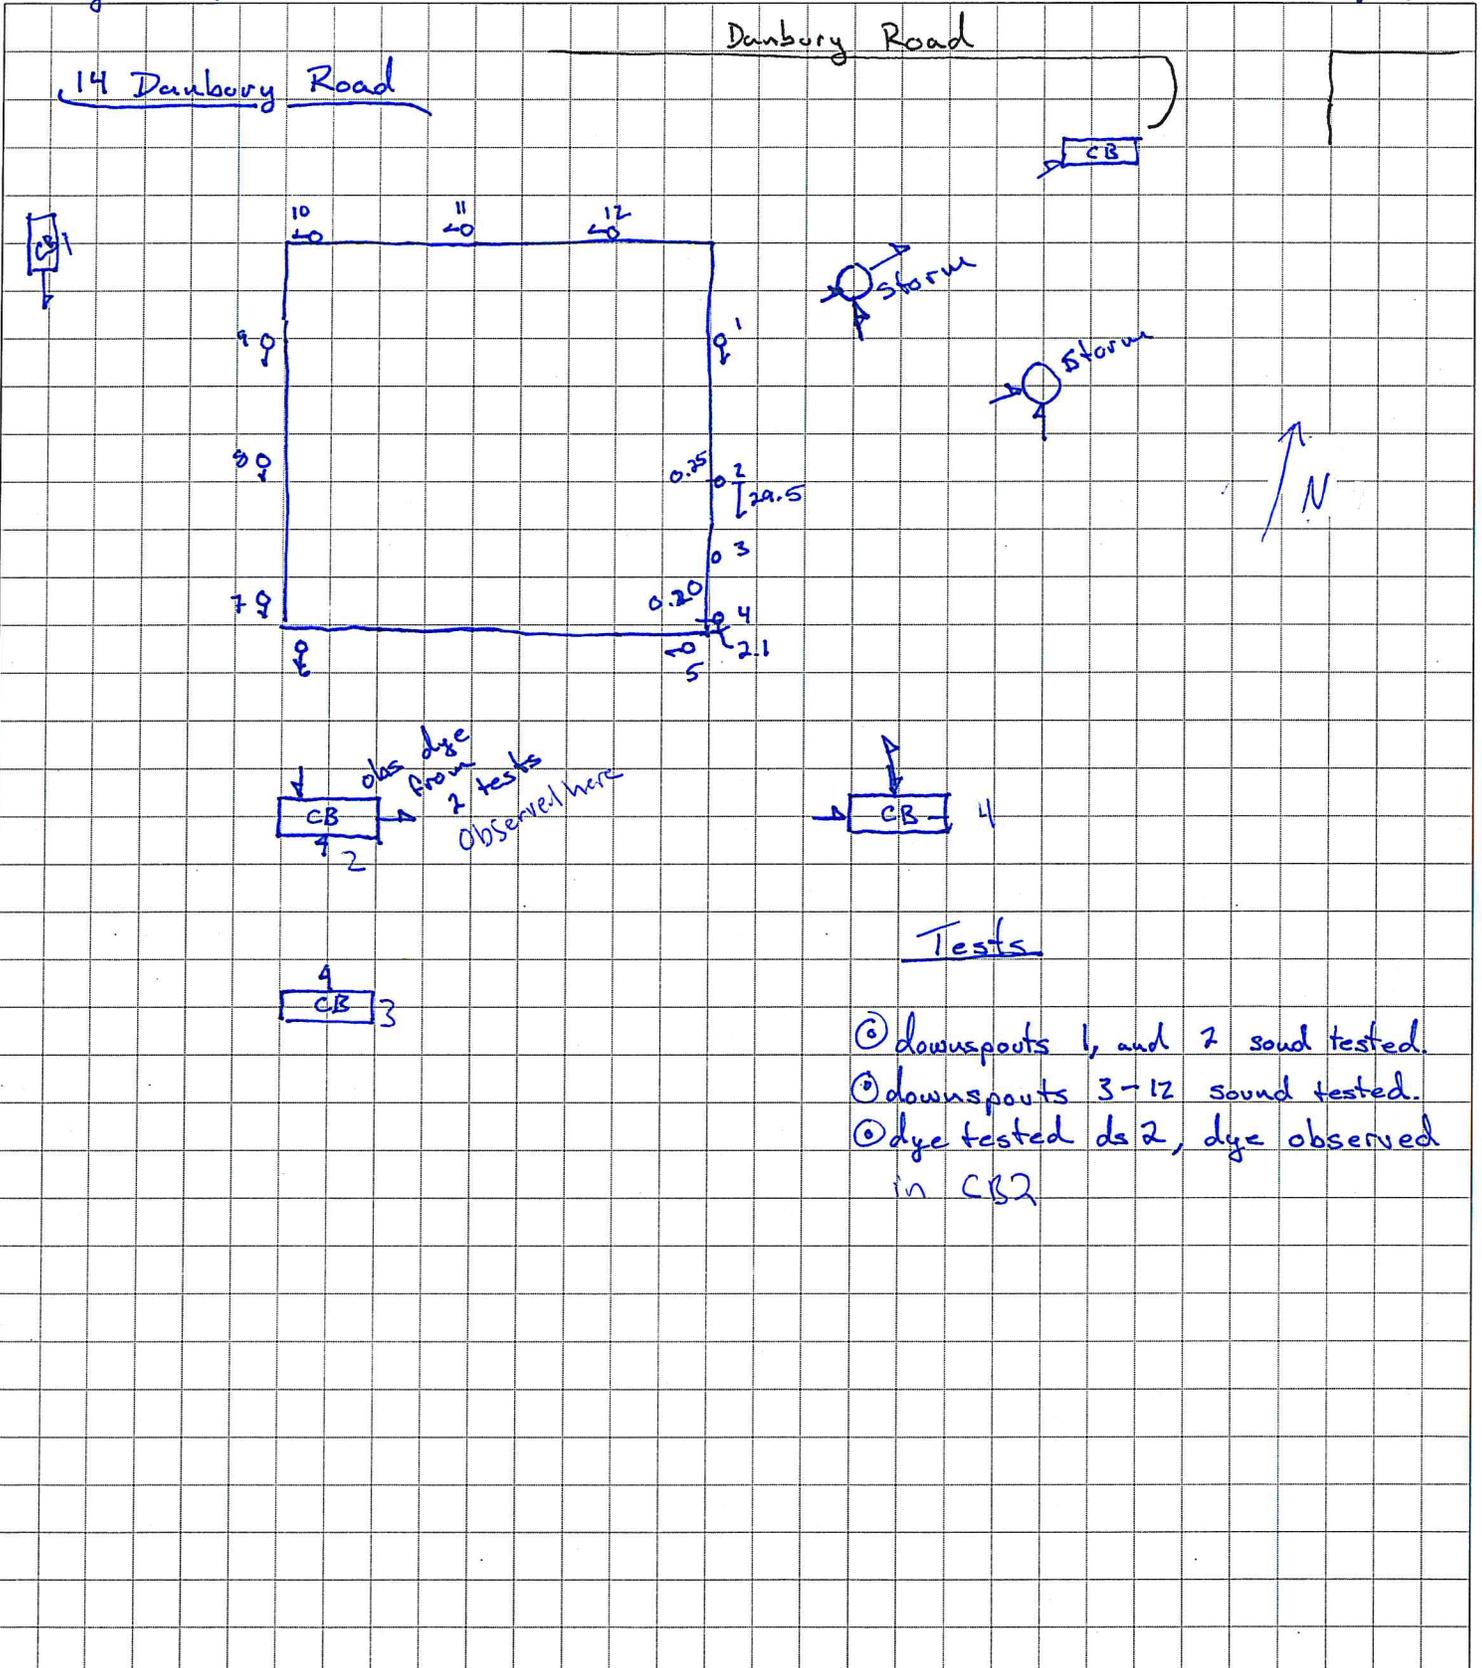
- Tests
- ⊙ downspouts 1, and 2 sound tested.
 - ⊙ downspouts 3-12 sound tested.
 - ⊙ dye tested ds 2, dye observed in CB2

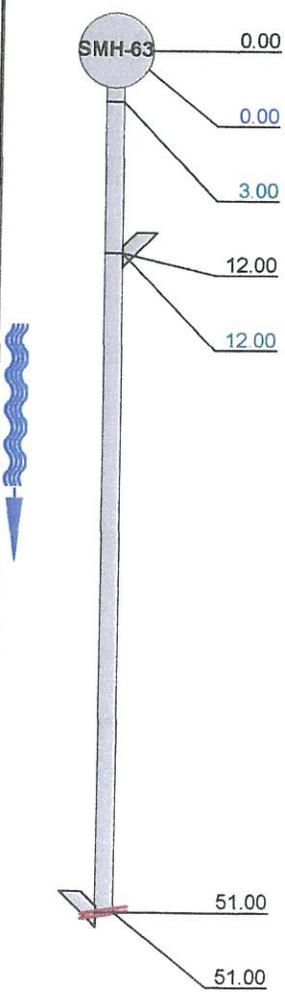
1:135	Position	Code	Observation	Grade
	0.00	AMH	Upstream Manhole, Survey Begins / SMH-064	
	0.00	MWL	Water Level, 5 % of cross sectional area	M 2
	3.00	MYV	Dye Test Visible / 3ft green dye	M 5
	12.00	TFC	Tap Factory Made Capped, at 09 o'clock, 6", within 8 inches of joint: YES	
	12.00	MYV	Dye Test Visible / 12 ft green dye	M 5
	51.00	TFC	Tap Factory Made Capped, at 03 o'clock, 6", within 8 inches of joint: YES	
	51.00	MSA	Survey Abandoned / found source

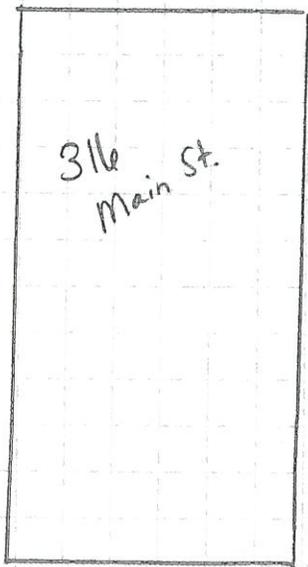
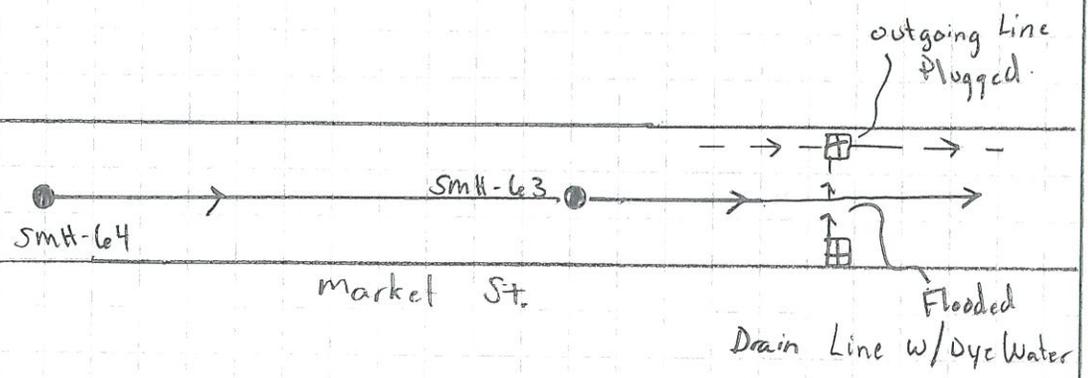
Flood #1

Sanitary Line was televised from SMH-63 Down stream while the storm drain was plugged and flooded with dye. The drain crosses the Sanitary. Two leaks had been found.

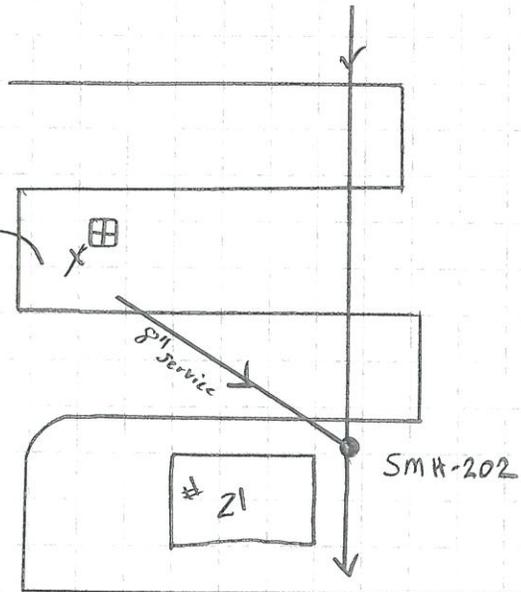
Dye was introduced
into hole in ground
By CB. Dye was found
Coming From Service Connection
into SMH-202

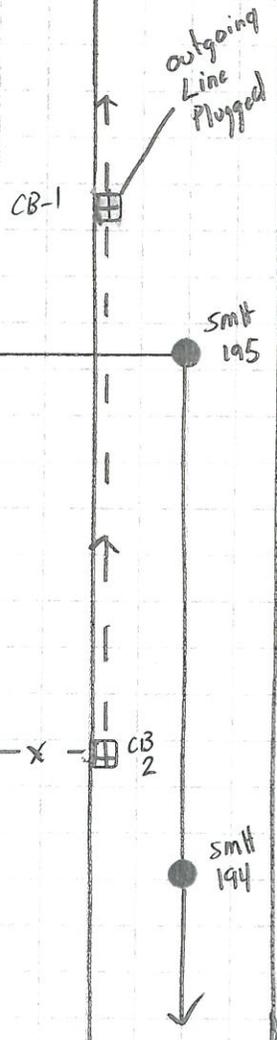
Possible that Sanitary service and Small 6" drain Line in CB-2 are in same trench?

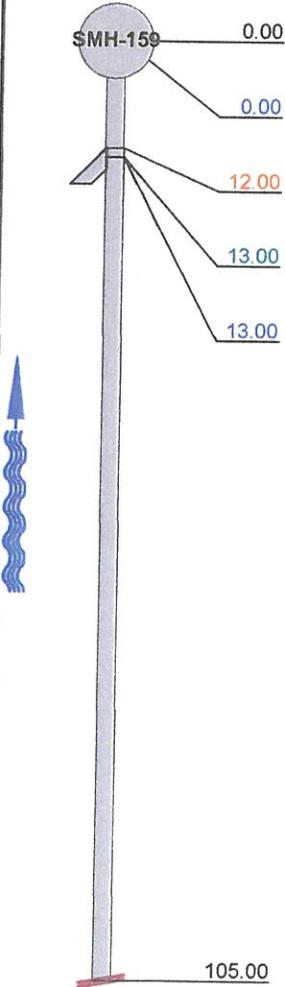
1:255	Position	Code	Observation	Grade

AMH	Downstream Manhole, Survey Begins / -	
	0.00	MWL	Water Level, 5 % of cross sectional area	M 2
	12.00	FL	Fracture Longitudinal, at 12 o'clock, within 8 inches of joint: YES	S 3
	13.00	MYV	Dye Test Visible / 13 ft source found	M 5
	13.00	TFD	Tap Factory Made Defective, at 03 o'clock, 6", within 8 inches of joint: YES / offset joint in svc	M 2
	105.00	MSA	Survey Abandoned / source found

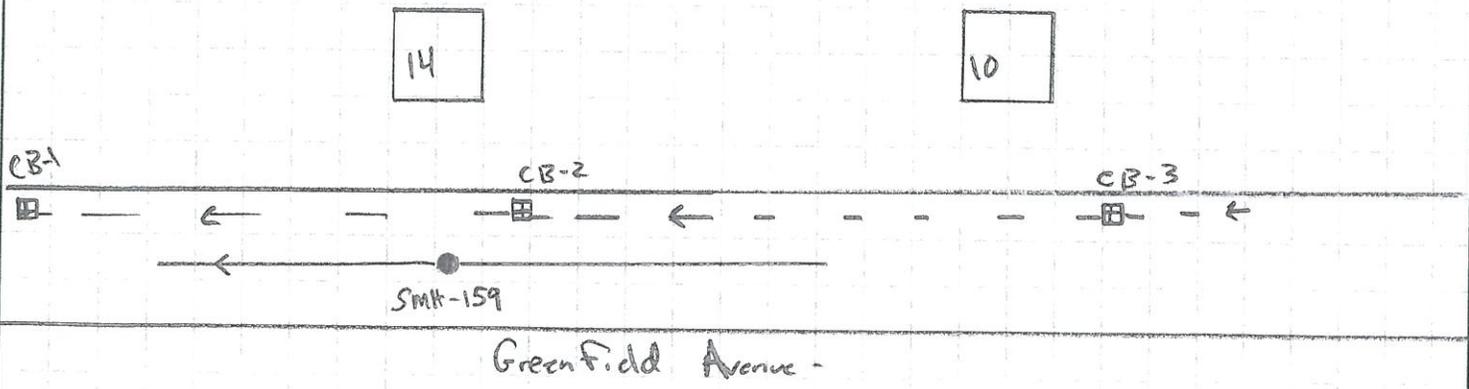
We plugged the incoming line of CB-1 and dye flooded the Drain Line
we then televised the Sanitary Sewer Line upstream of SMH-159
and a leak was found at a service Connection.
