Technical Memorandum

To	Ridgefield WPCA	Page	1 of 22
CC	C. Fisher, J. O'Brien, J. Pennell		
Subject	Town of Ridgefield, CT Phase 2 Wastewater Facilities Plan Technical Memorandum No. 1 – Dyed Water Testing and Tracing		
From	Jon Pearson/Alberto Angles		
Date	October 27, 2016

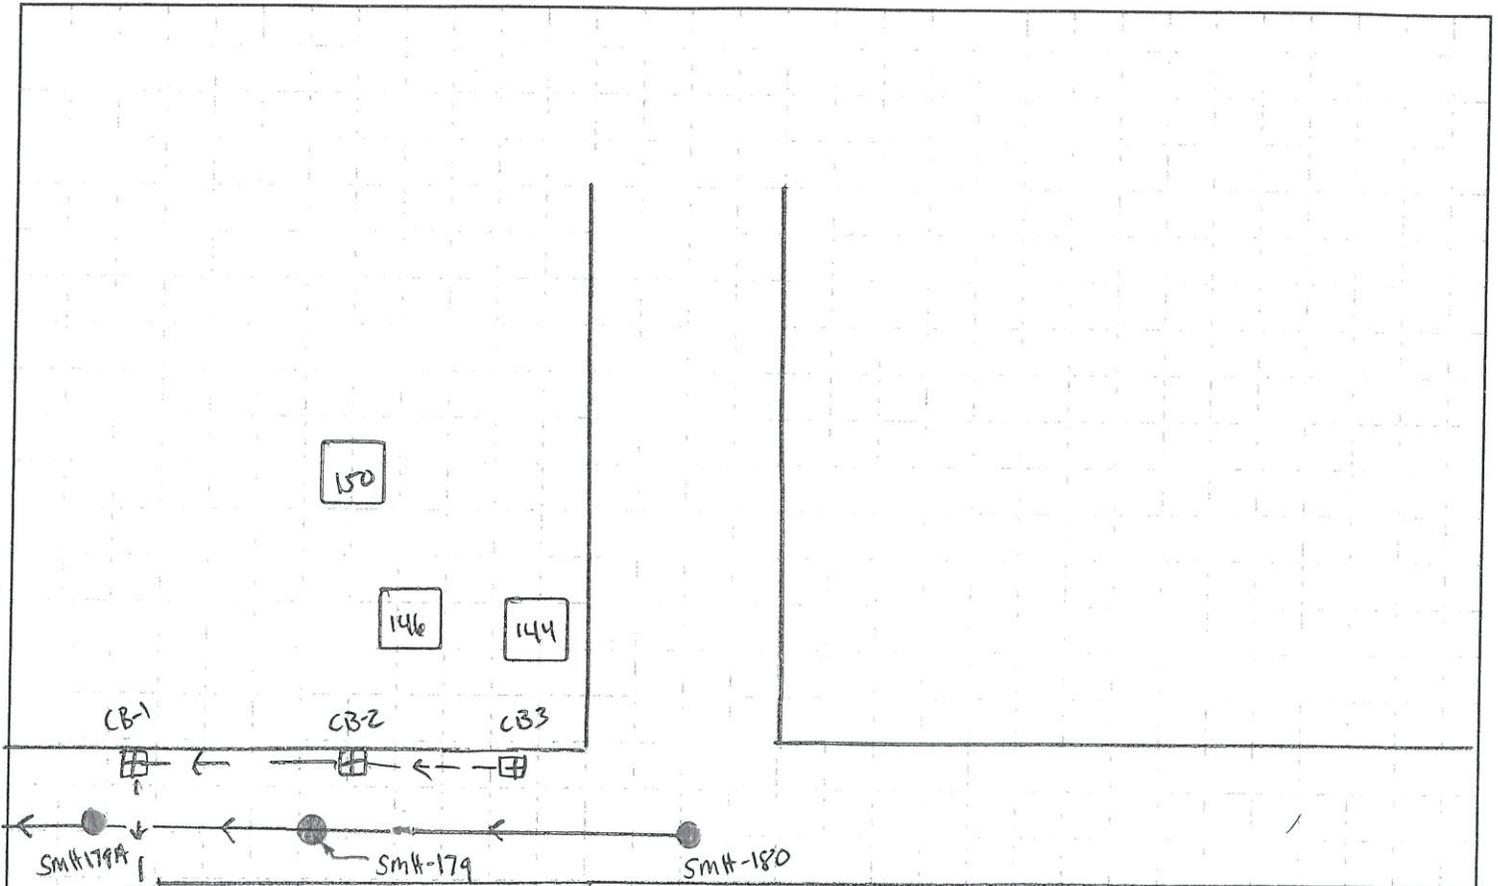
CB-1 Incoming Line was Plugged and line was flooded, the Corrugated pipe was so deteriorated it wouldn't hold water, we then Plugged CB-2 and flooded upstream to CB-3, the Sanitary sewer was televised and no dye was found.

CB-2 is the Structure that Smoked, It is possible the defect is Between CB-1 and CB-2, but not being able to flood pipe due to deteriorated pipe hindered results.

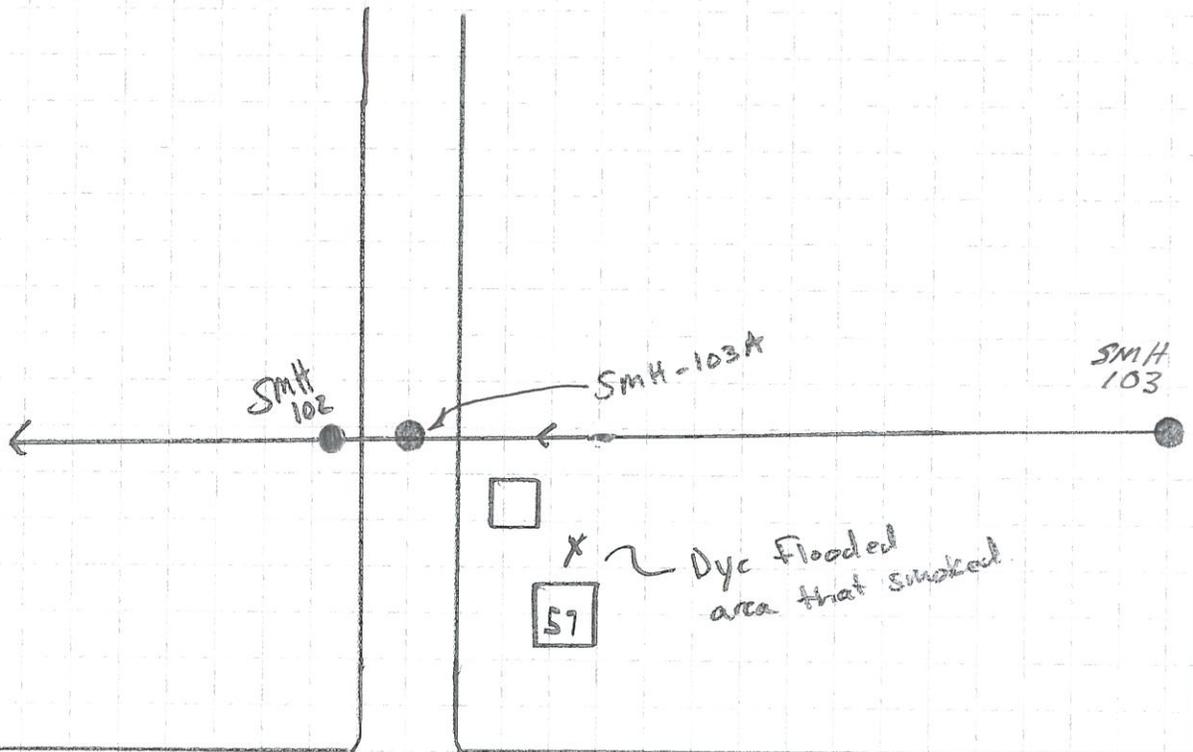
Main St.

Dye water was introduced to the area that smoked behind 57 Main st. The sewer was televised from SMH-102 upstream and dye water was observed coming out of a service connection at 135'

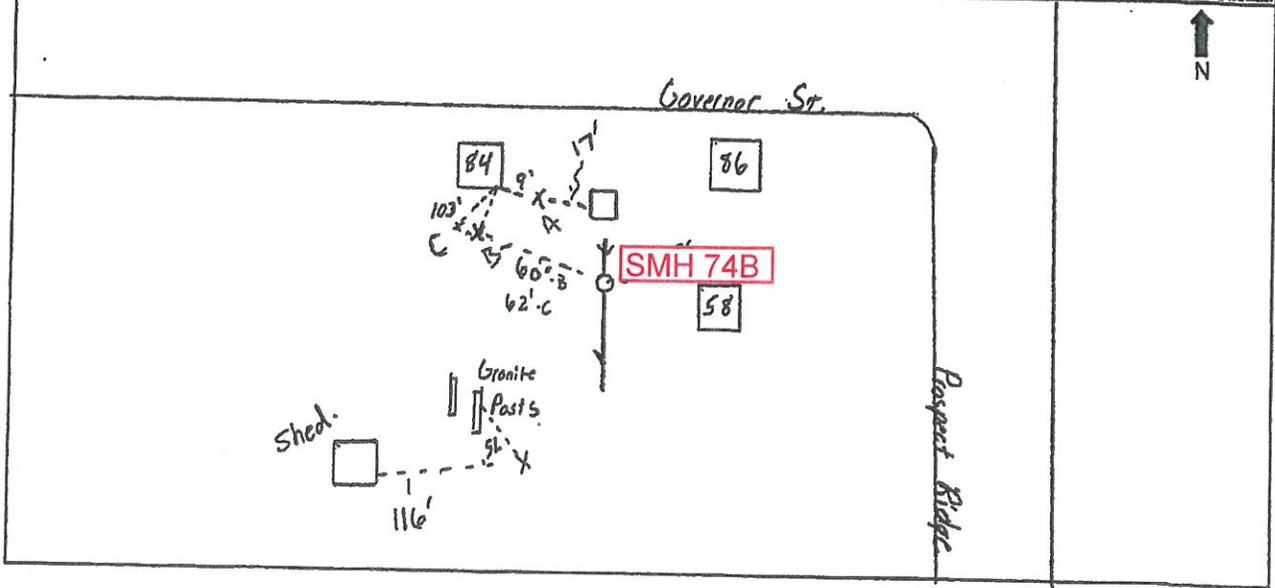
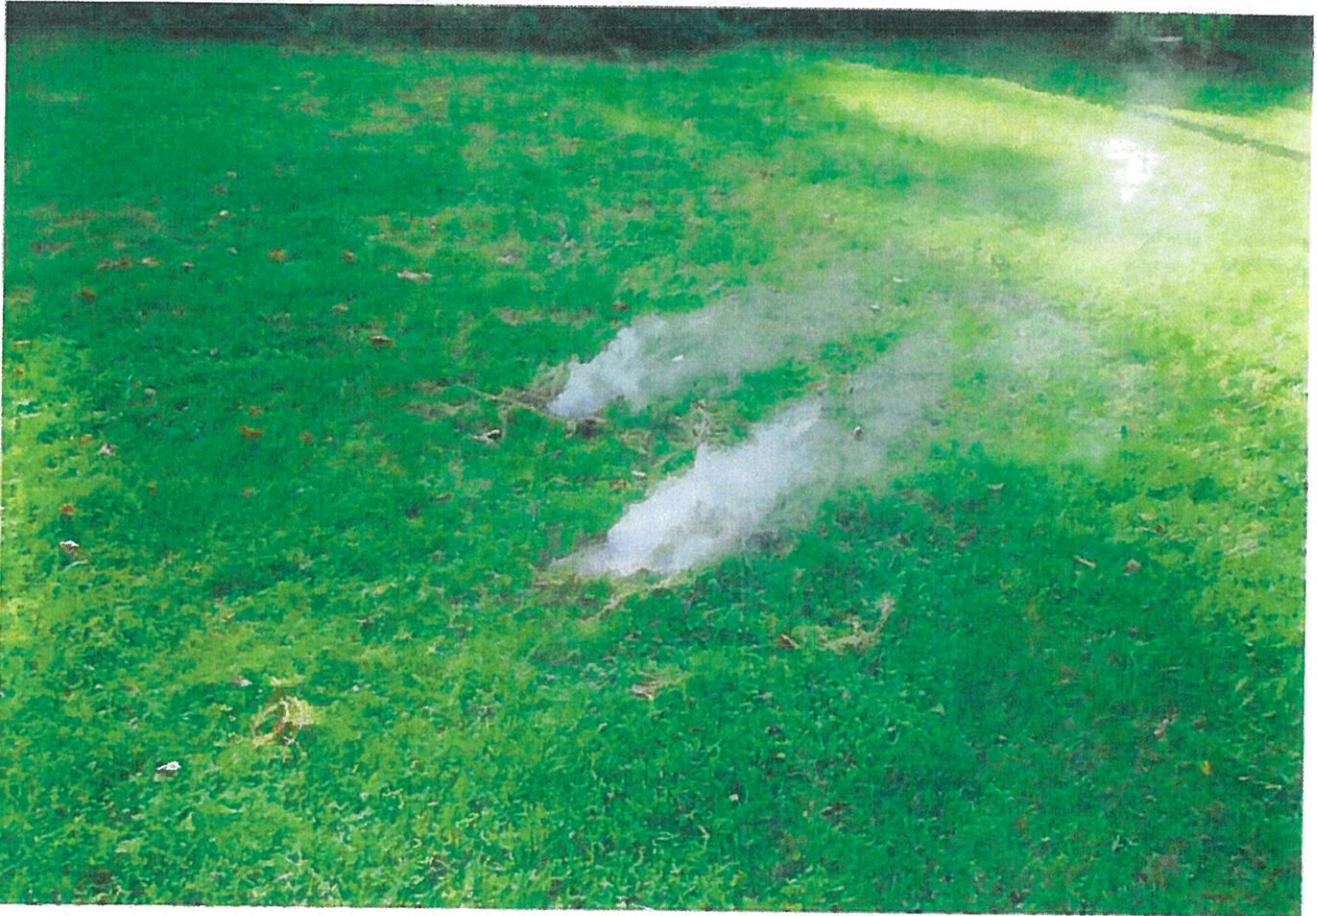
Date 7/18/16 Project 84 Governor St. Initial S.S.

We flooded the area around the defect "hole" with green dye and green dye was found coming into SMH- 74B through what appeared to be a possible abandoned service connection.

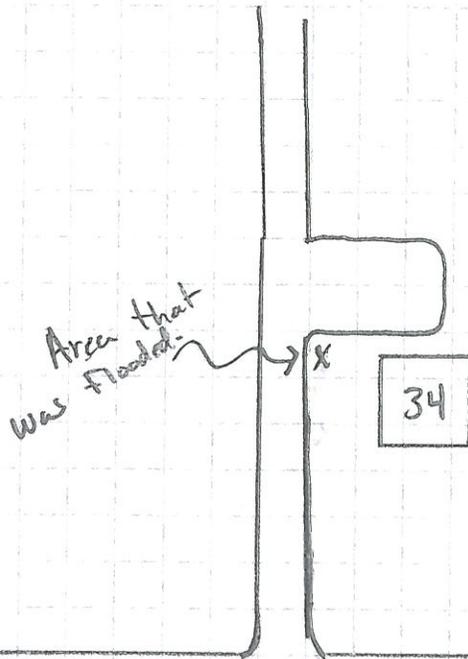
Defect at 34 Catoonah St. had been repaired prior to doing dye Flood. The defect was caused by a contractor that installed a gas line and punctured a 2" Ejector Pump Line. A dye flood was performed to confirm and no dye was found in the Sanitary Sewer.
