Technical Memorandum

To	Ridgefield WPCA	Page	1 of 9
CC	C. Fisher, J. O'Brien, M. Burke, J. Pennell		
Subject	Town of Ridgefield, CT Phase 2 Wastewater Facilities Plan Technical Memorandum No. 2 – Internal CCTV Inspection of Selected Mainline Sewers and Lateral Service Connections		
From	Jon Pearson/Alberto Angles		
Date	November 17, 2016

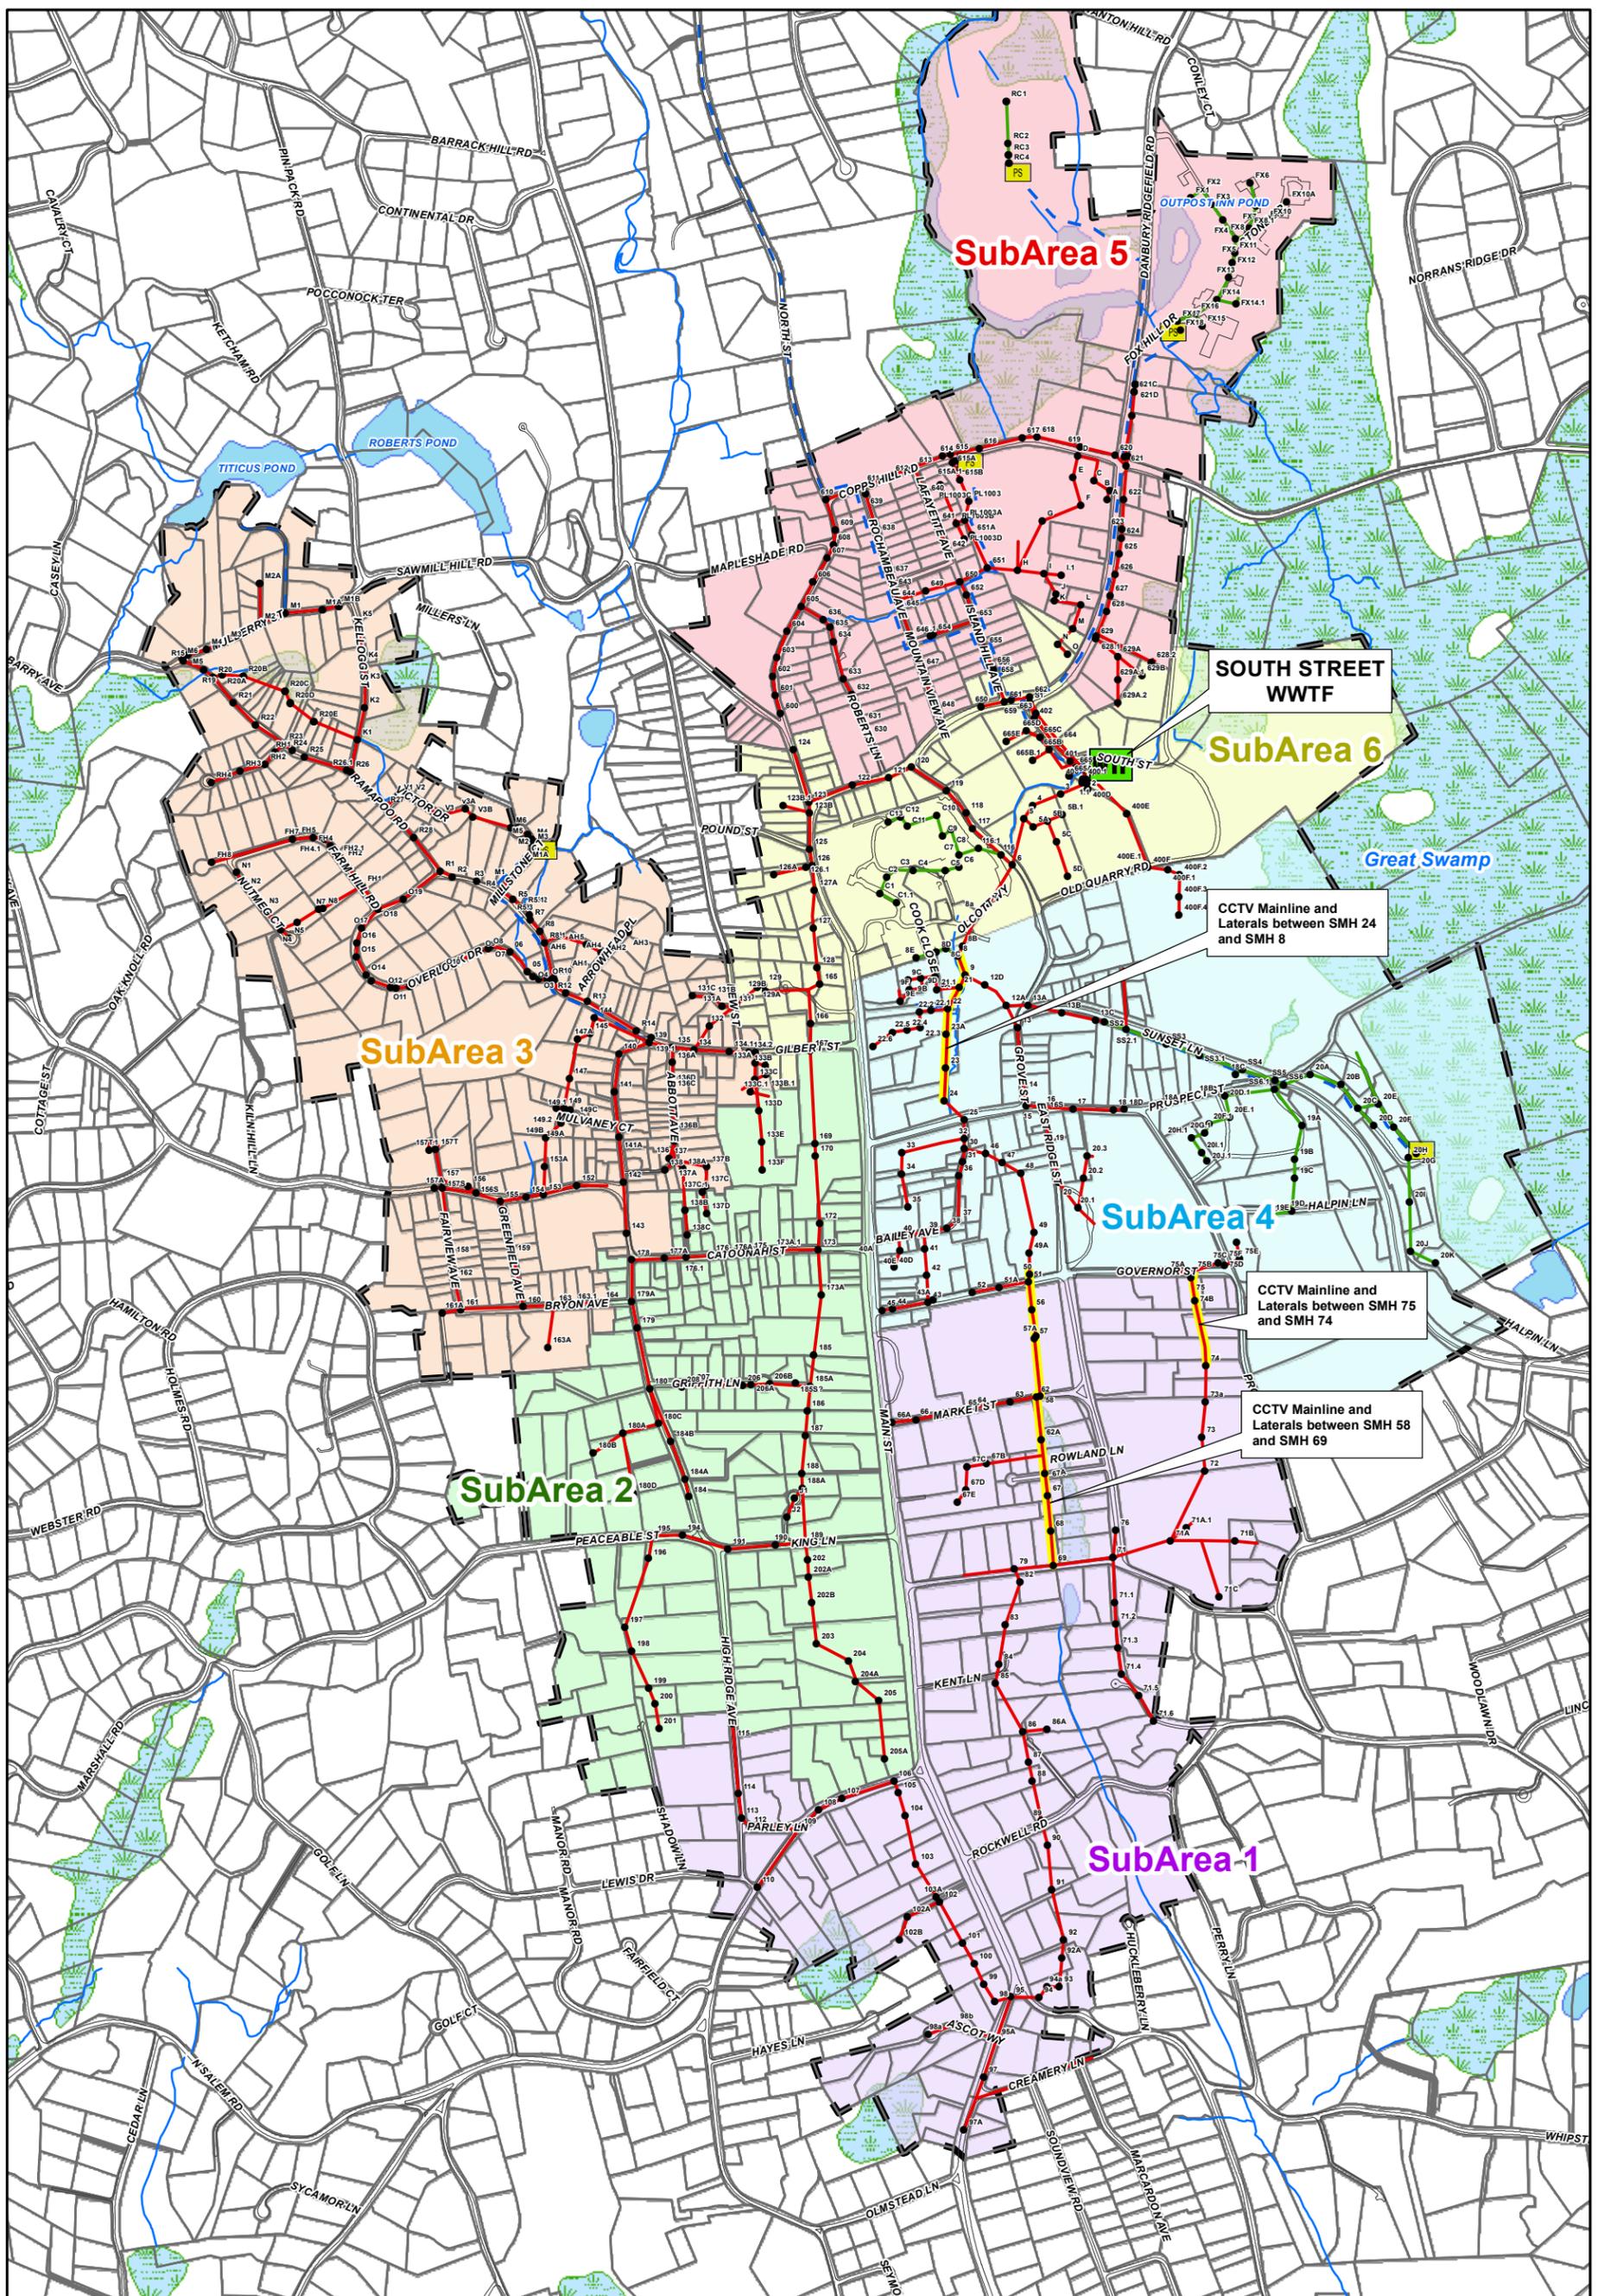
FIGURE 1: CCTV OF SELECTED MAINLINE AND LATERAL SANITARY SEWERS
 TECHNICAL MEMORANDUM NO.2
 NOVEMBER 2016

Field work consisted of closed circuit television (CCTV) inspection of selected mainline sewers and lateral service connections to identify infiltration sources. The criteria for selecting locations of the CCTV inspections included low-lying areas which may be subject to flooding, and those which have unusually long service connections. The locations of the CCTV inspection of mainline sewers and lateral service connections are indicated on Figure 1.
