Technical Memorandum

To	Ridgefield WPCA	Page	1 of 22
CC	C. Fisher, J. O'Brien, J. Pennell		
Subject	Town of Ridgefield, CT Phase 2 Wastewater Facilities Plan Technical Memorandum No. 1 – Dyed Water Testing and Tracing		
From	Jon Pearson/Alberto Angles		
Date	October 27, 2016

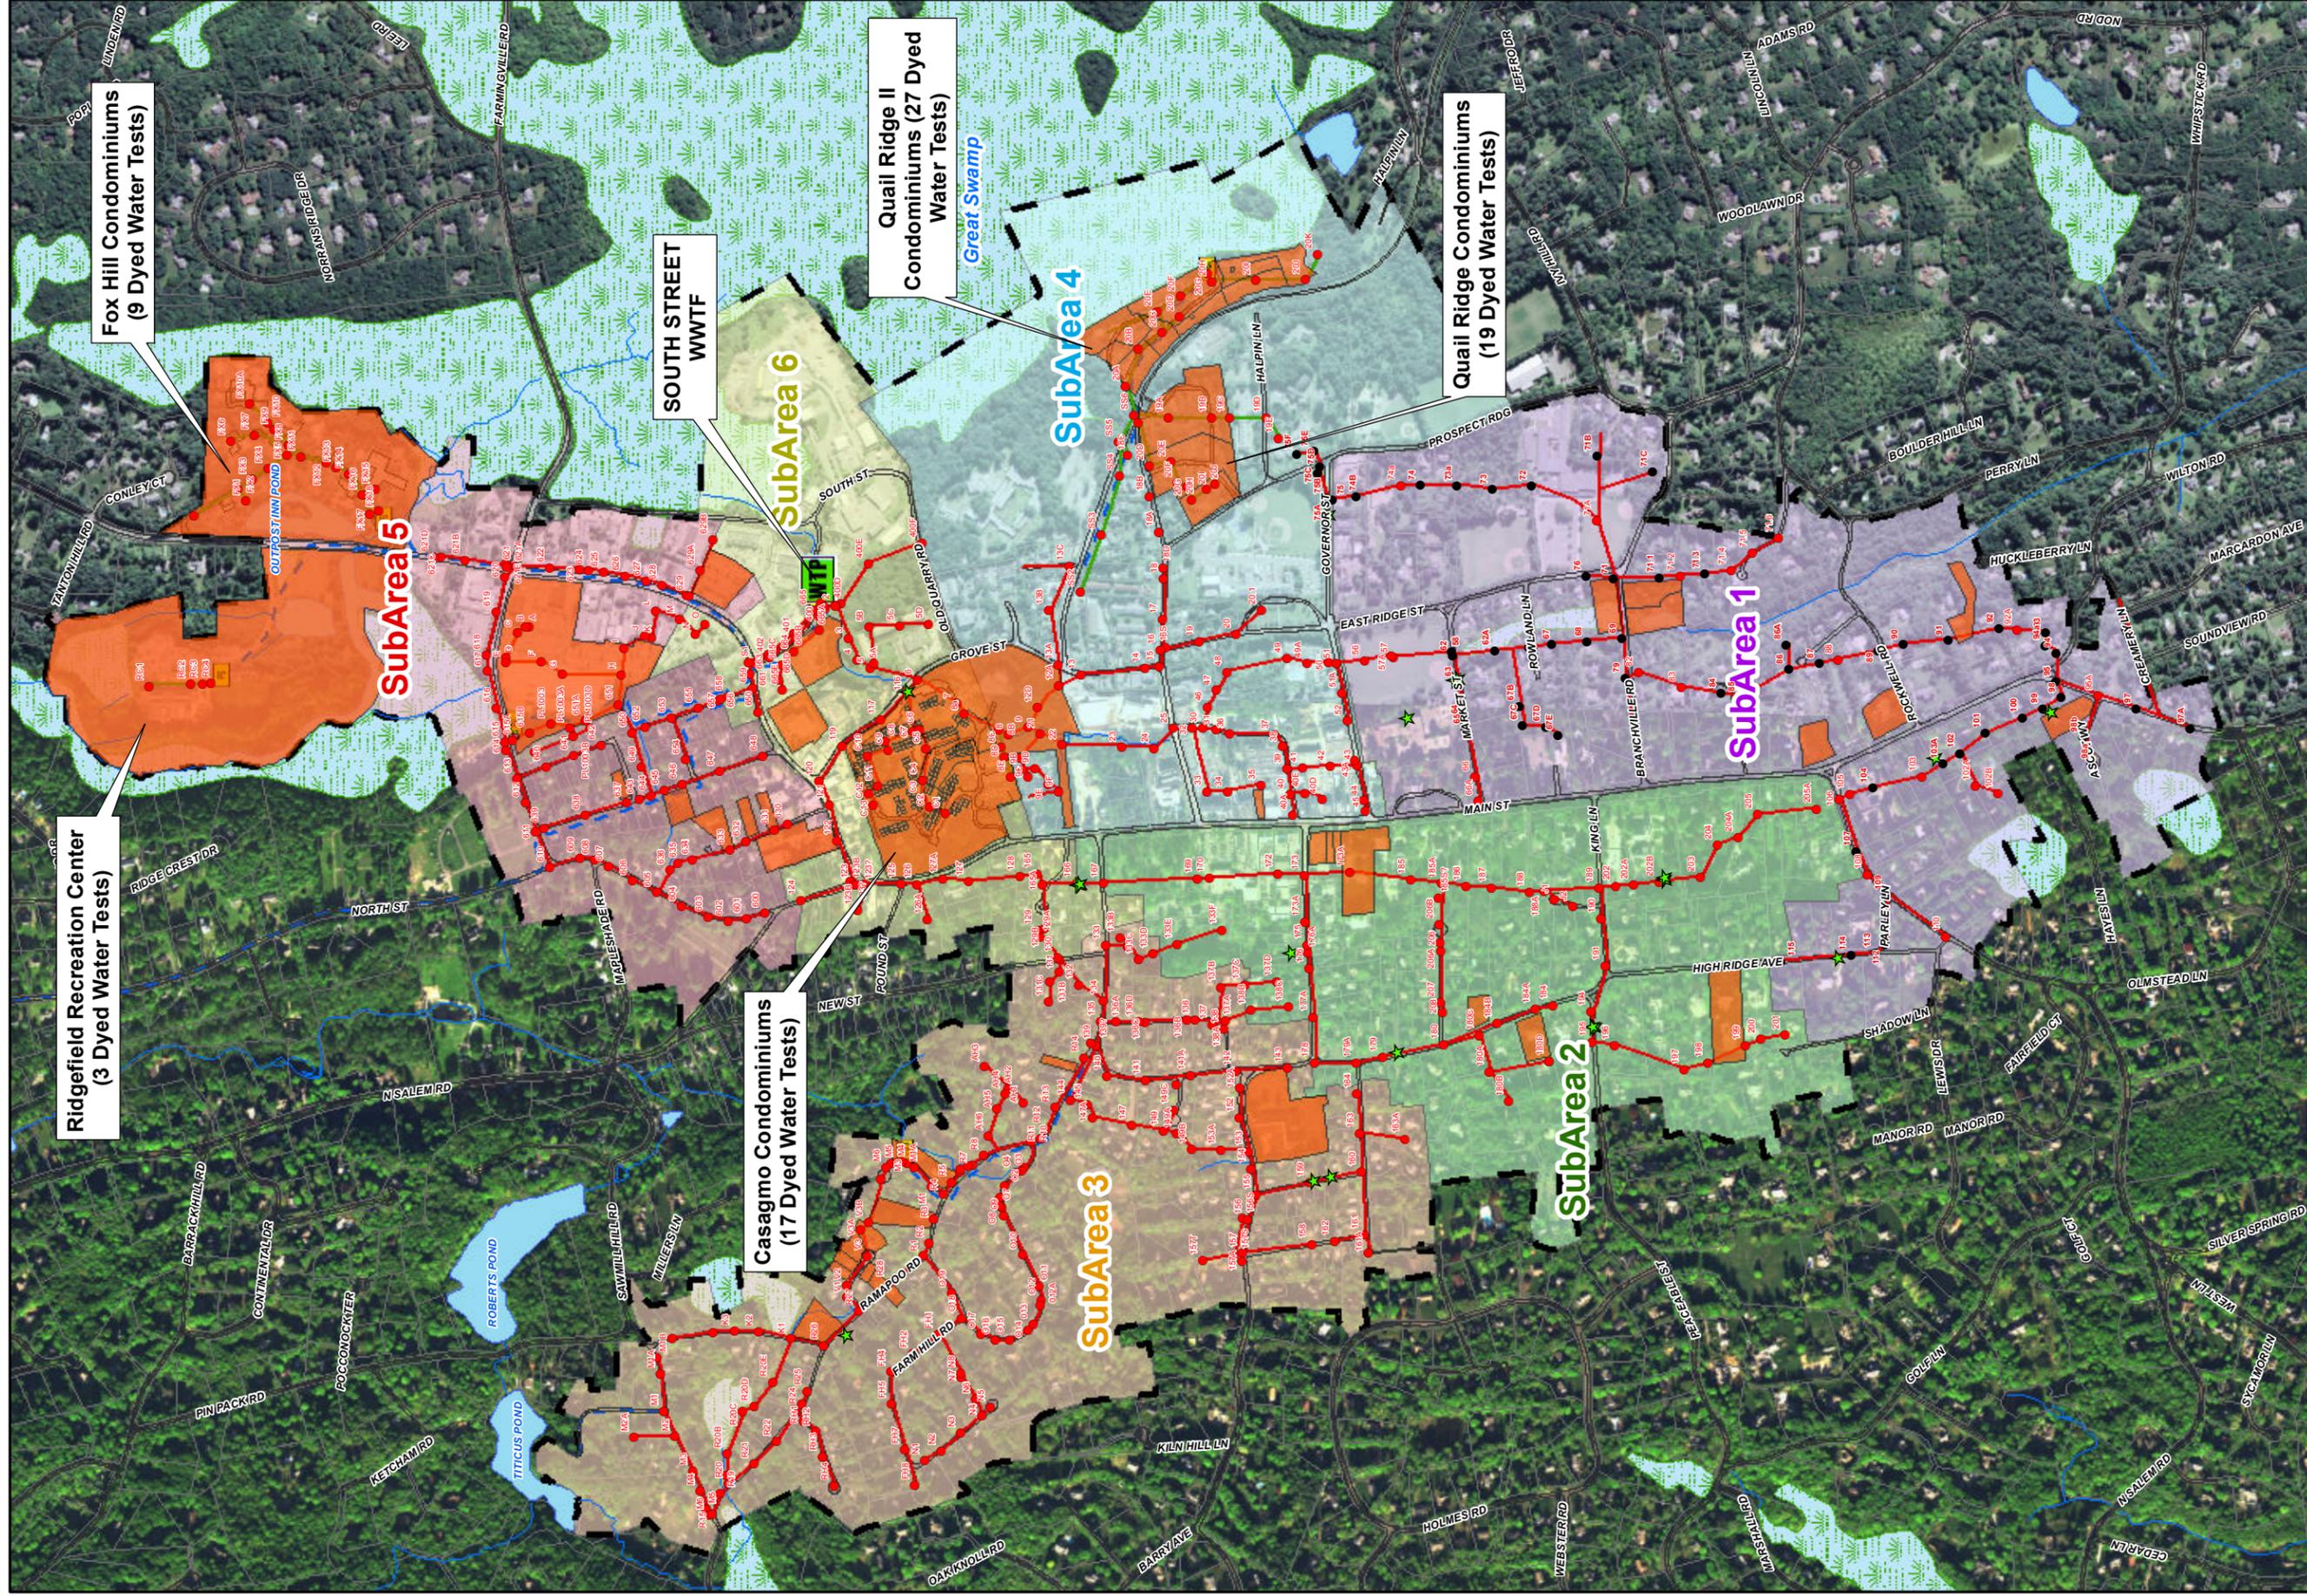
FIGURE 1: DYED WATER TESTING/TRACING
 OCTOBER 2016
 RIDGEFIELD, CT
 PHASE II WASTEWATER FACILITIES PLAN

Dyed water testing was performed at locations throughout the six sub-areas of Sewer District 1. Figure 1 depicts the locations where dyed water testing was performed. The locations are listed in Table 1. Dyed water testing is performed by introducing a small amount of dyed water into a designated storm water structure such as downspouts, area drains, yard drains, driveway drains, building drains, and window well drains, without plugging the storm water structure. During the dyed water testing, surrounding sanitary manholes, storm drain manholes, catch basins, and other structures in the vicinity were opened and inspected for the visual observation of the presence of dyed water. The information collected in the field was tabulated and summarized by sub-area, including the discharge location of each suspect source. Field data logs, sketches and digital photographs were included. A copy of the Dye Testing Report is included as Attachment A.

Dyed water tracing was recommended to identify the location of the connection where inflow enters the sanitary sewer of the 20 indirect inflow sources that were identified during smoke testing. These inflow sources were identified at 14 addresses, within sub-areas 1, 2, 3, and 6 of Sewer District 1. Figure 1 depicts these locations. The locations are also listed in Table 2.

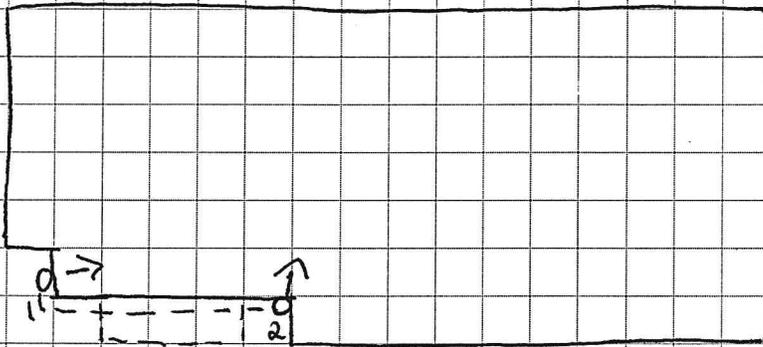
Branchville RD

Dye seen discharging
to surface
here →

- Downspouts 1 and 2 connect, sand tested
- Surface discharge

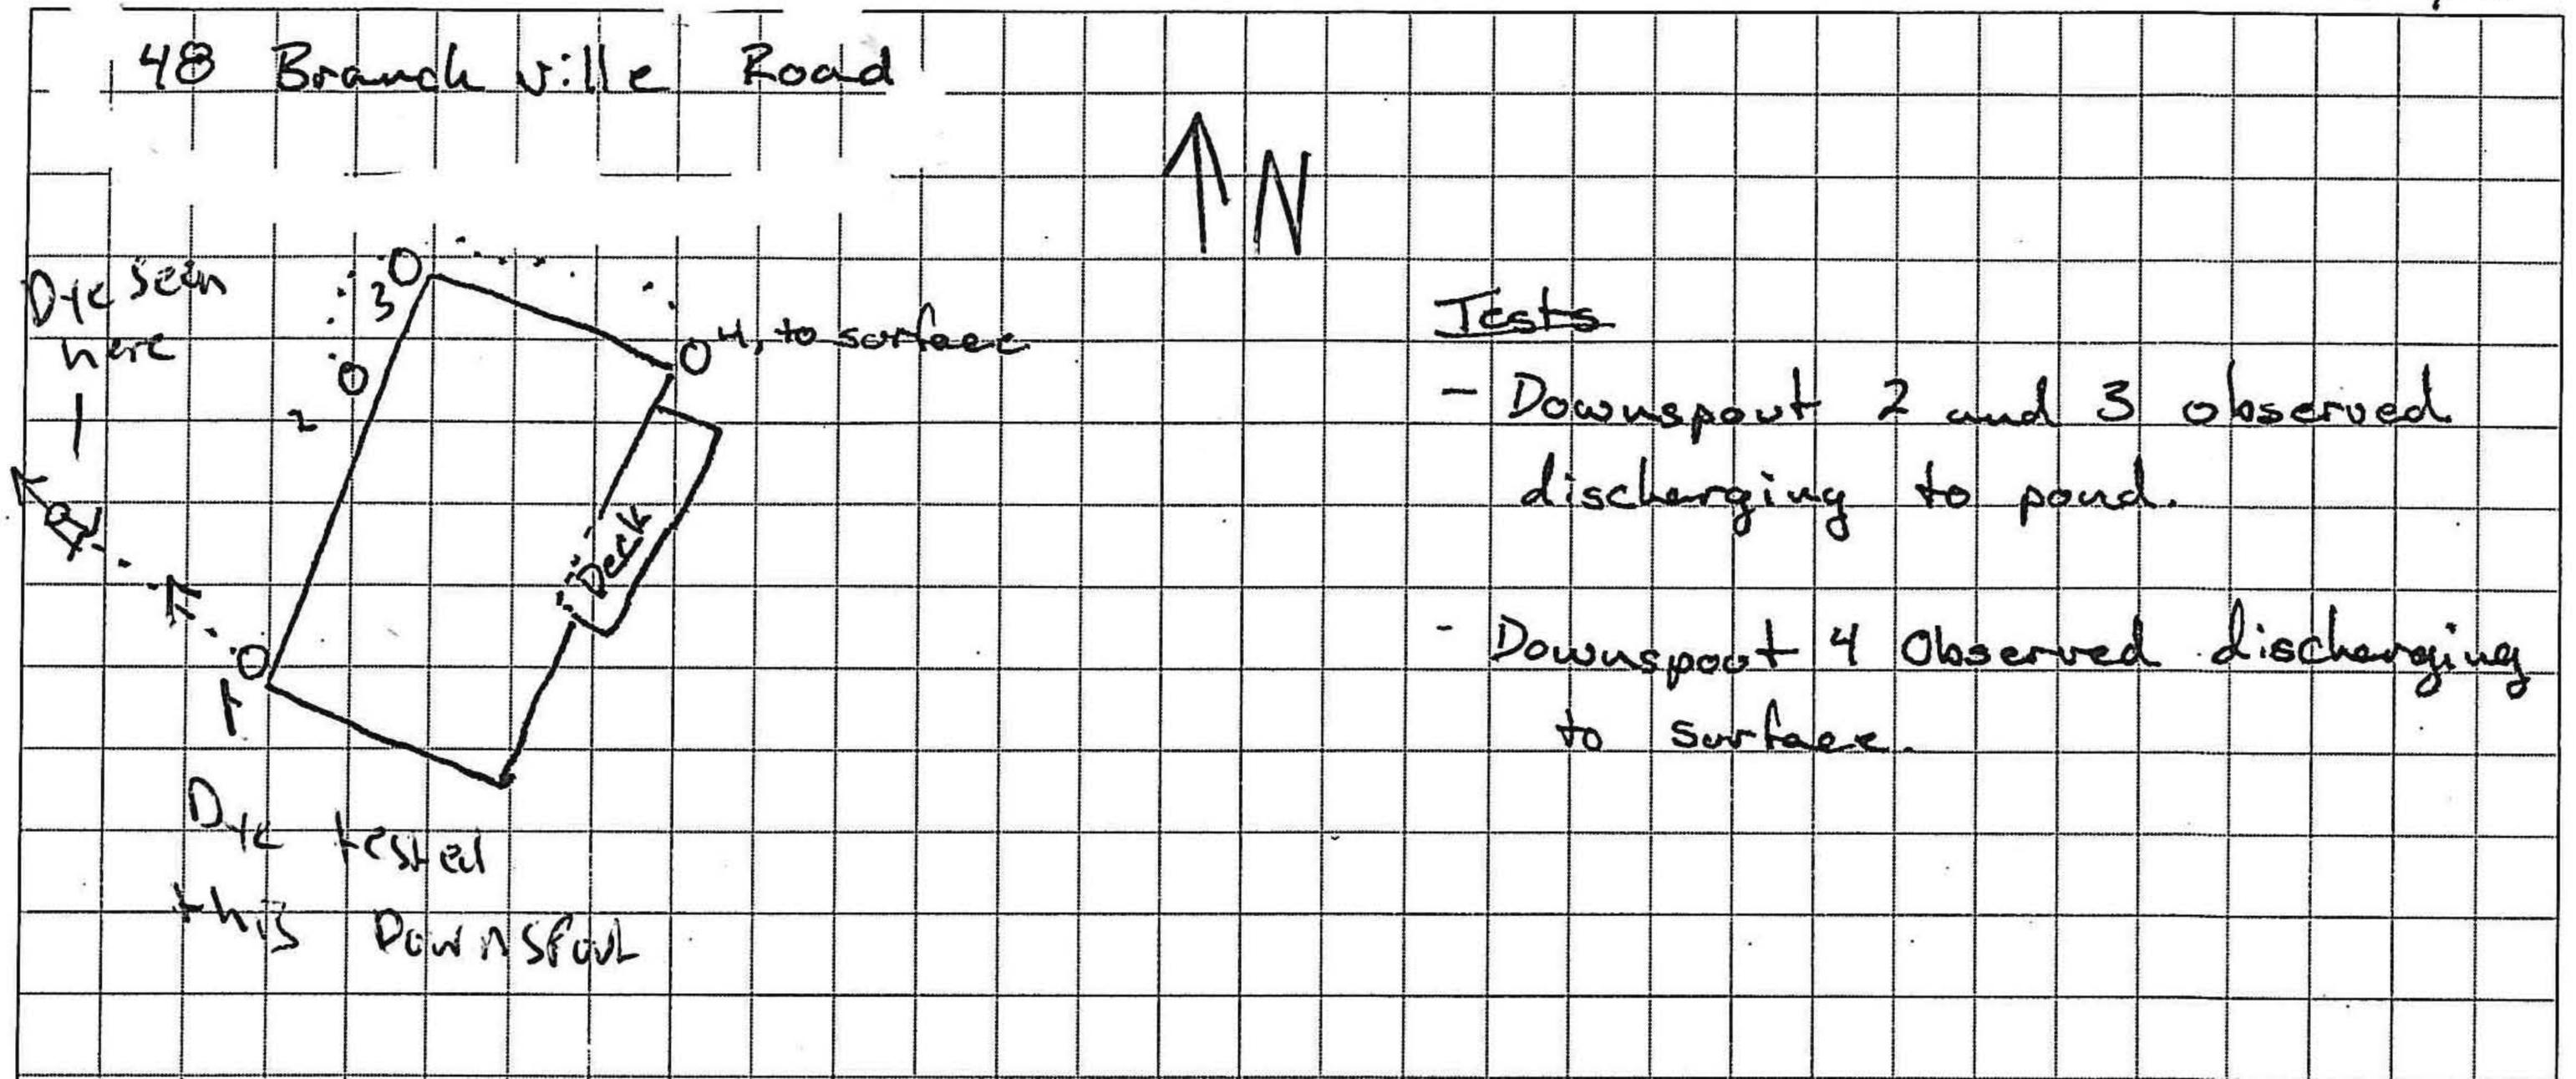
Dye tested downspout 1 from sketch. Dye observed discharging to yard and pond. All other downspouts observed discharging to surface.

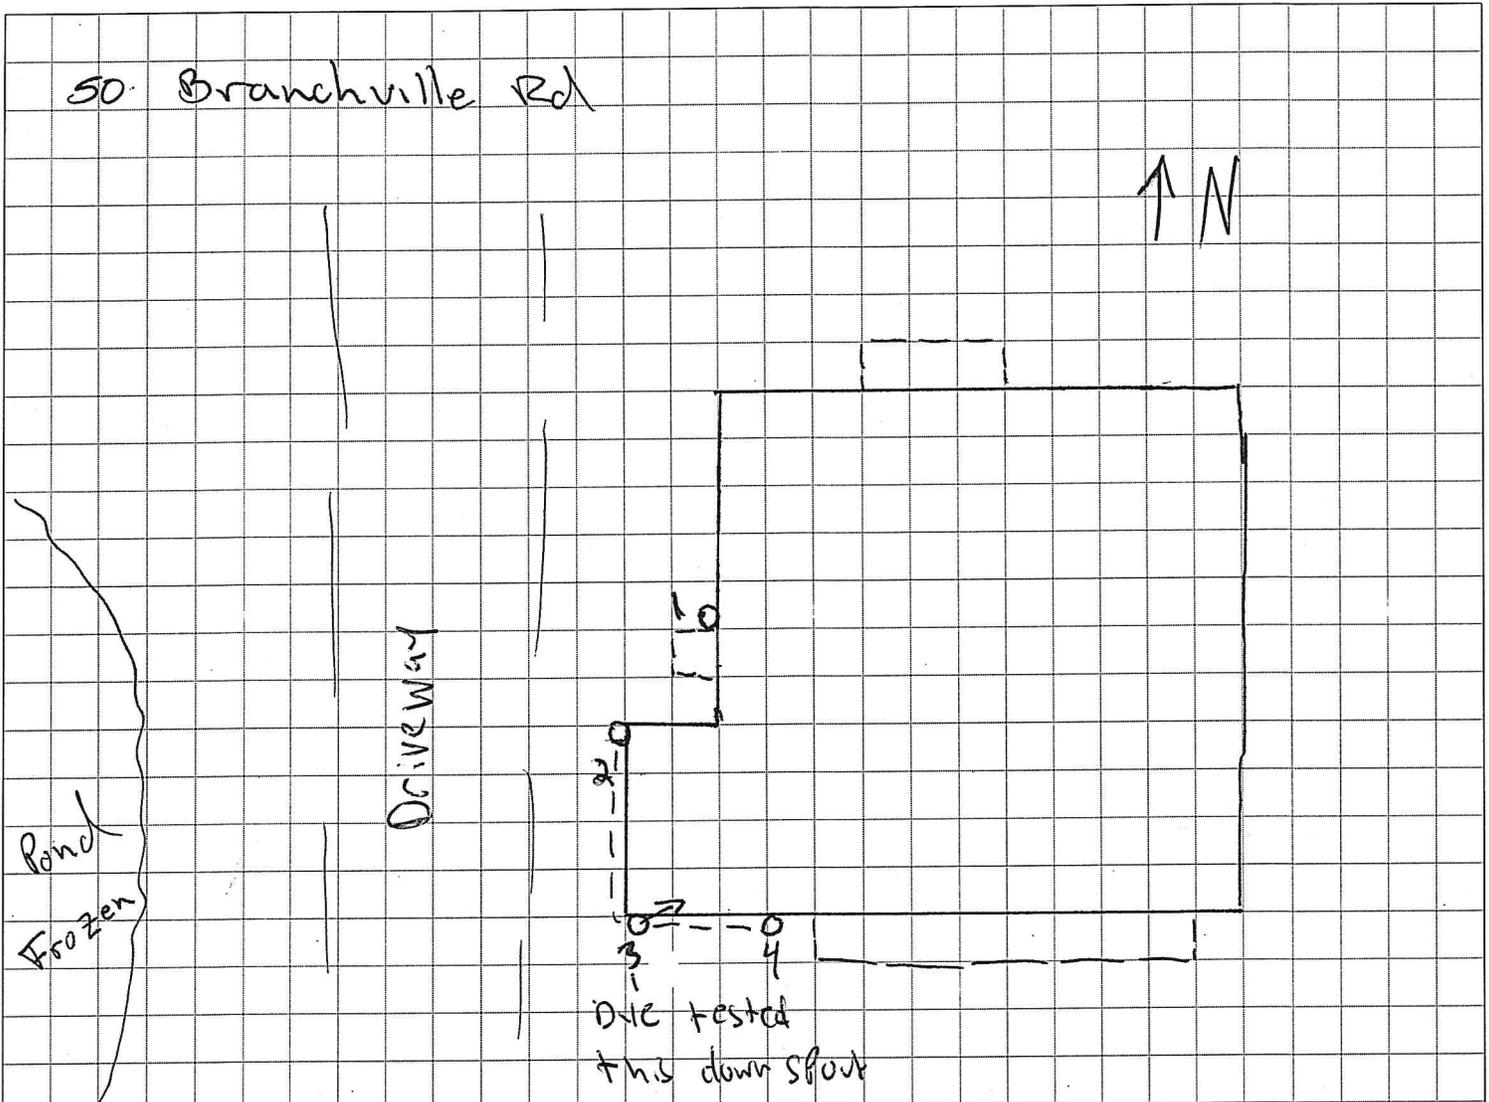
Crew poured over 100 gal of water into downspouts and waited at the sewer and drain for over an hour. Homeowner mentioned they either had a sump pump or ejector pump in the basement. Pond across the driveway was frozen. Downspout was tested 3 times.

- Downspouts 2-4 connect, sand tested
- Crew panned over logal into drain and waited over an hour at the sewer and drain
- Pond across the driveway frozen at the time
- Homeowner mentioned they either have a sump pump or ejector pump in the basement

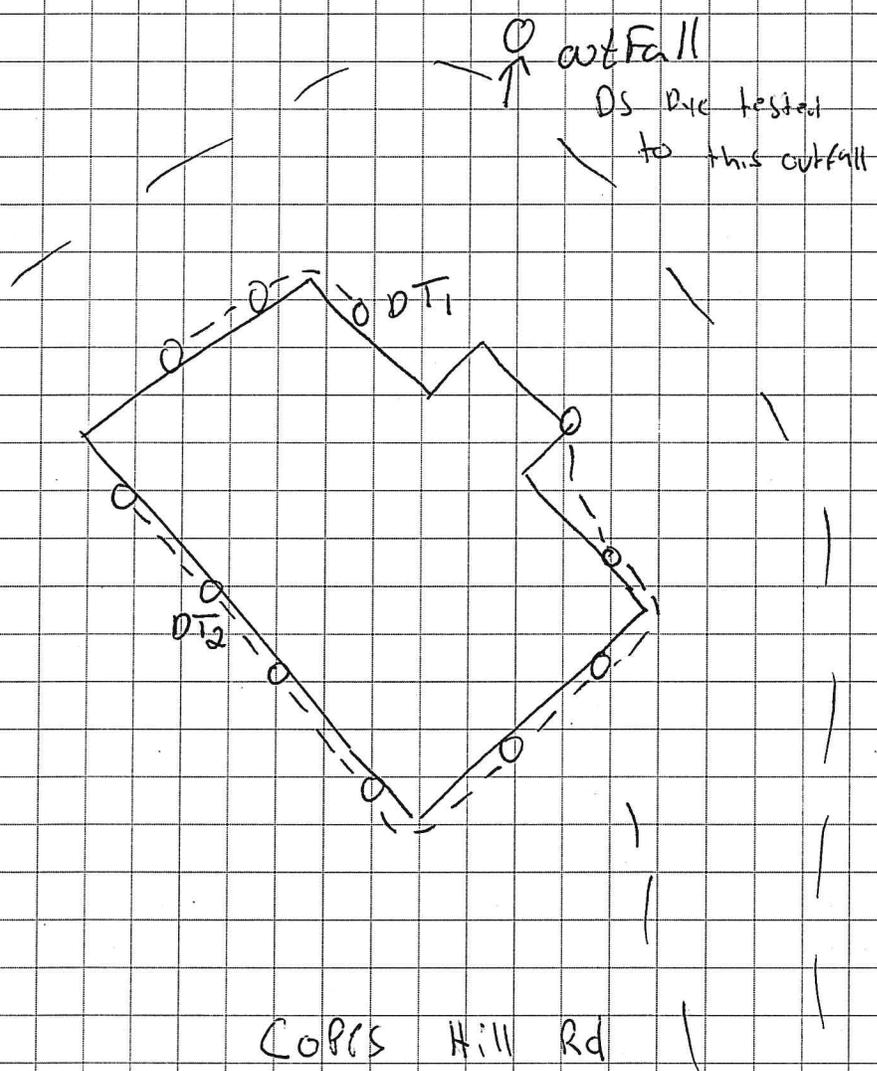
35 Capps Hill (School)

Dye seen discharging from outfall into wetland area behind building.

outfall
DS are tested
to this outfall

All downspouts discharge to ground surface in wetland area.

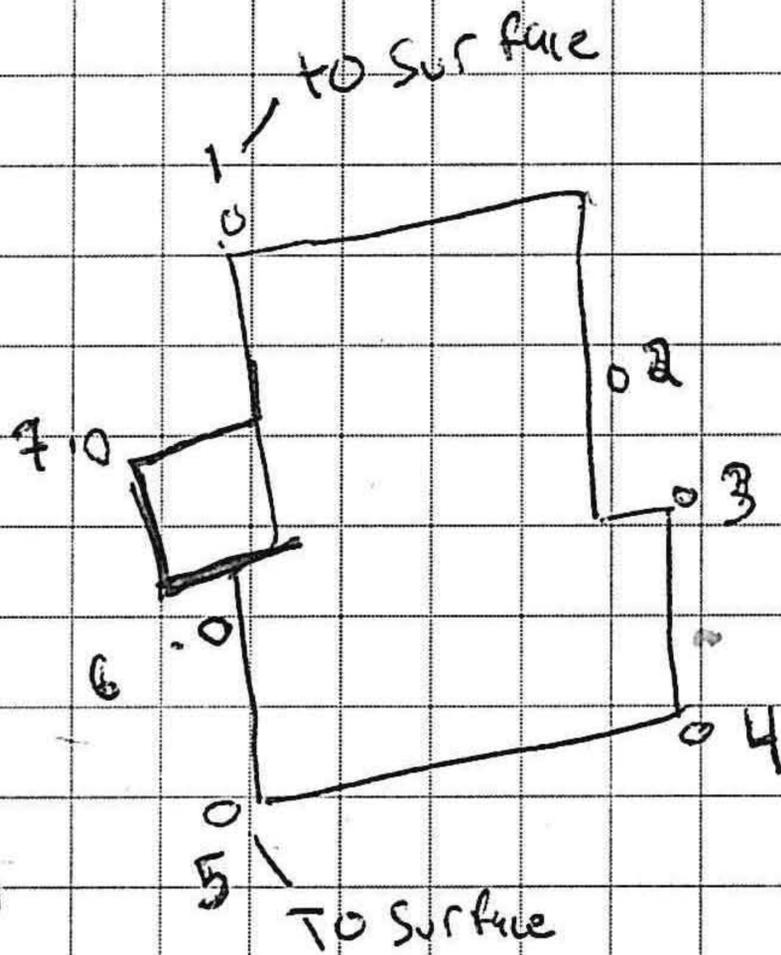
DYE seen
here for DS 5

Downspouts 6, 7 discharge to
surface.

Dye tested downspouts 5, observed
discharging to surface.

Dye tested downspout 1, observed
discharging to surface.

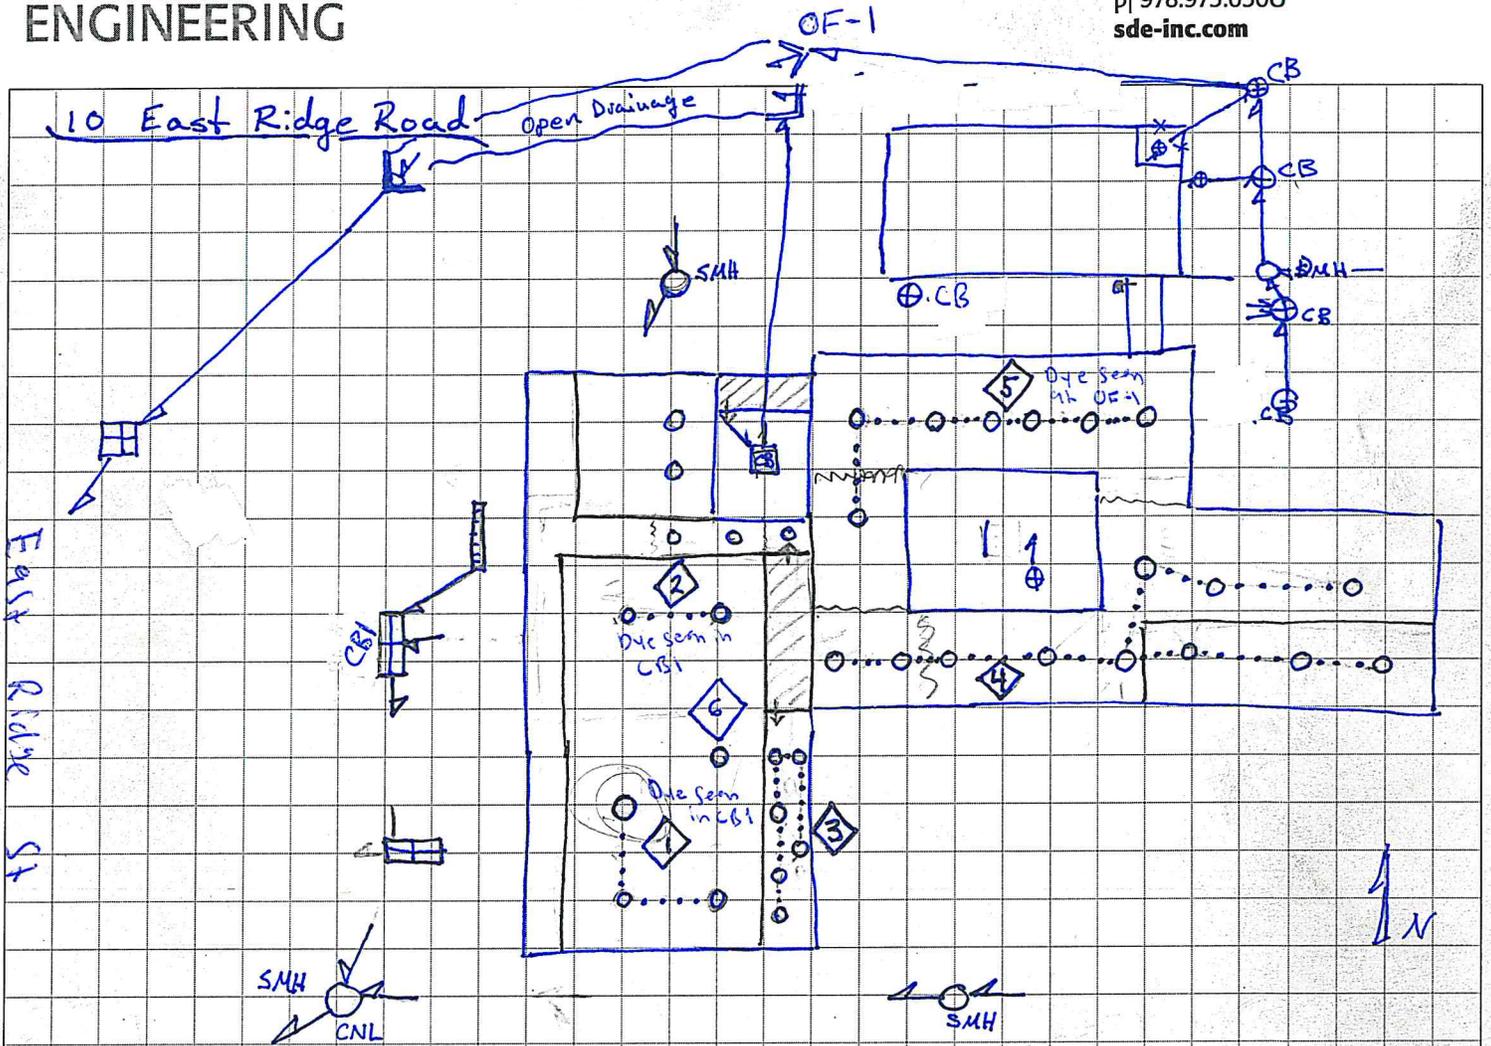
Dye tested roof drain located in zone 2 from sketch. Dye seen in CB1 from sketch.

- Tested roof drains using sound tests to find common connections with drains. Sound connections denoted with dotted lines and labeled with a Zone number in a "◇"
- Zone 1 ◇ Sound tested to catch basin in front of school, and dye tested to the same catch basin (CBI)
- Zone 2 ◇ Dye tested to catch basin (CBI) in front of the school.
- Zone 5 ◇ Dye tested to the outfall (OF-1) to the north of the school.

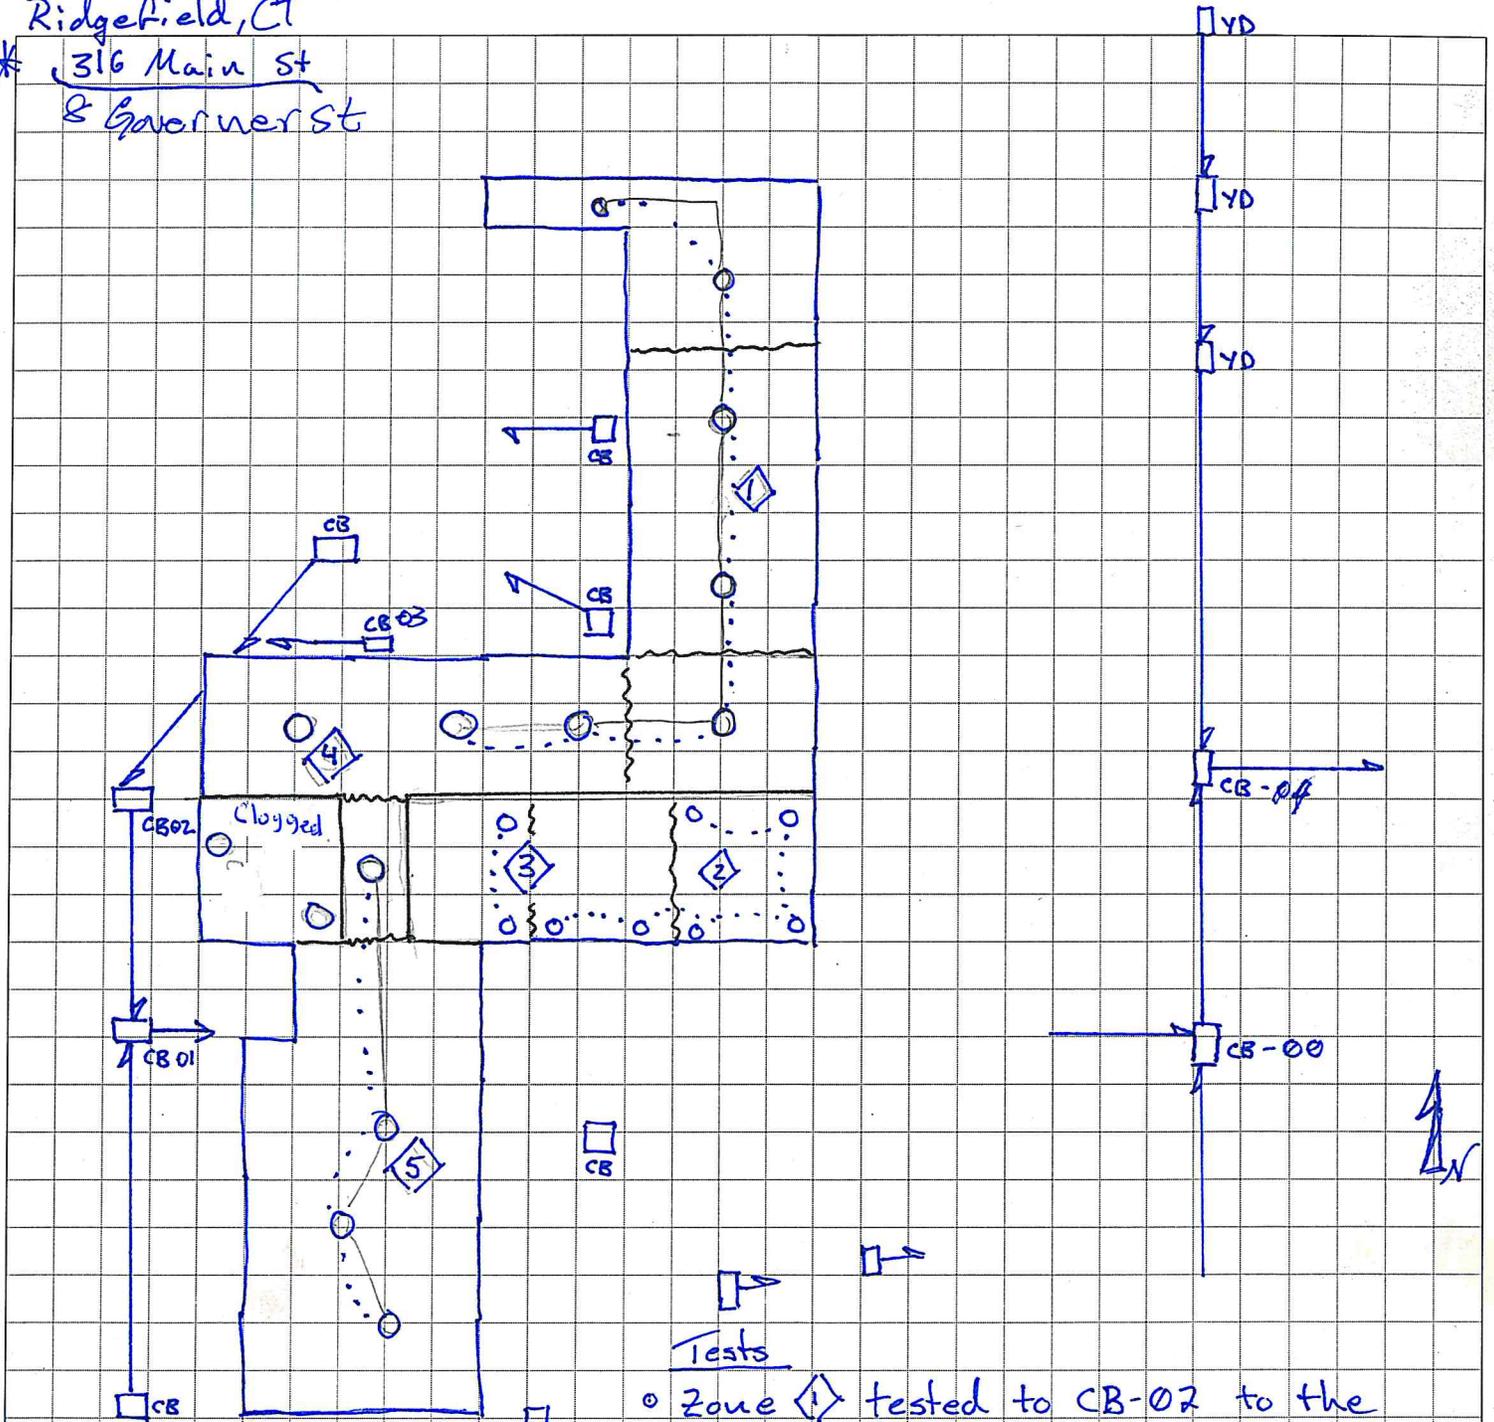
Ridgefield, CT
* 316 Main St
& Governor St

Roof drain in zone 4 (Refer to drawing for zones and CB).

- Zone 1 tested to CB-02 to the West of the school.
- Zone 2 tested to CB00 in Soccer field
- Zone 3 tested to CB00 in the Soccer field
- Zone 4 tested to CB03 on the W. Mid-line of the school
- Zone 5 tested to CB01 on the W. side of the school

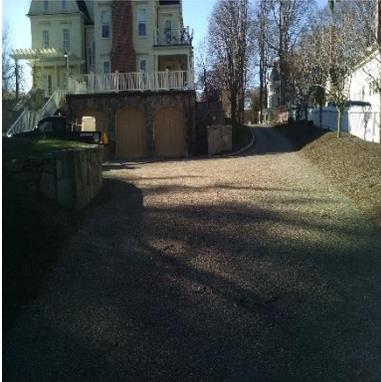
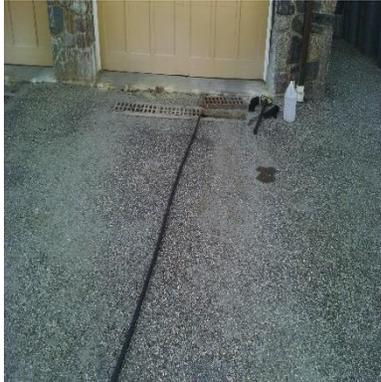
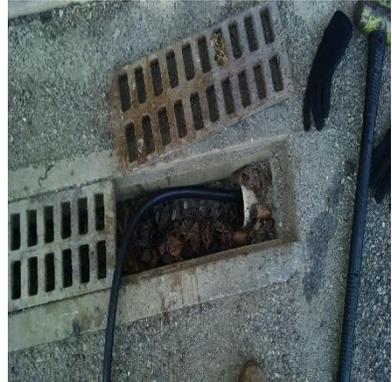
Crew poured 60 gallons of water into drain and waited roughly 1 hour. Homeowner told crew that the driveway drains go to the ground surface. Multiple discharge pipes seen but no dye observed.

- Crew poured about 60 gal of water into driveway drain
- Homeowner claimed that all the yard drains discharge on to surface. Crew found multiple discharge pipes but no dye observed.

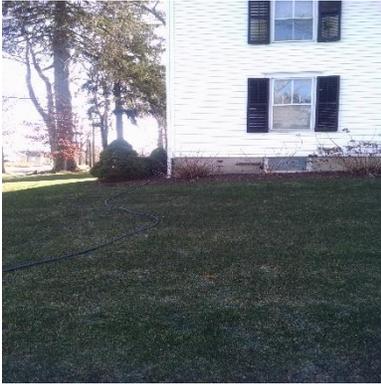
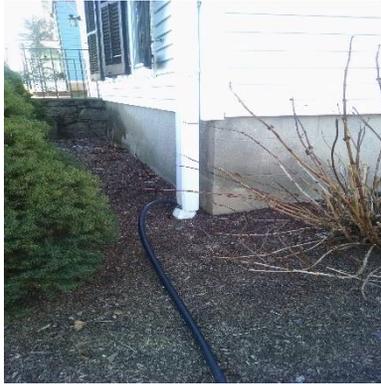
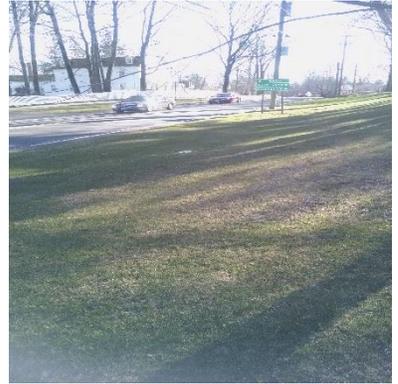
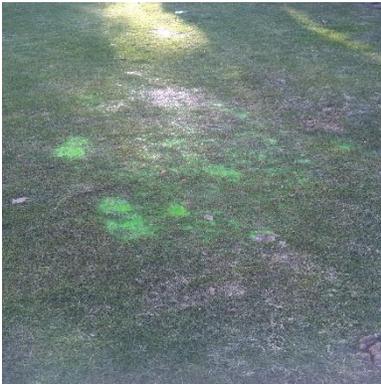
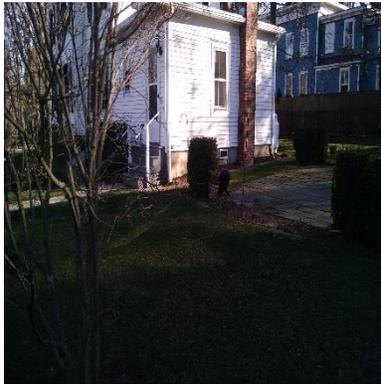
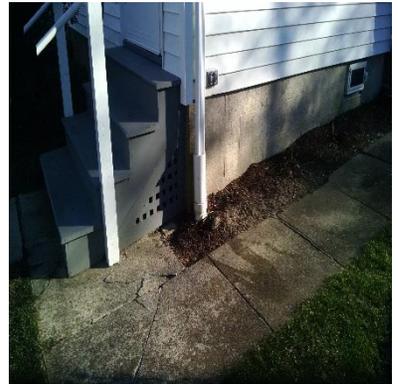
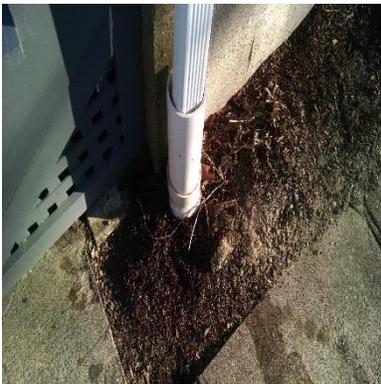
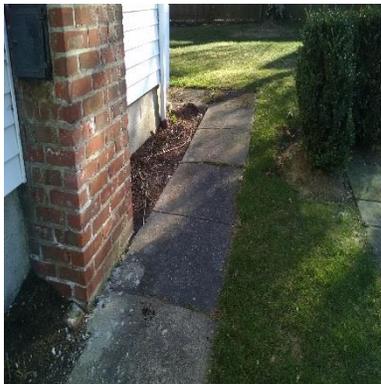
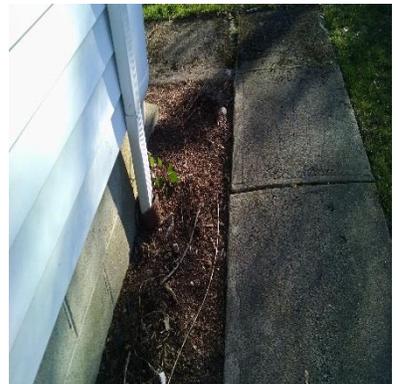
Tested downspout 2 from sketch. Crew added roughly 60 gallons of water and waited for over 1 hour. No dye found in sewer, drain or discharging to ground surface.

- Downspouts 3 and 2 connect, sand tested
- Crew poured about 60 gal of water into downspout 2 and waited at the sewer MH 205 and drain MH1 for about an hour. Crew noticed a wetland area behind the property with small amount of flow but no dye seen after an hour.
- Downspout 1 discharges onto surface

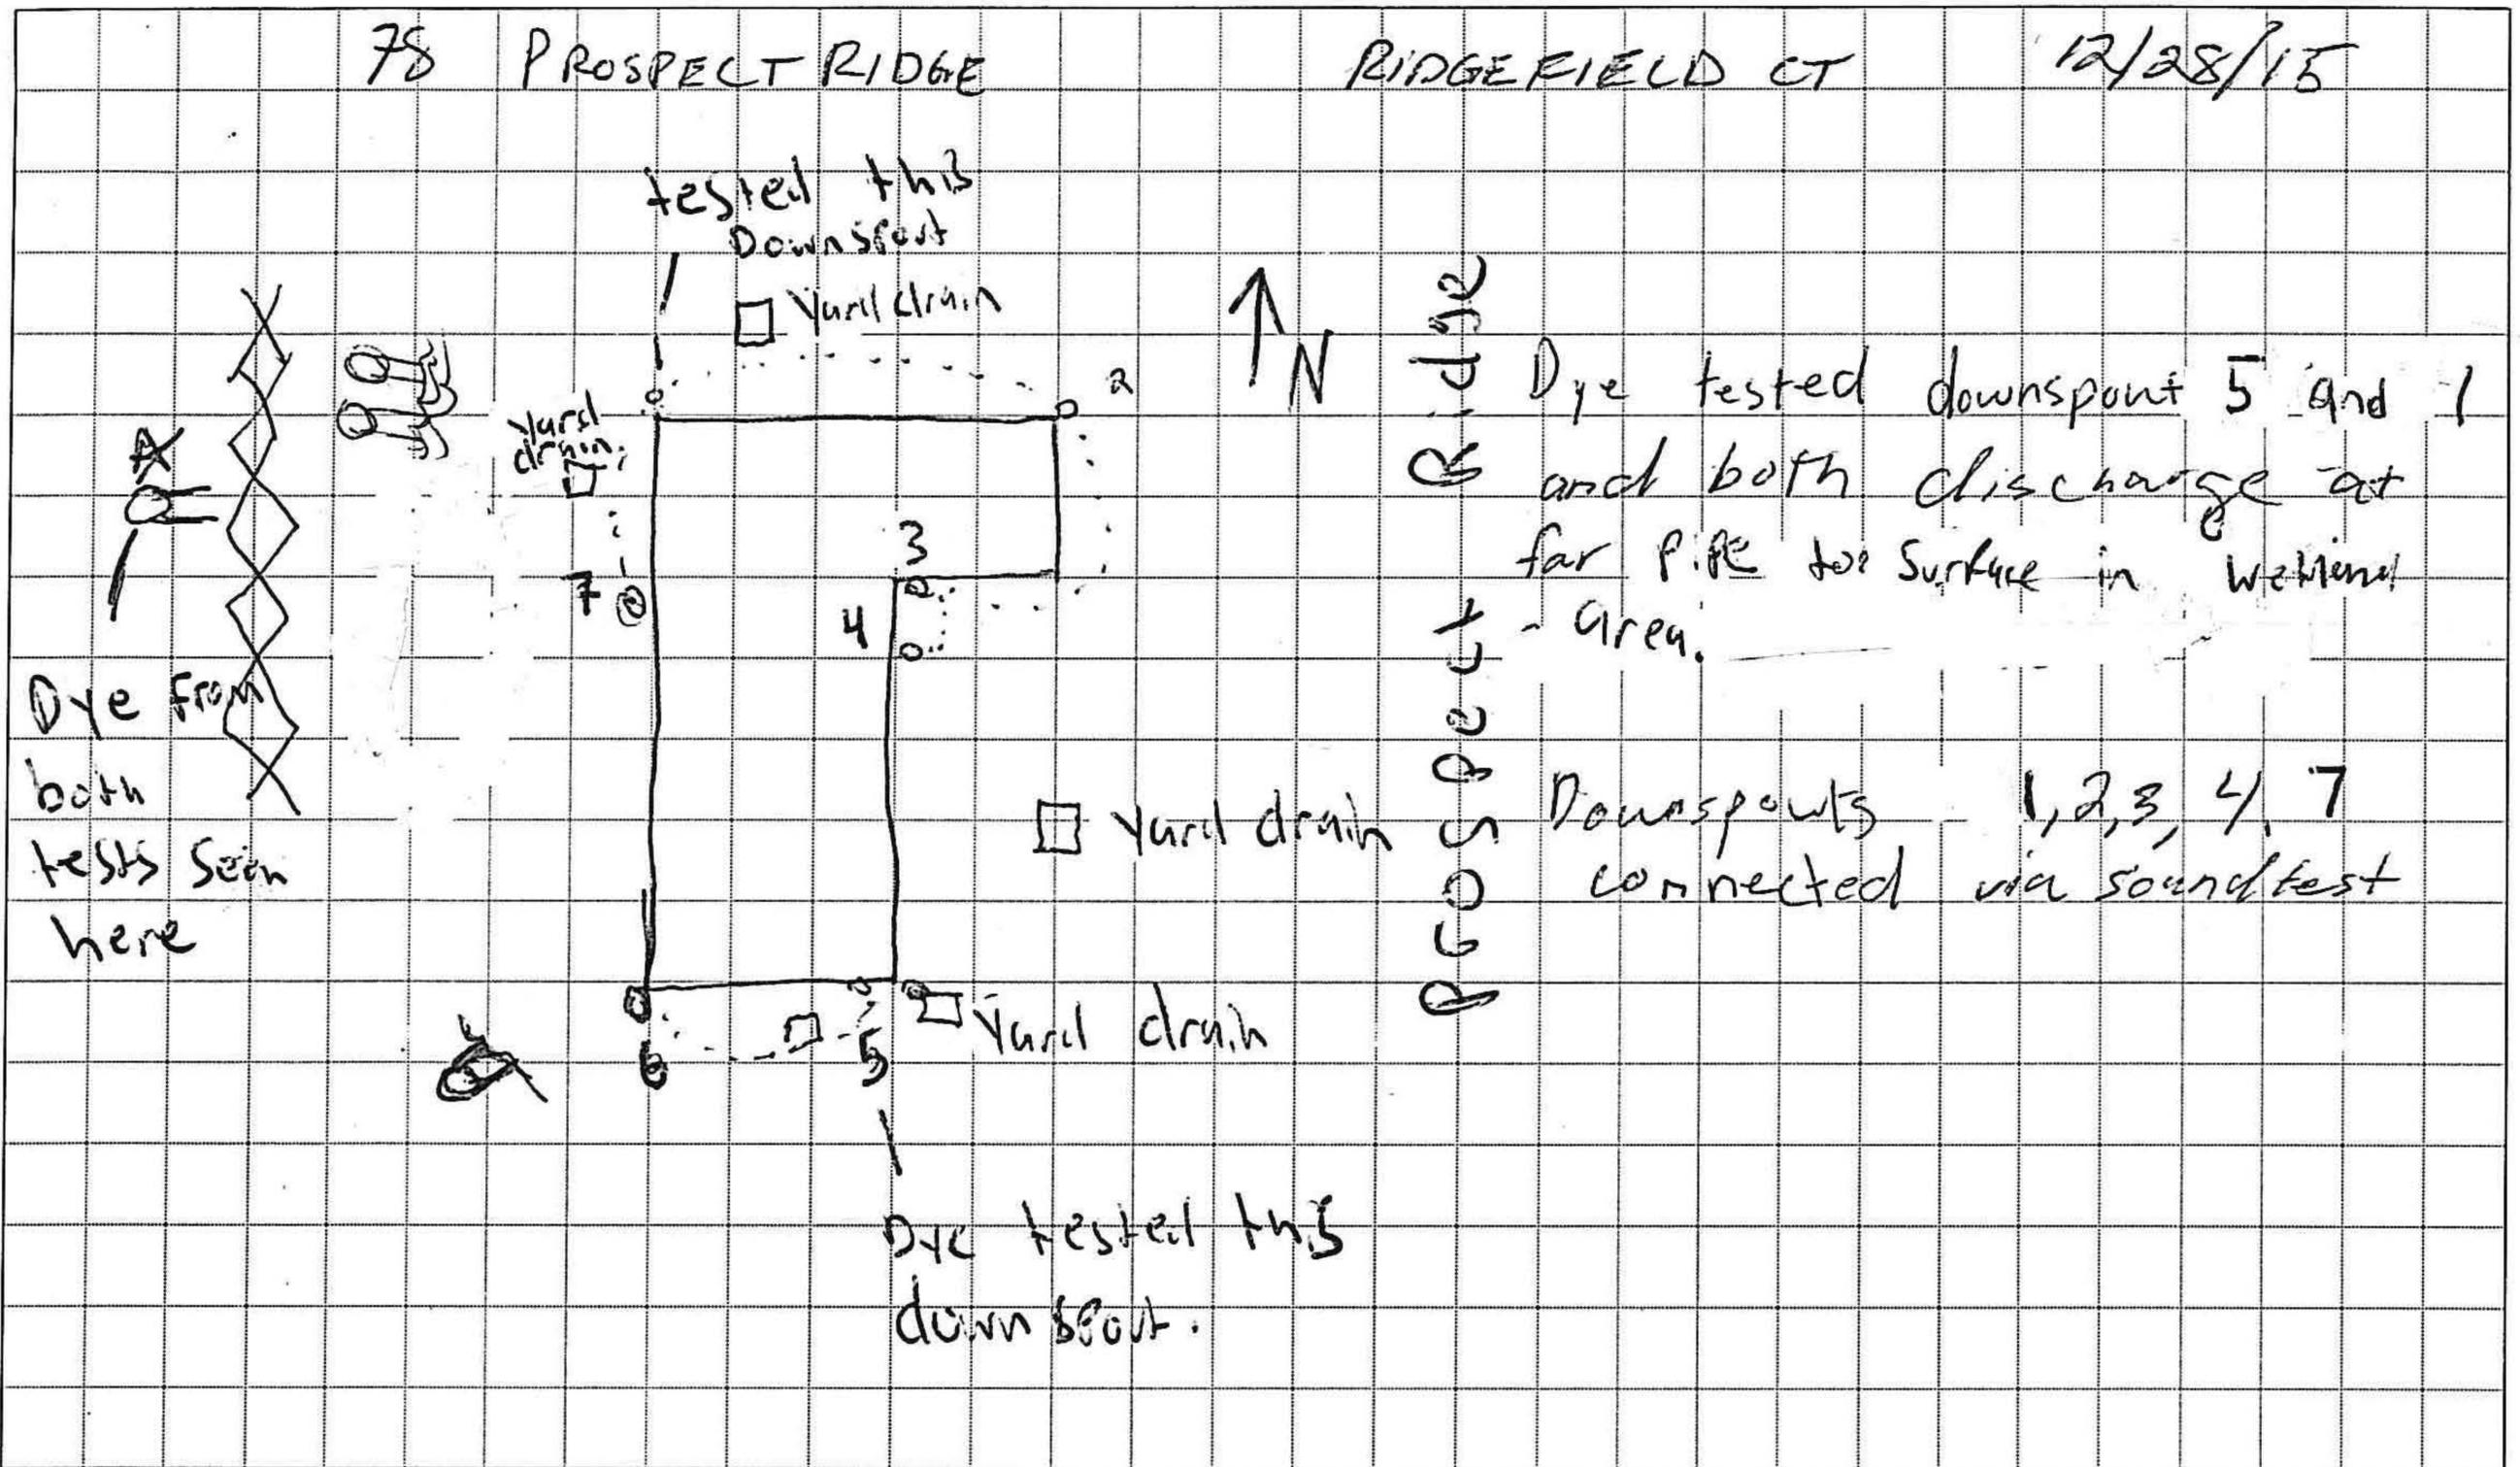
Dye tested DS 0.5' E of NW corner of building and 0.25' from wall(downspout 1 from sketch). Dye was seen discharging into wetland from PVC outlet.

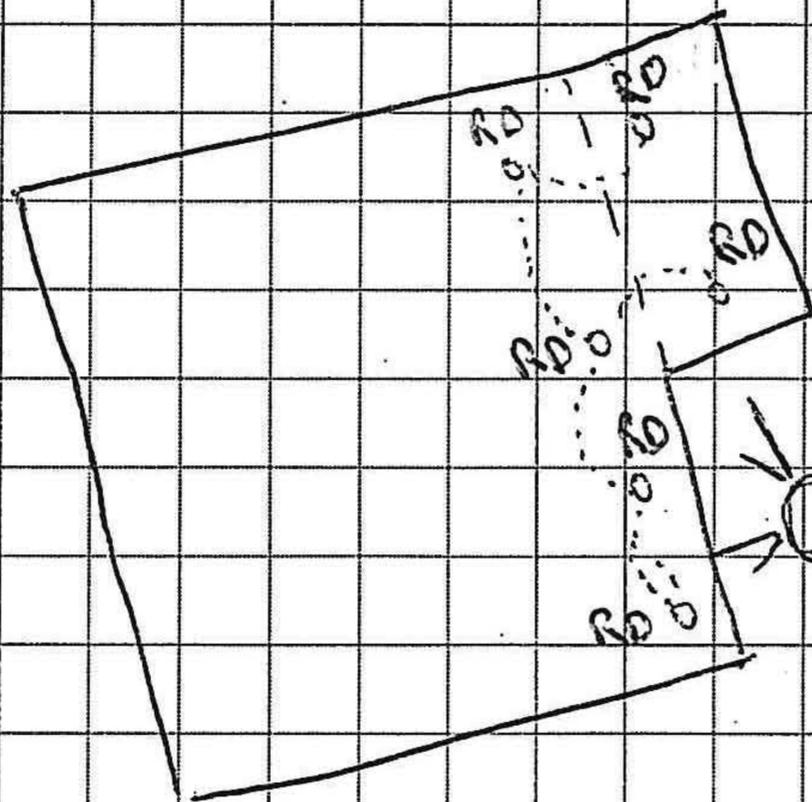
12/22/15 46 DANBURY ROAD

Roof drains
observed discharging to
DMH 1

DNE from RD
Seen here

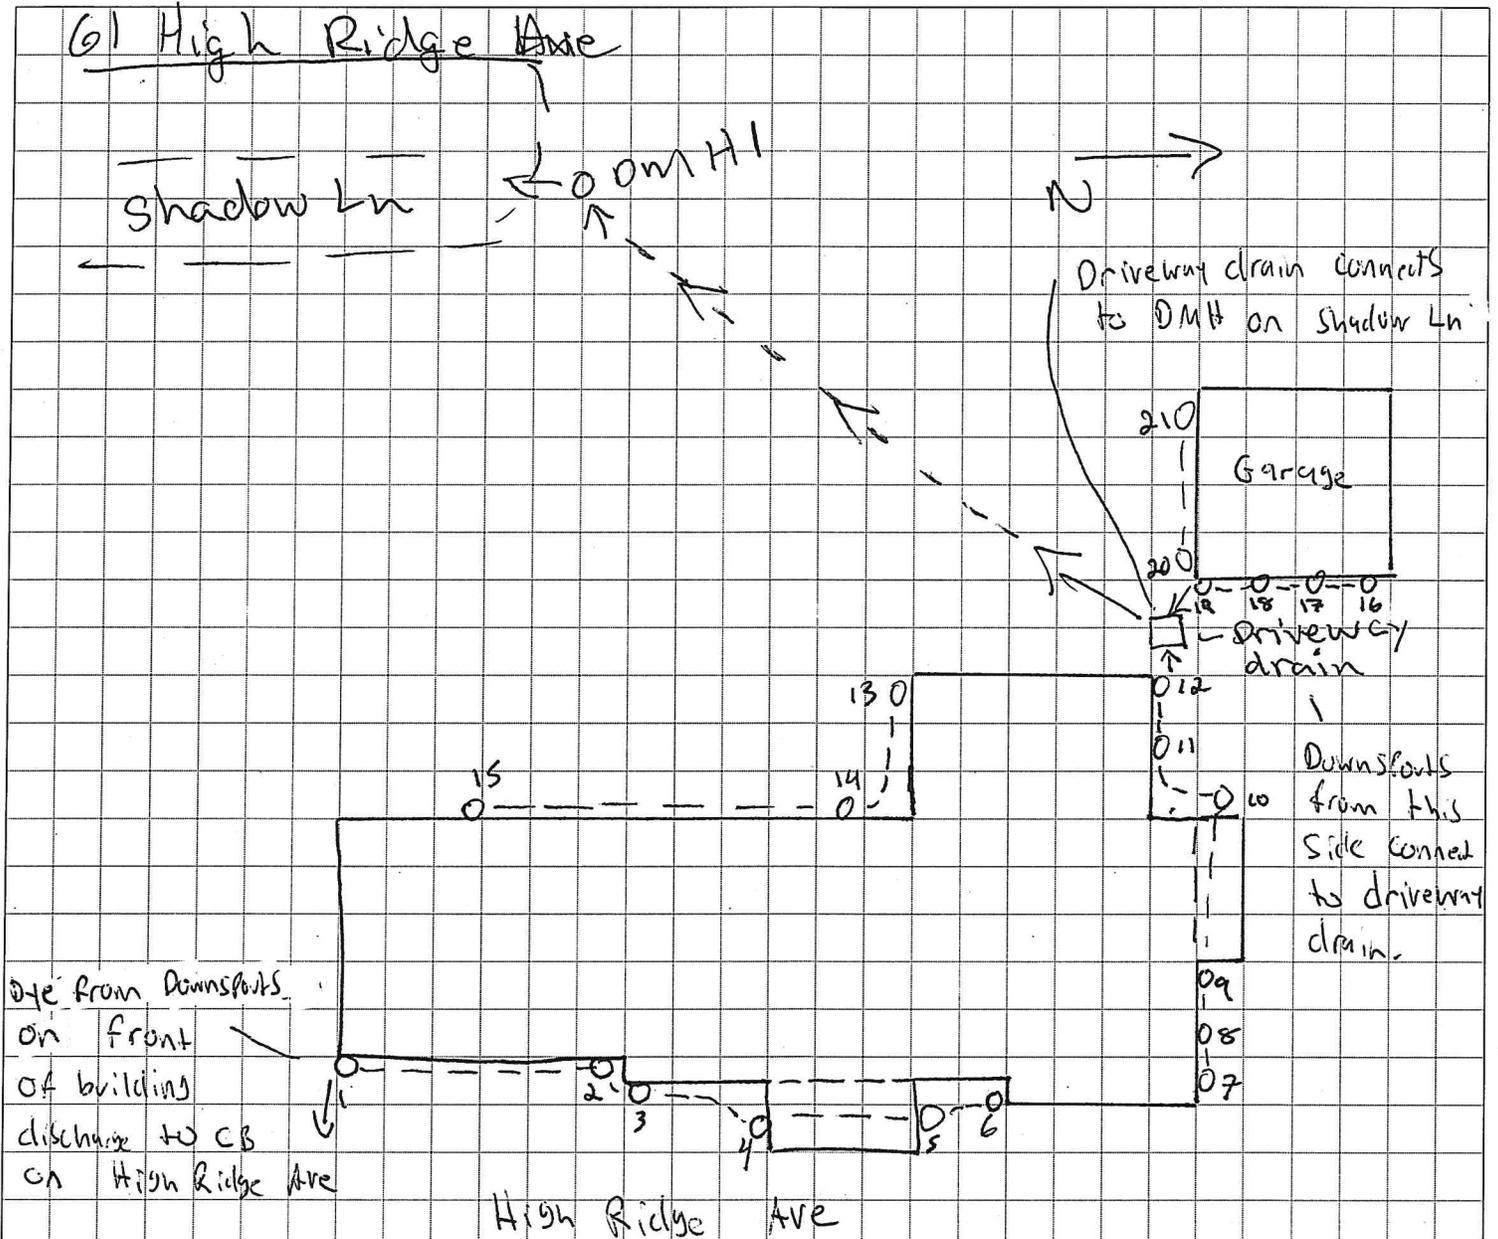
Downspouts on the front of the house connect, sound tested. Tested downspout 1 from sketch. Downspouts discharge into catch basin on High Ridge Ave.
