Technical Memorandum

To	Ridgefield WPCA	Page	1 of 22
CC	C. Fisher, J. O'Brien, J. Pennell		
Subject	Town of Ridgefield, CT Phase 2 Wastewater Facilities Plan Technical Memorandum No. 1 – Dyed Water Testing and Tracing		
From	Jon Pearson/Alberto Angles		
Date	October 27, 2016

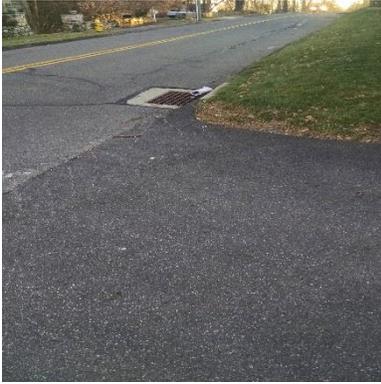
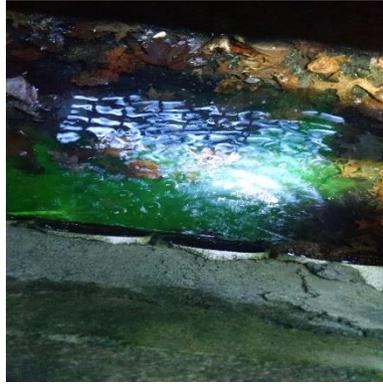
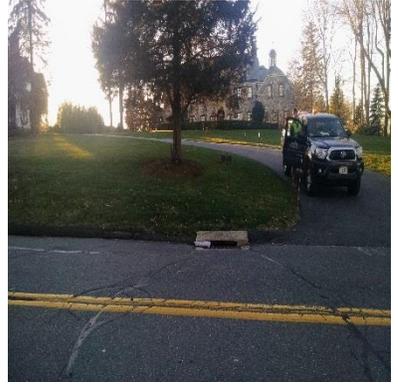
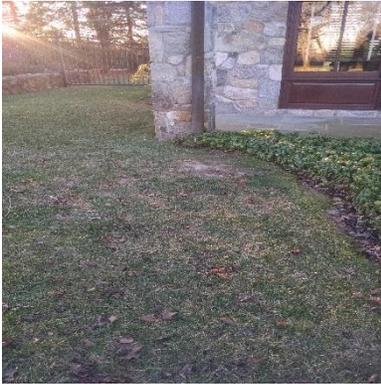
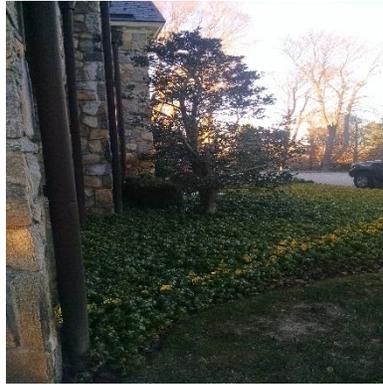
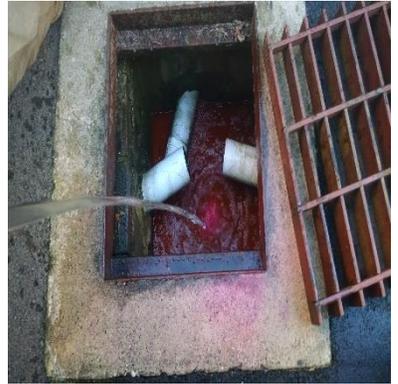
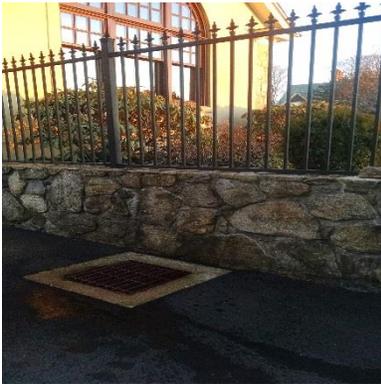
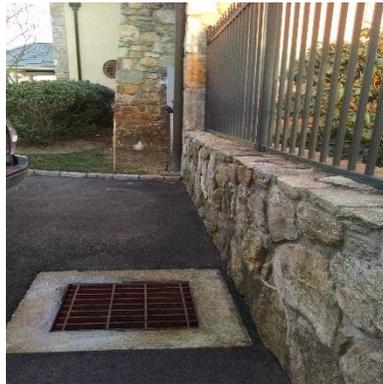
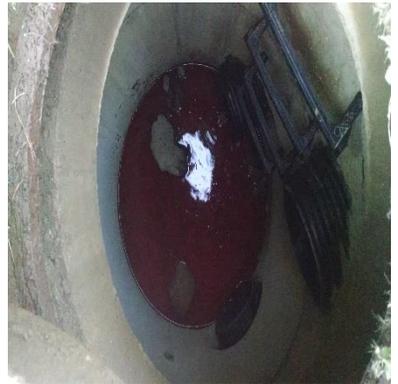
- Downspouts 1-6 connect, sand tested. Downspout discharge into catch basin on High Ridge Ave.
- Downspouts 7-15 and 16-21 all discharge into driveway drain, sand tested. Driveway drain discharges into DMH on Shadow Ln.

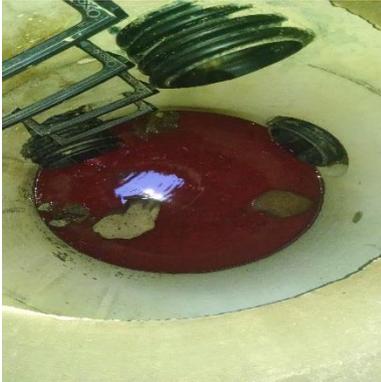
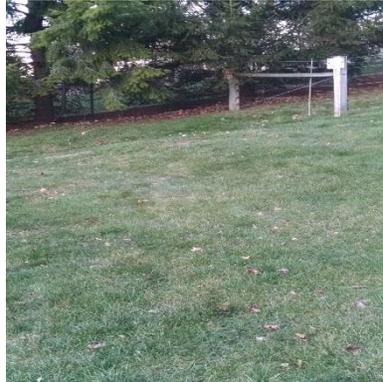
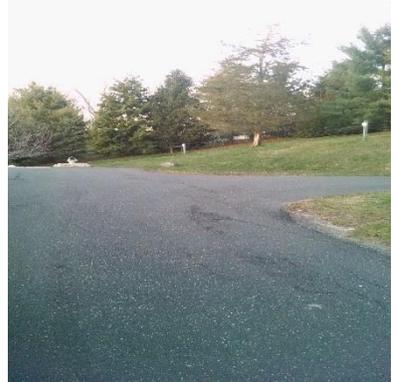
Tested DS 0.5' E of NW corner of building and 0.25' from wall. all DS for building sound tested together. Dye was observed passing through driveway drain and then discharging into a CB in front of 111 High Ridge Ave.

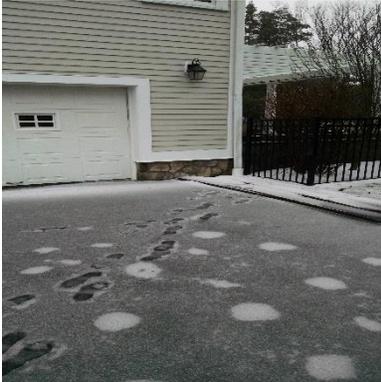
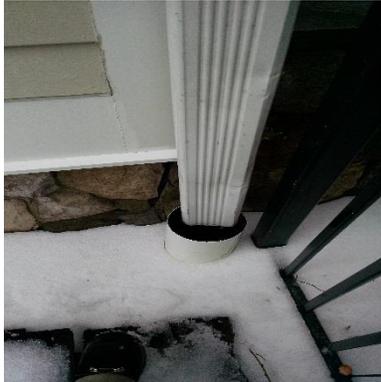
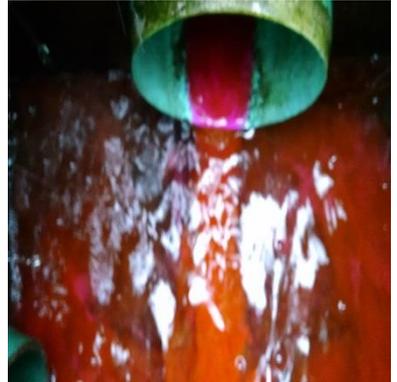
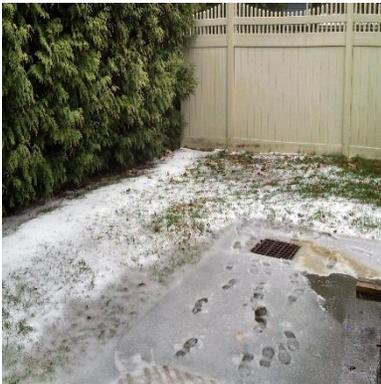
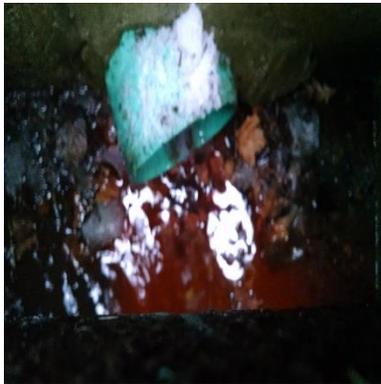
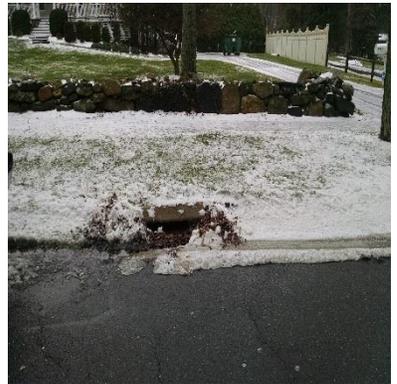
Dye tested downspout 1,
observed discharging in
Driveway drain catch basin
from SE inlet, observed
emptying into catch
basin on street from SW inlet.

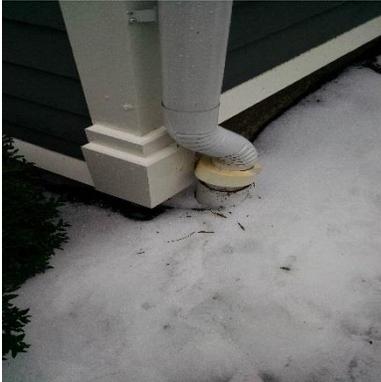
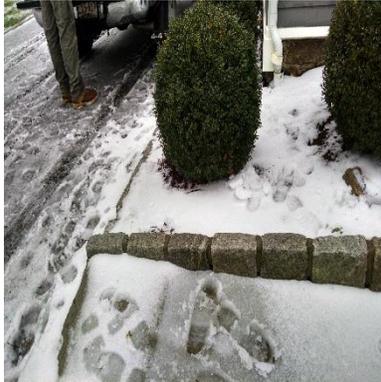
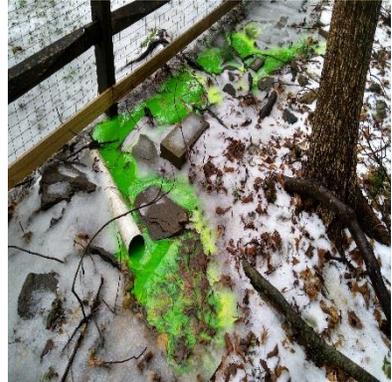
Downspout is 0.5' N of SE corner and 0.25' from wall (downspout 9 from sketch). Dye was observed discharging from a pipe in the yard North of building.

Dye tested downspout 7, observed discharging to surface in yard.

dye tested this downspout. Dye seen discharging from open pipe.

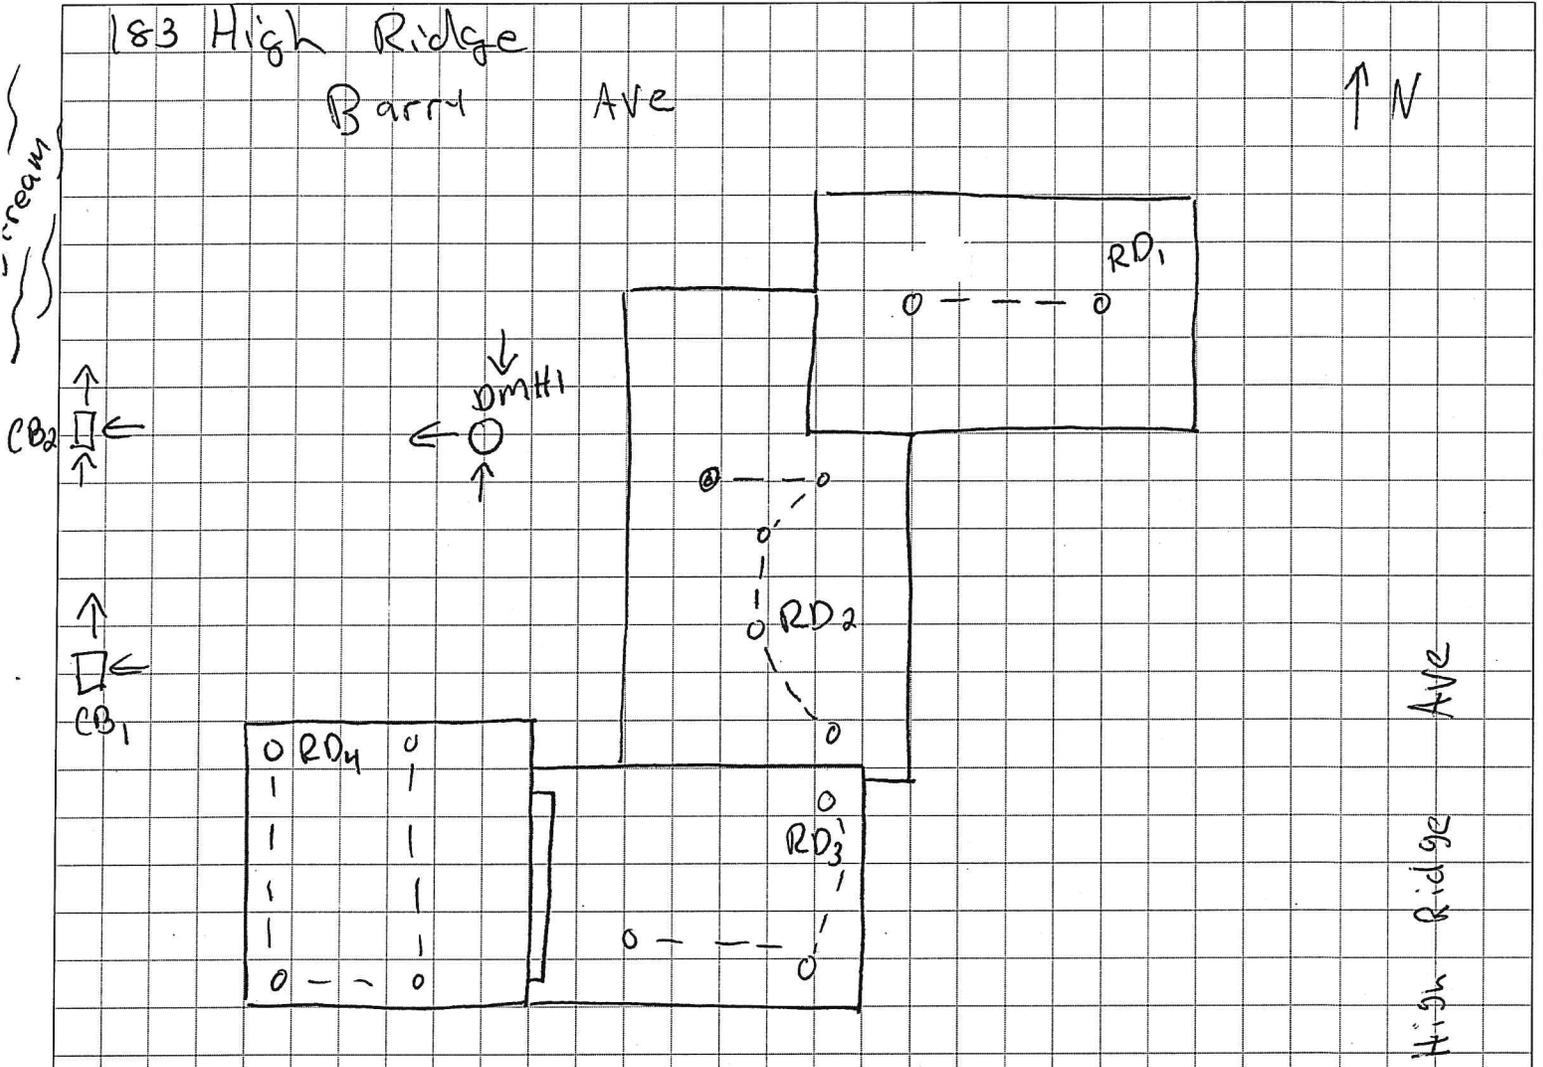
RD1 from sketch. Drain manhole located in the school parking lot.

- Roof drains (RD₁) discharges into DMH1
- Roof drains (RD₂) discharges into DMH1
- Roof drains (RD₃) discharges into DMH1
- Roof drains (RD₄) discharges into catch basin (CB₁)

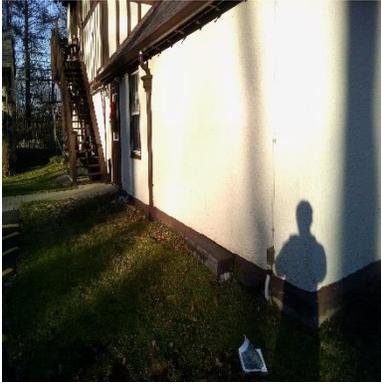
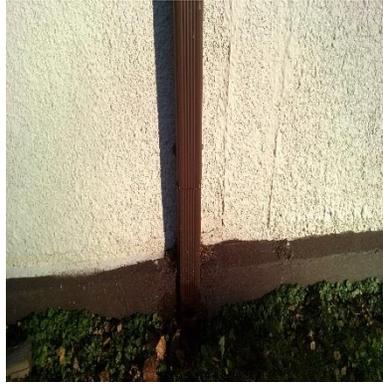
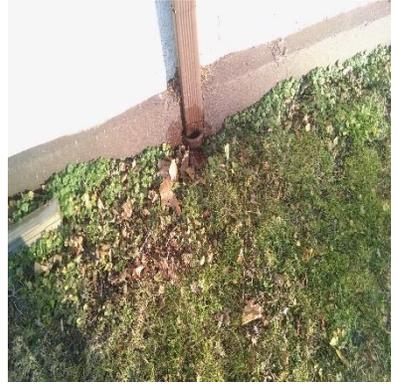
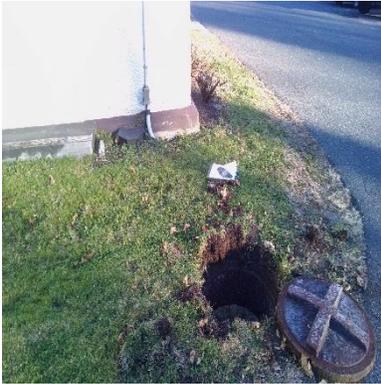
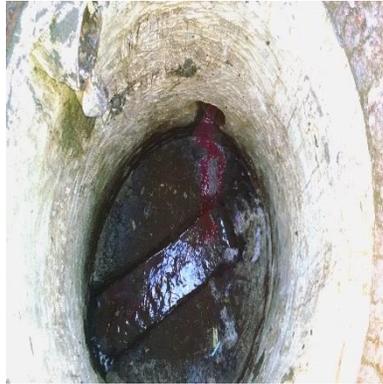
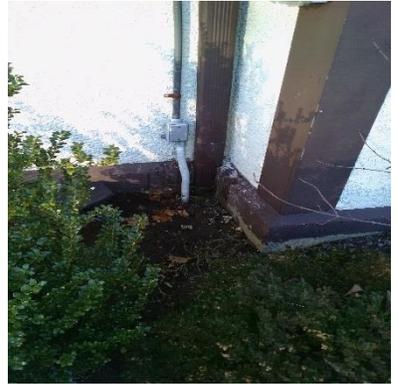
- Downspout 1 sound tested to Downspout 2. Downspout 2 dye tested to SMH 202 from the S.E. inlet. Dye seen in this inlet.
- Downspout 4 sound tested to Downspout 5. Downspout 5 was dye tested with 20gal H₂O and was waited on for 1.25hr, No dye was observed.
- Downspout 8 did not sound test to any other downspouts and was dye tested with 20gal H₂O and waited on for 1.5hr, No dye was seen.
- Downspouts 3 and 7 were found to be clogged and would overflow when filled with water.
- Downspout 6 was seen discharging to ground surface.

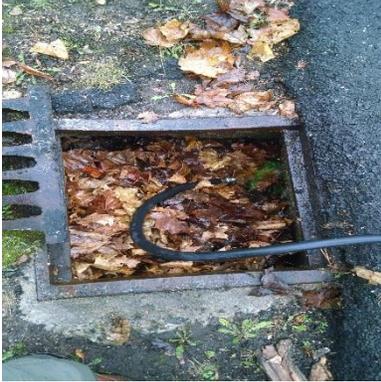
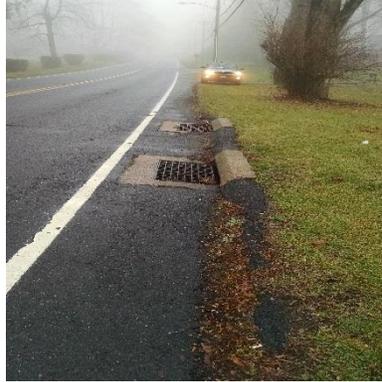
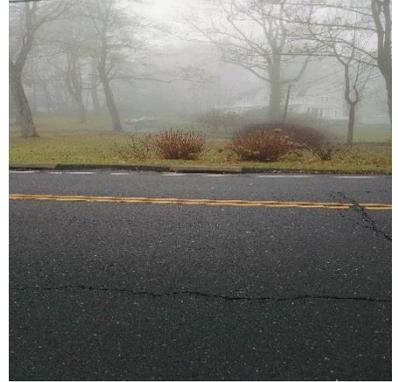
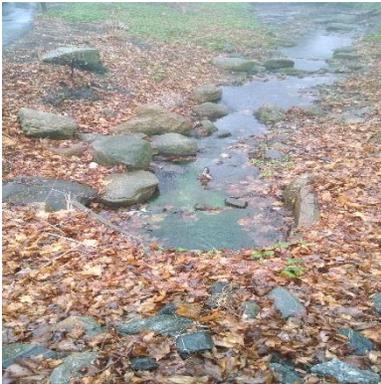
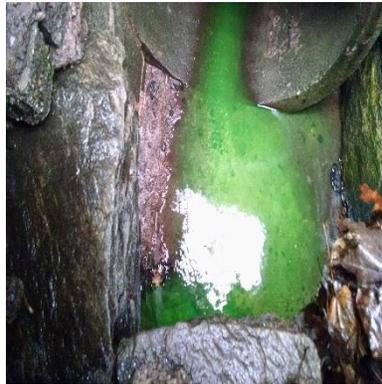
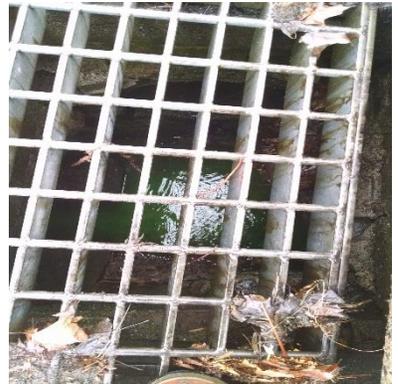
- Driveway drain marked DD sound tested to Drain marked CB1.
- Dye test at CB1 was observed in catch basin marked CB3.

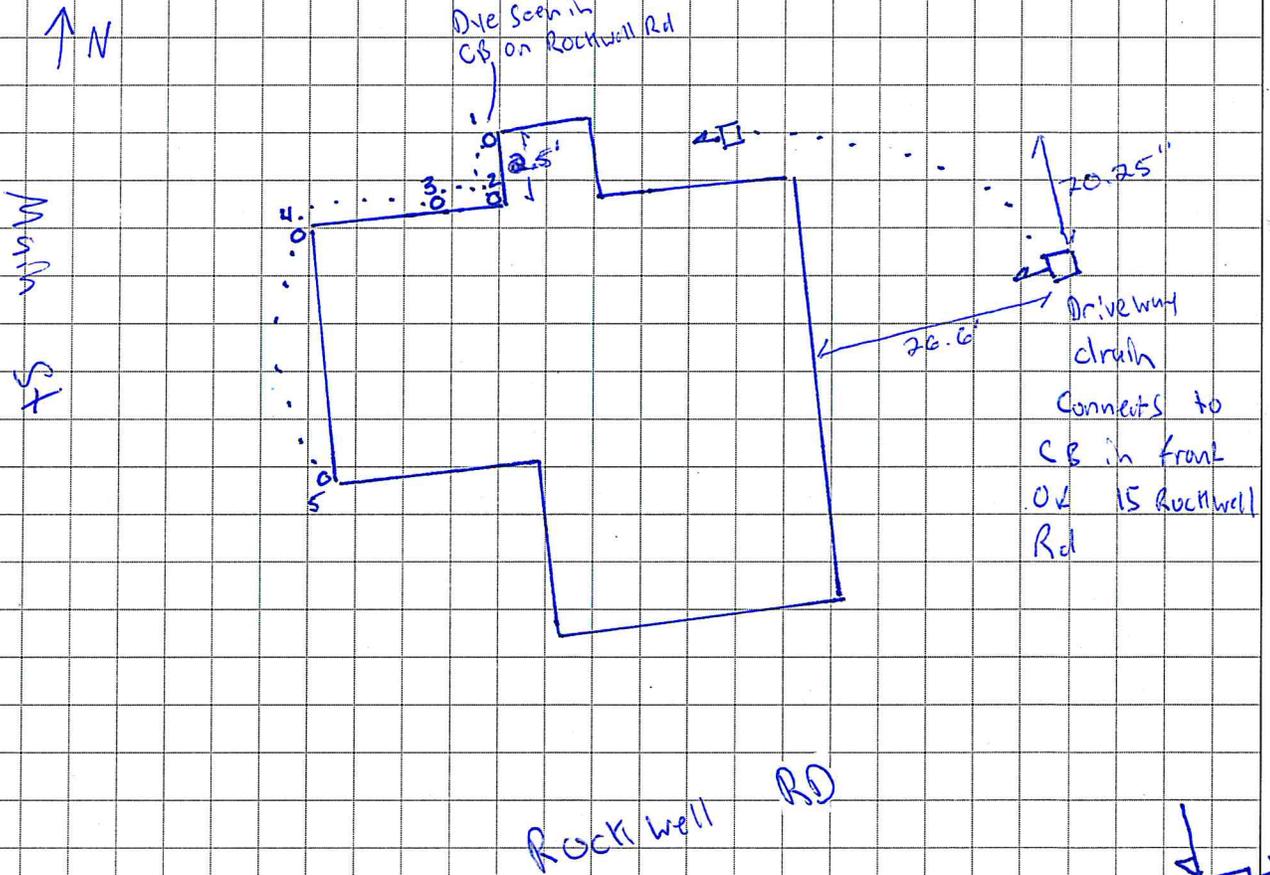
88 Main Street

- Downspouts 1-5 confirmed connected by sound testing. Downspout 1 was confirmed connected to the catch basin in front of 15 Rockwell Rd.
- Driveway drain was dye tested and confirmed connected to the catch basin in front of 15 Rockwell Rd.

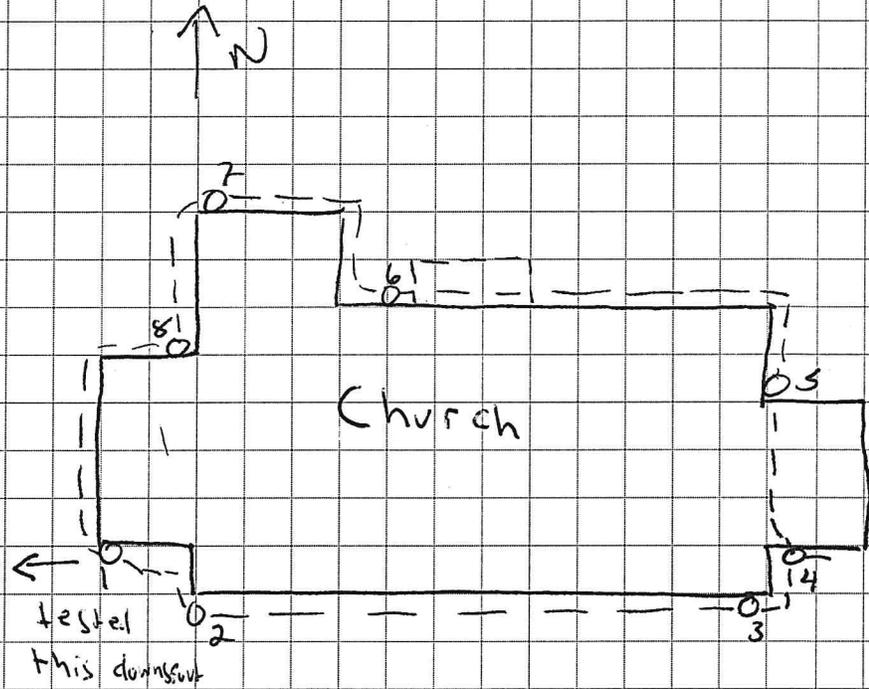
353 main st (church)

Re-test, previous results indicated connection to sewer. Rectory Building. Dye first seen in the cistern (drain structure) located in the back of the building and then in the sewer and the brook about 30 minutes after test was conducted. Connection to sewer appears to be indirect.

- All downspouts connect, sand test
- Downspouts discharges into sewer MH 173A

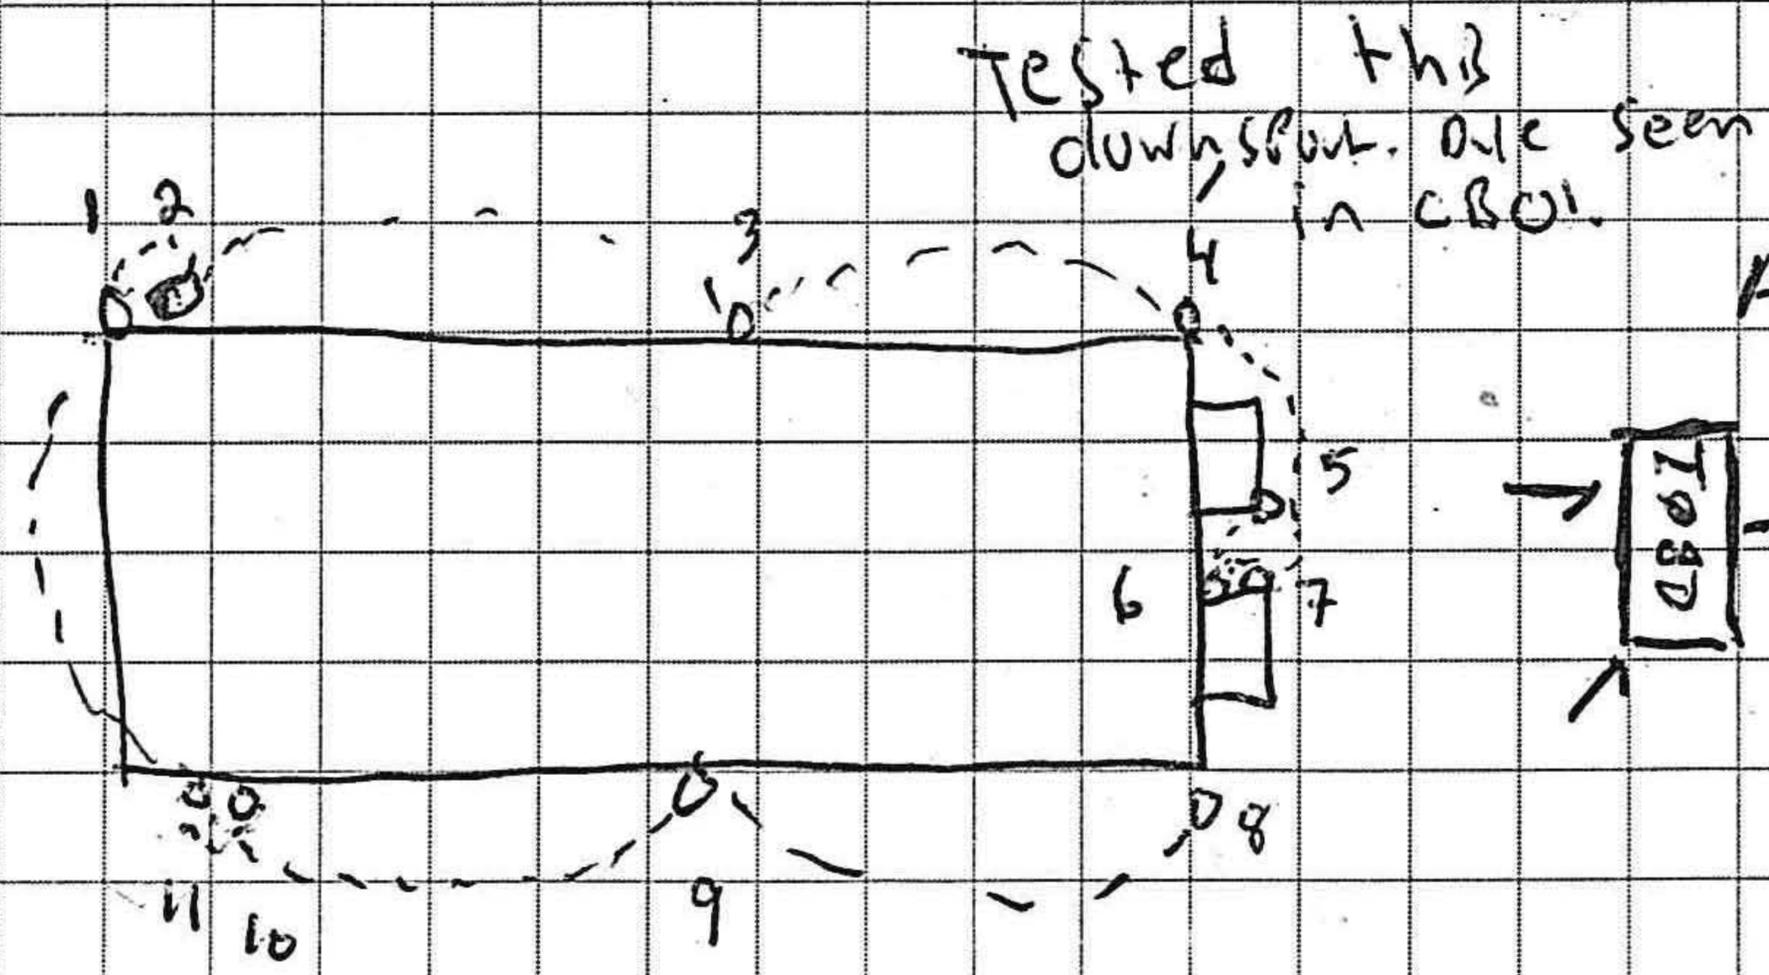
378 MAIN ST

Front yard downspouts sound tested connected to back yard downspouts. Backyard downspouts dye tested to CB01 in parking lot behind building.

All downspouts sound tested to each other.

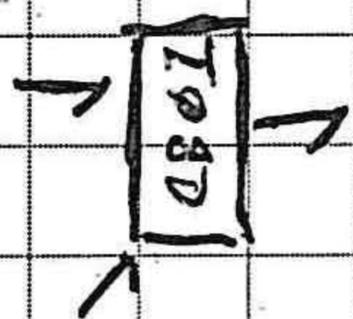
Dye tested downspout 4 to catch basin - CBOI

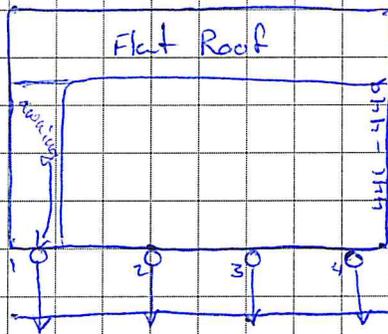
441 Main St

All downspouts discharge to parking lot surface. No dye required for inspection.

Notes: 4 downspouts on S. side
of building all discharge
to Driveway surface

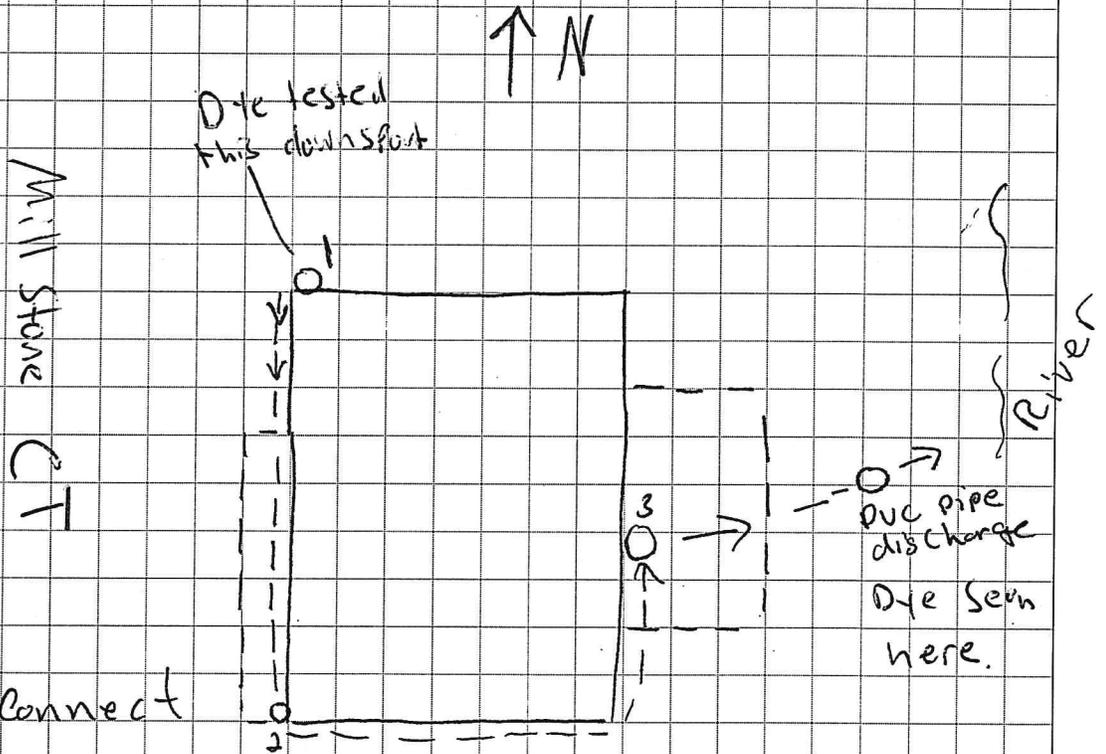
10 Millstone Ct

Dye tested downpout 1 from sketch. Dye seen discharging from PVC pipe behind house.

- Downspouts all connect
- Sand tested
- PVC pipe discharge into river

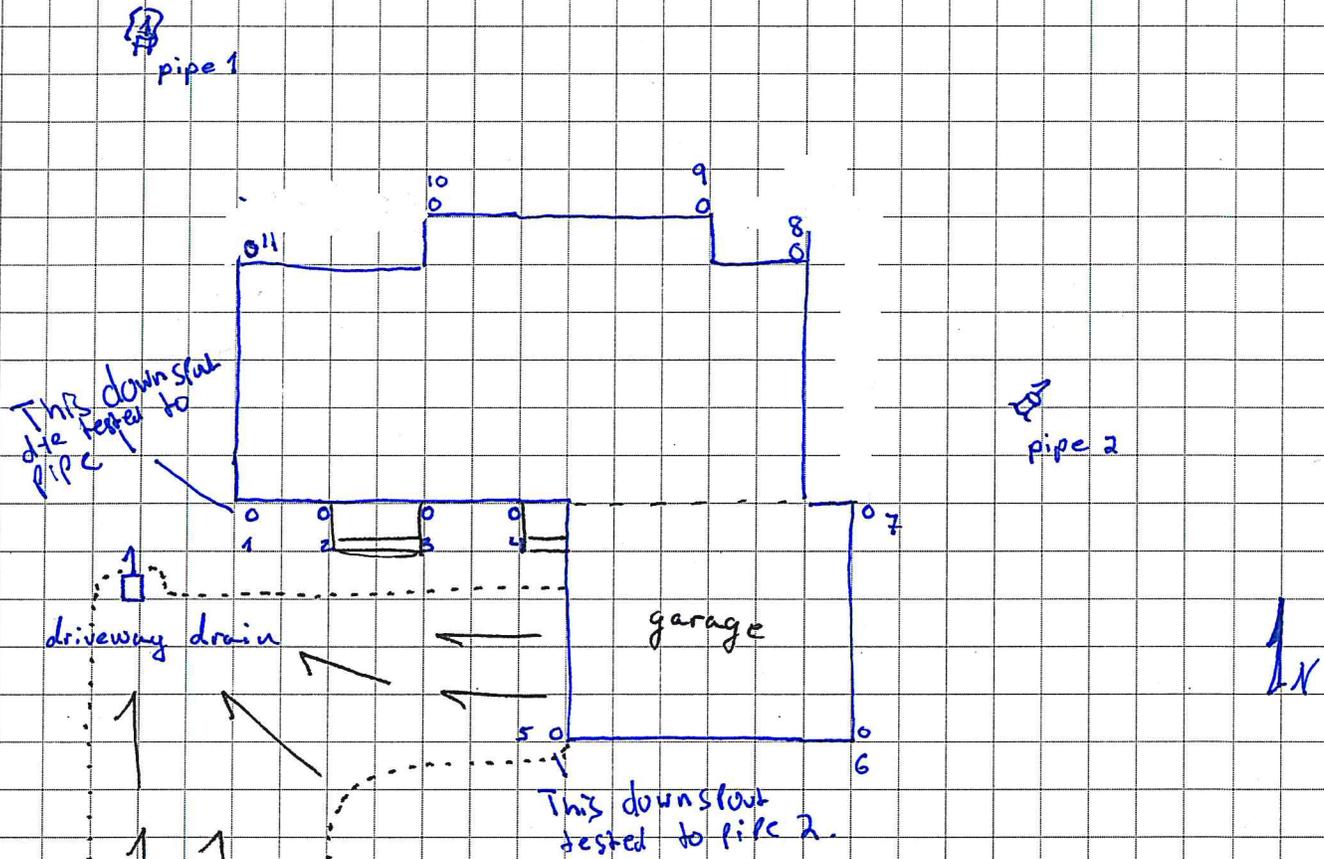
70 Ramapoo Road

- downspout 1 dye tested to pipe 1, drains to backyard
- downspout 5 dye tested to pipe 2, drains to backyard
- driveway drain sound tested positive to downspout 1

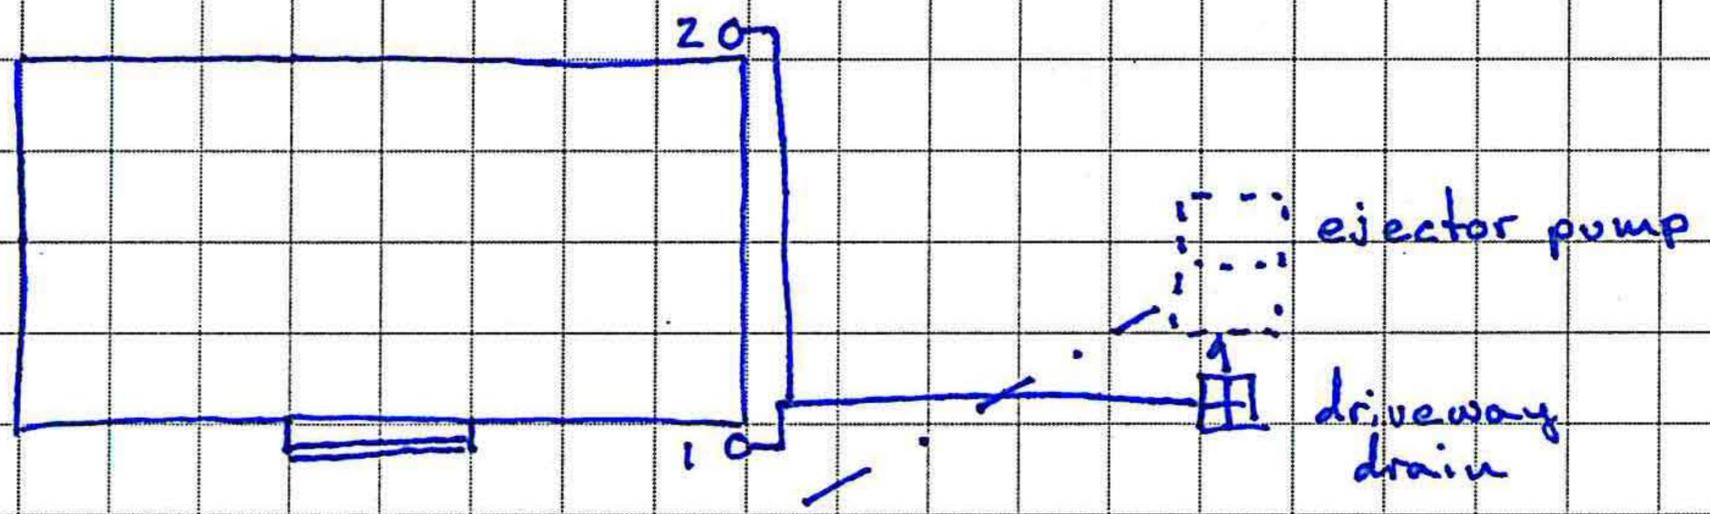
85 Ramapoo Road

Downspout discharges into driveway drain. Driveway drain discharges into ejector pump then into catch basin.

-
- ① Tested ds1, dye was seen in the driveway drain. The ejector pump kicked on and pumped the dye into a catch basin on Ramapoo Rd

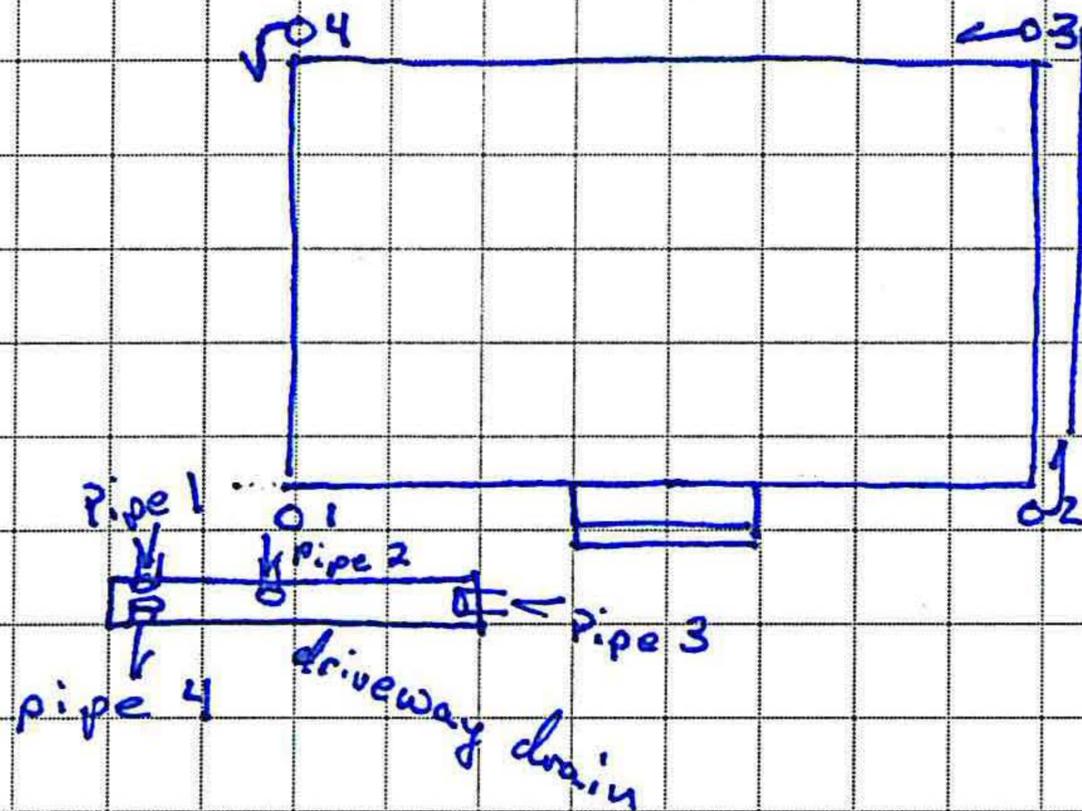
86 Ramapoo Road

- ⊙ downspout 1 ^{dye} tested to driveway drain from pipe 1 using dye.
- ⊙ downspout 2 tested to pipe 1 in the driveway drain. Also saw dye from ds2 in ds3.
- ⊙ Driveway drain was tested and dye was seen in the drain pipe on Ramapoo Rd S. of Victor Dr.

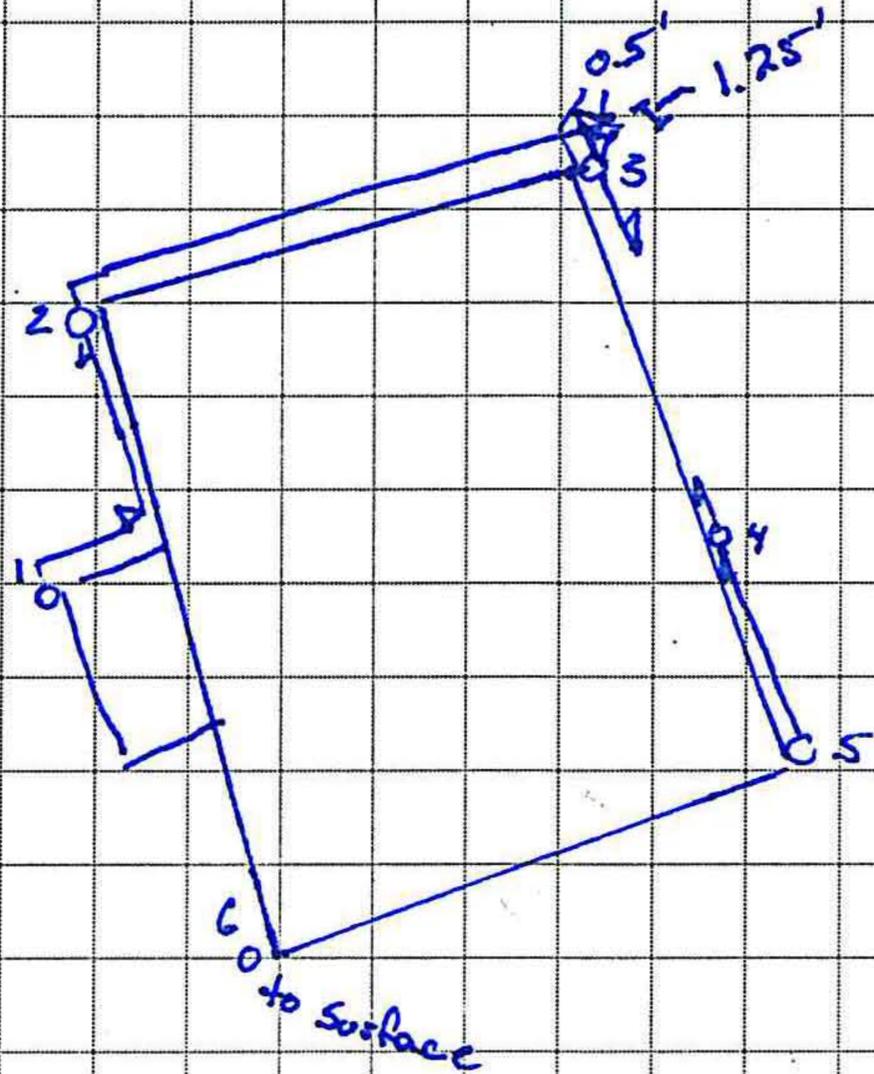
102 Ramapoo Road

- ⊙ downspouts 1-5 sound tested to each other.
- ⊙ downspout 3 tested to pipe 2 in the pond behind 102 Ramapoo Rd

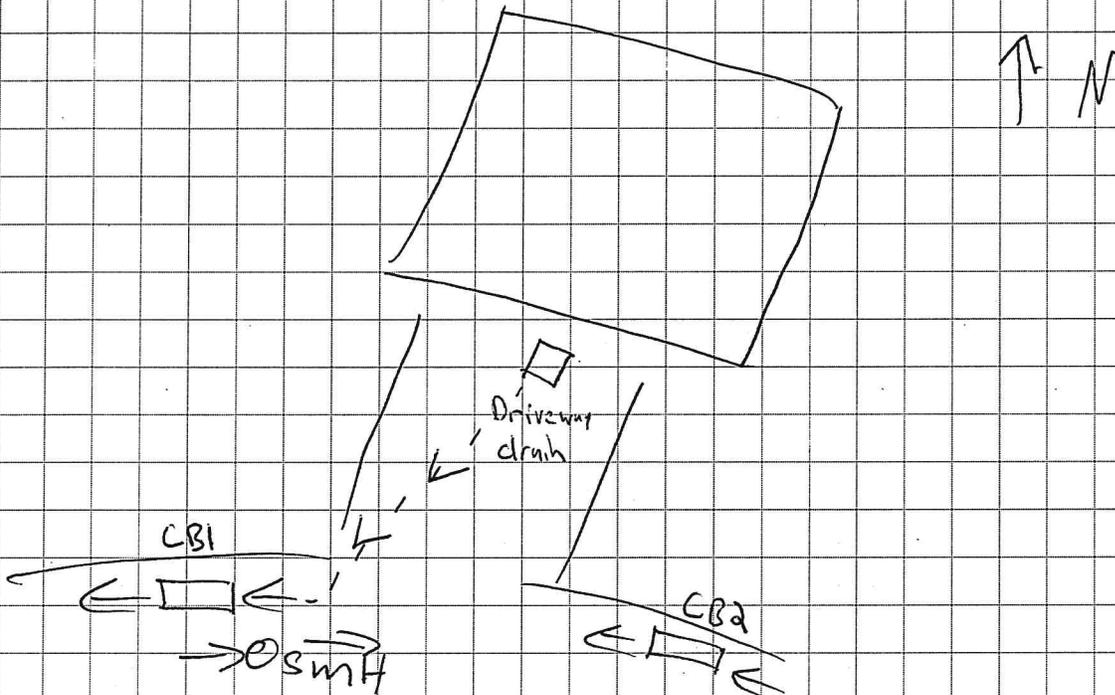
9 victor Dr

Driveway drain discharges into catch basin in front of 7 Victor Dr (CB1 from sketch).

*Driveway drain discharges into catch basin
in front of 7 Victor Dr.

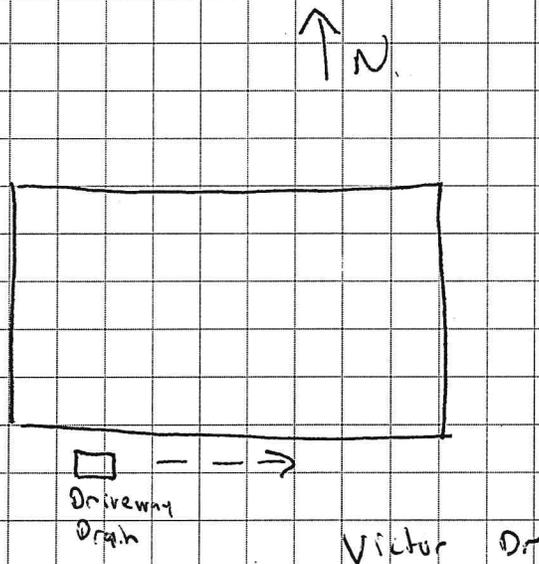
15 Victor Dr

Crew poured about 80 gal into driveway drain and waited for about an hour. Homeowner mentioned a dry well located behind the house that was covered up with rocks. Crew returned at the end of the day but no dye was seen.

- Crew poured about 80 Gal of water into Driveway drain and waited for about an hour at the sewer (M4) and drain. Homeowner mentioned there was a dry well behind the house and that it was covered up with rocks. Crew returned at the end of the day but no dye was seen.

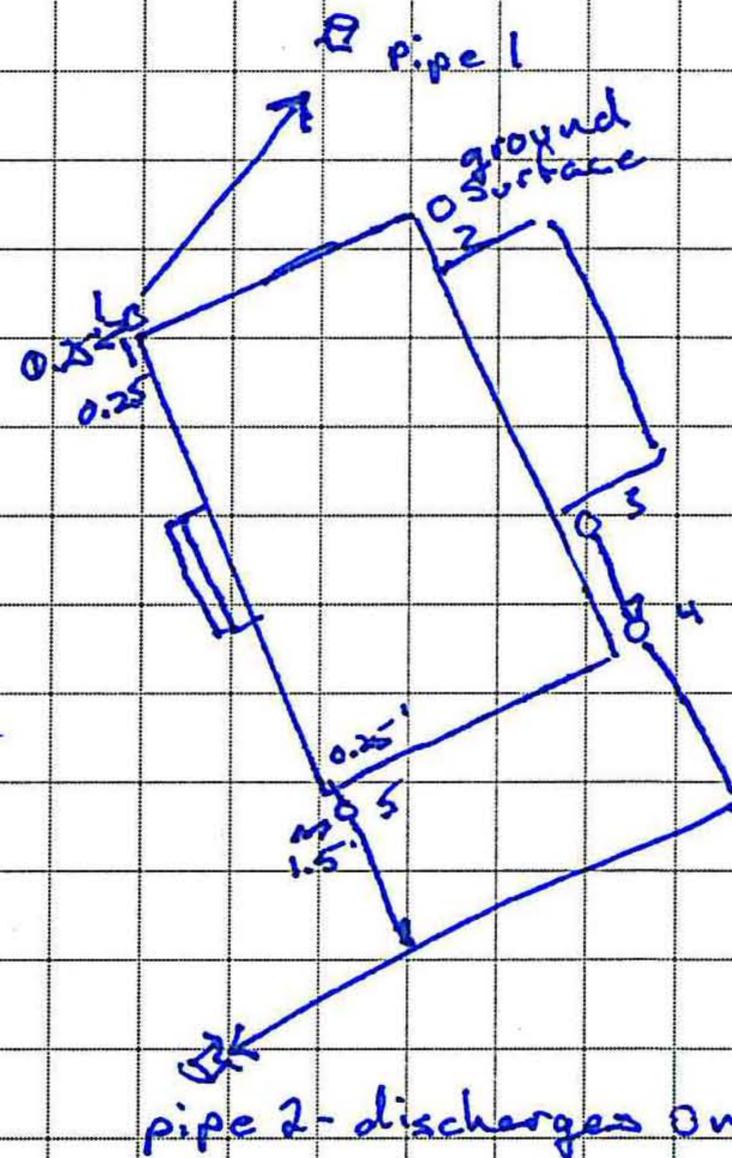
17 Victor Drive

⊙ downspout 1 sound tested to pipe 1 in backyard

⊙ downspouts 3, 4 observed connected and sound tested to pipe 2.

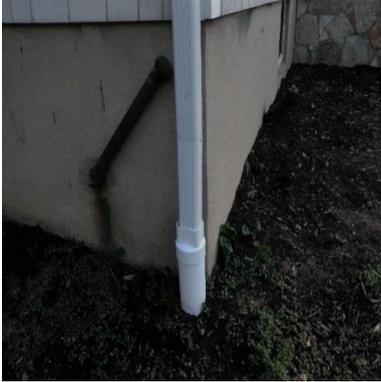
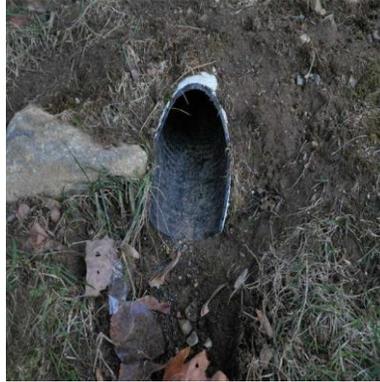
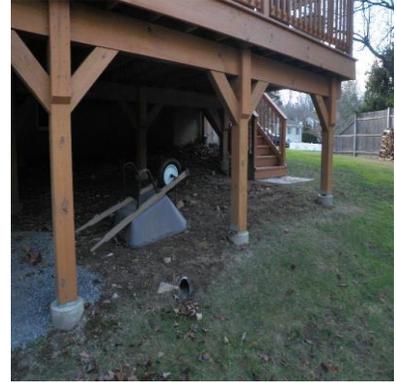
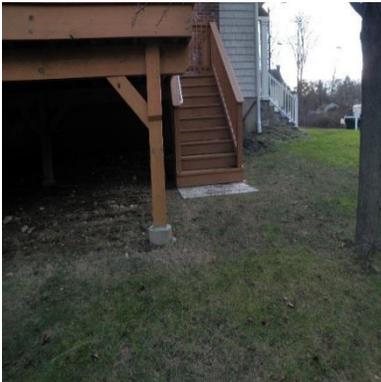
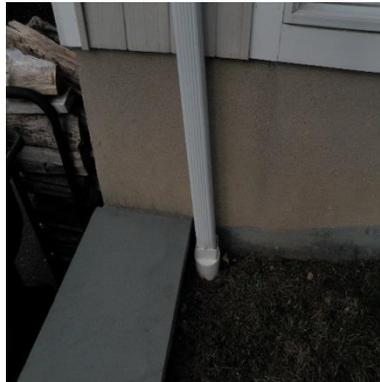
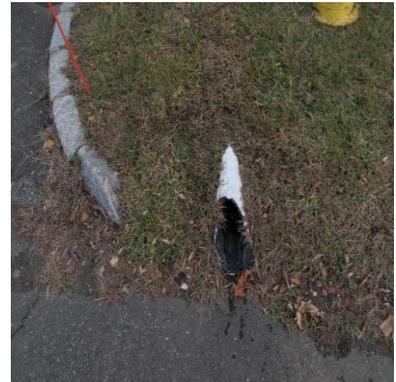
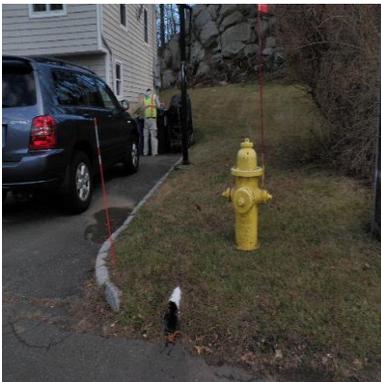
⊙ downspout 5 sound tested to pipe 2.

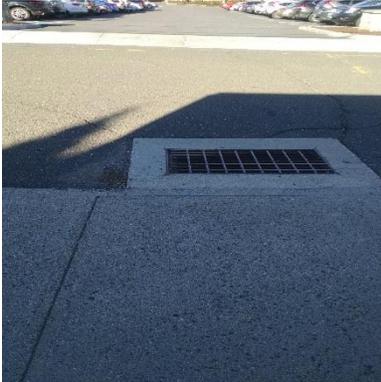
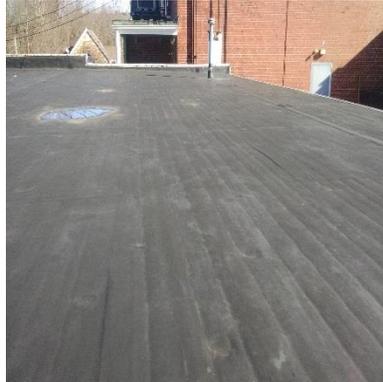
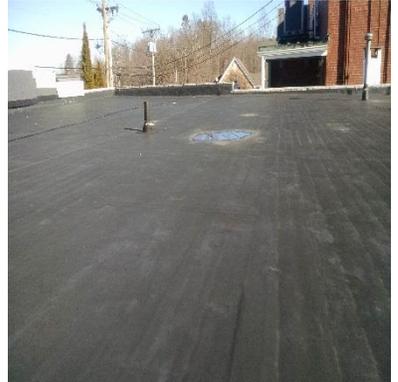
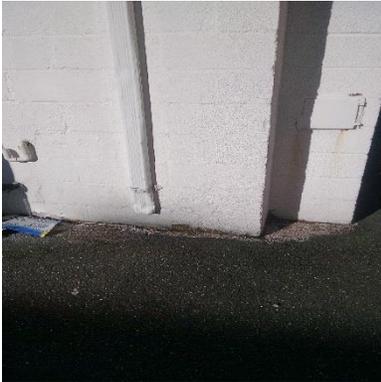
OS — Roof Pitched towards this downspout. Discharges to Surface.

- No Flat roof on the building. Downspout discharge onto surface

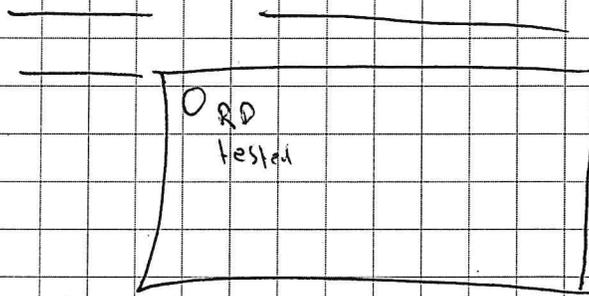
374 Main St (Bank)

Roof drain discharges into catch basin behind building (on sketch as CB01).

One from RD
Seen in CB.

- Roof drain discharges into catch basin behind the building

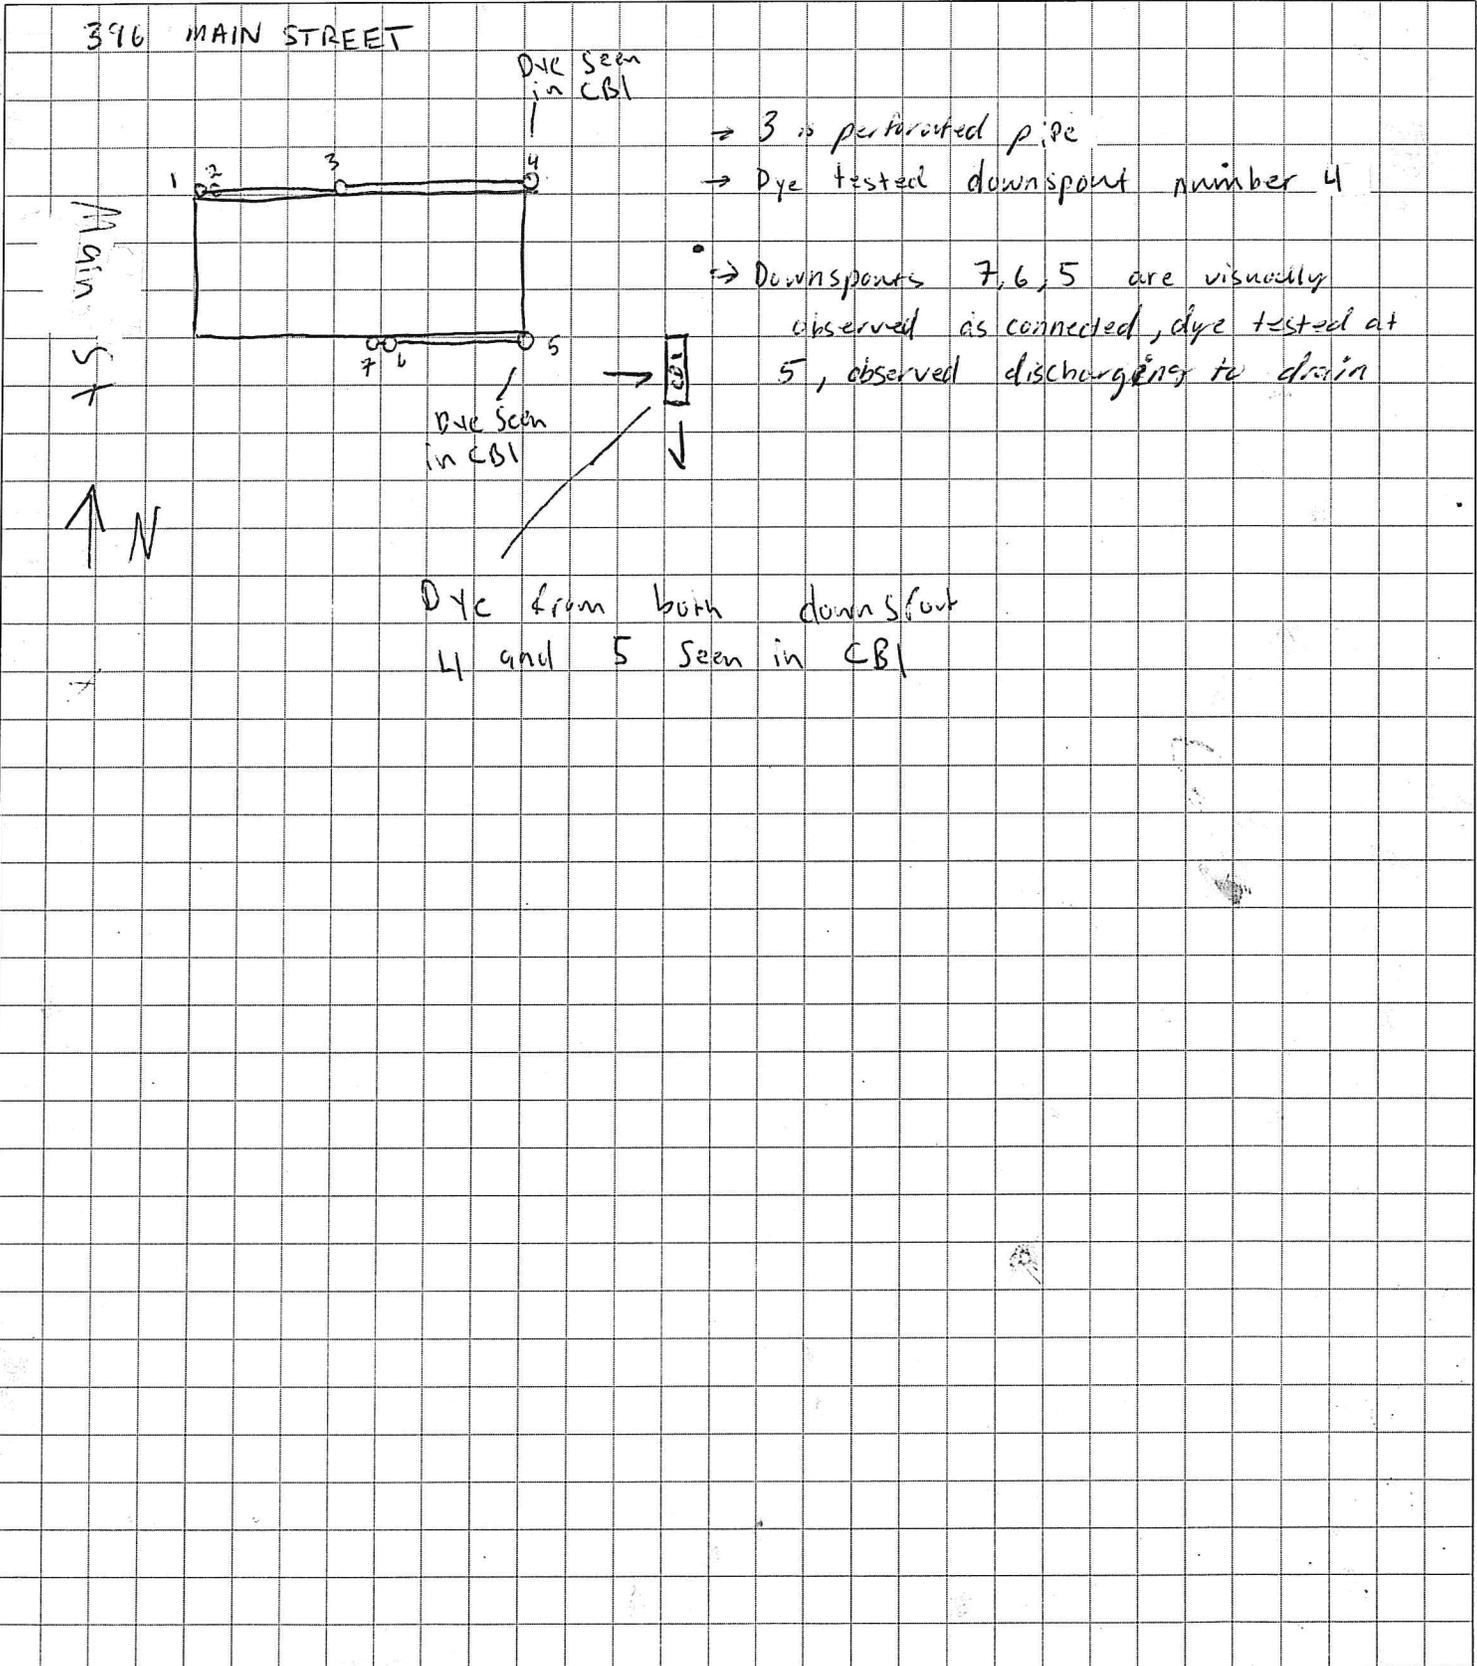
**DS on SE corner of building. 0.3' from the east and 0.2' from the edge of building. Downspout 5 from sketch.
Dye seen in CB1 behind building.**
