Technical Memorandum

To	Ridgefield WPCA	Page	1 of 22
CC	C. Fisher, J. O'Brien, J. Pennell		
Subject	Town of Ridgefield, CT Phase 2 Wastewater Facilities Plan Technical Memorandum No. 1 – Dyed Water Testing and Tracing		
From	Jon Pearson/Alberto Angles		
Date	October 27, 2016

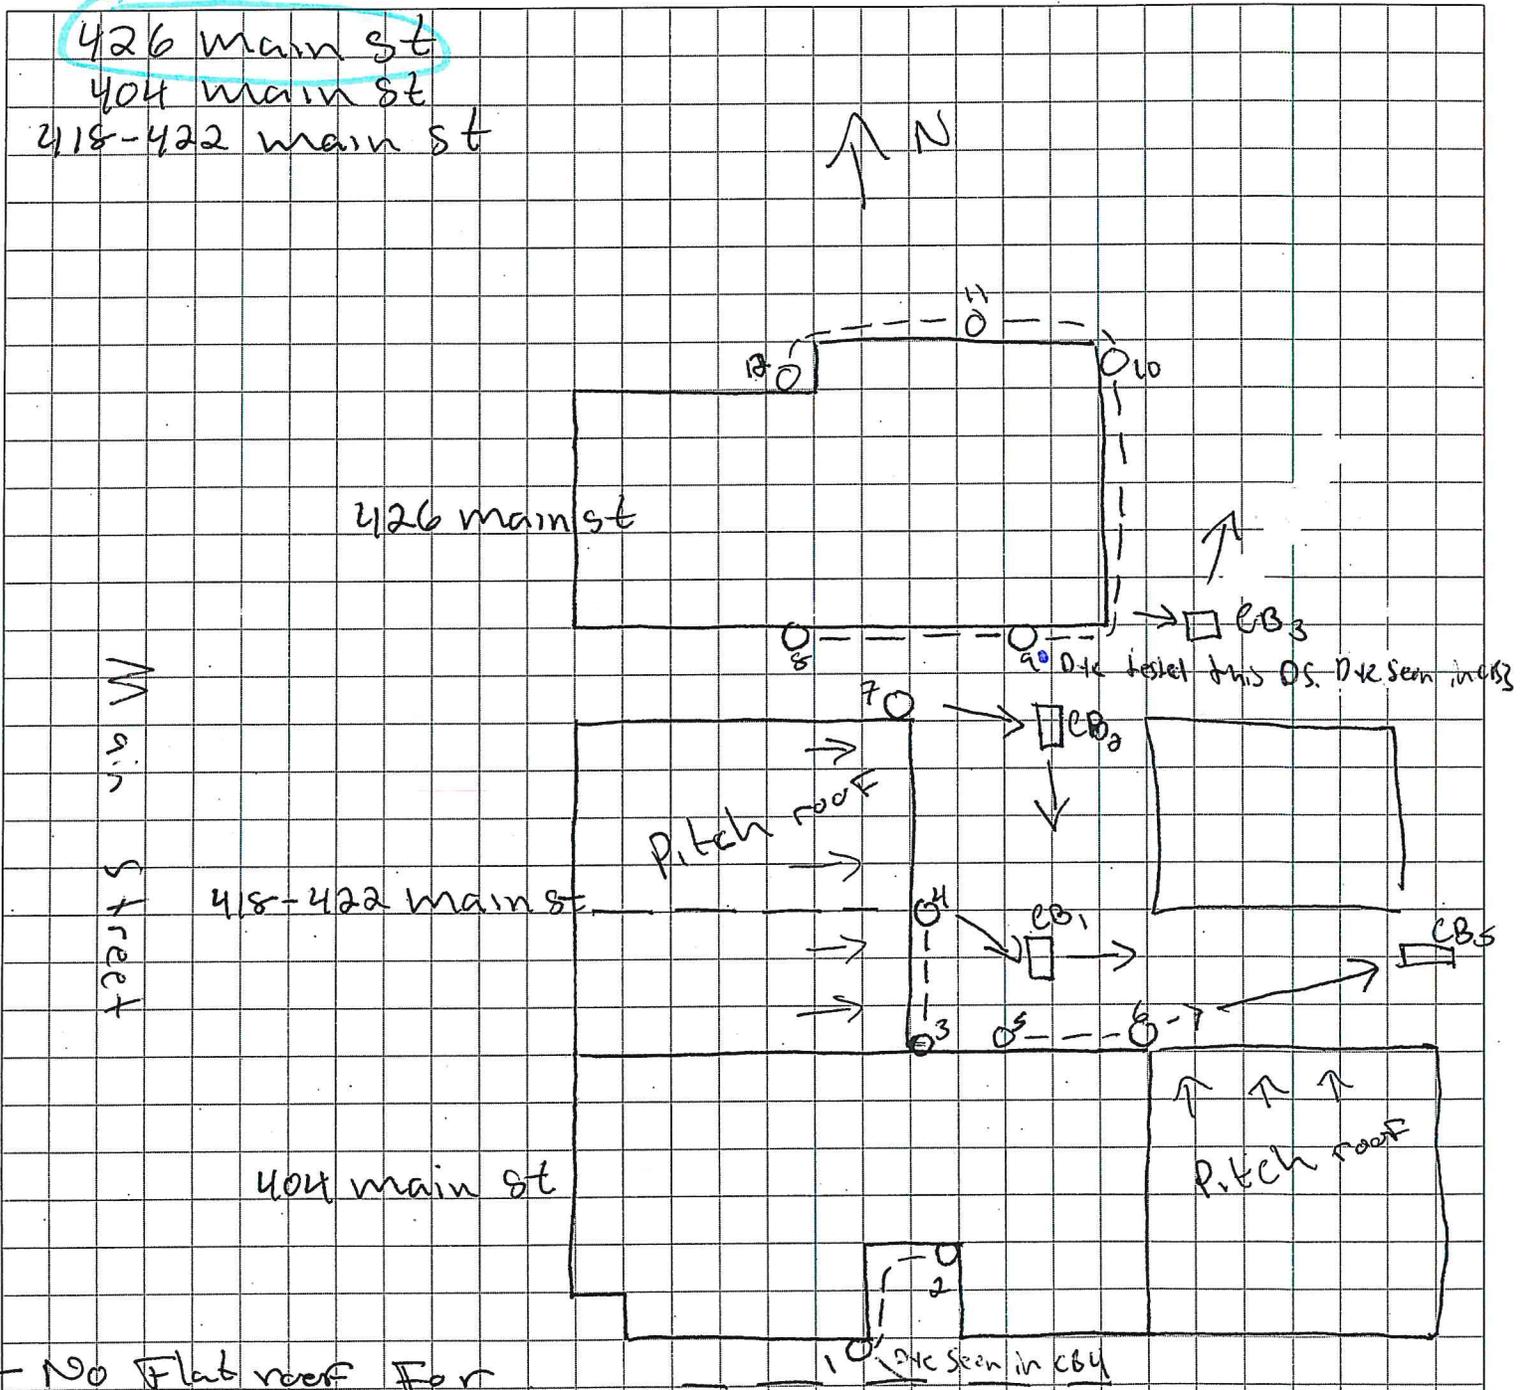
Not a flat roof. All downspouts connected. Dye seen in CB3 behind the building.

- No Flat roof for 426 and 418-422 main st
- Down spouts for 426 all discharge into CB3, CB4
- 418-422 main st downspout 7 discharge into CB2 and downspout 3-4 discharge into CB1
- 404 main st has no Flat roofs. Down spouts on the South end of the building discharge into CB4 on Bailey Ave. Down spout on the North of the building discharge into CB5.

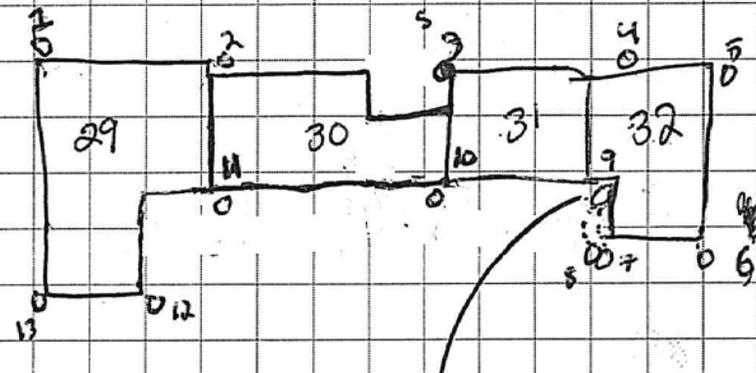
Quail Ridge I

→ Downspouts 3, 6 were observed discharging to surface.

→ Downspouts 7, 8, 9 connected via sound test

Dye tested downspout 9, observed discharging to surface, next to man hole on side of driveway.

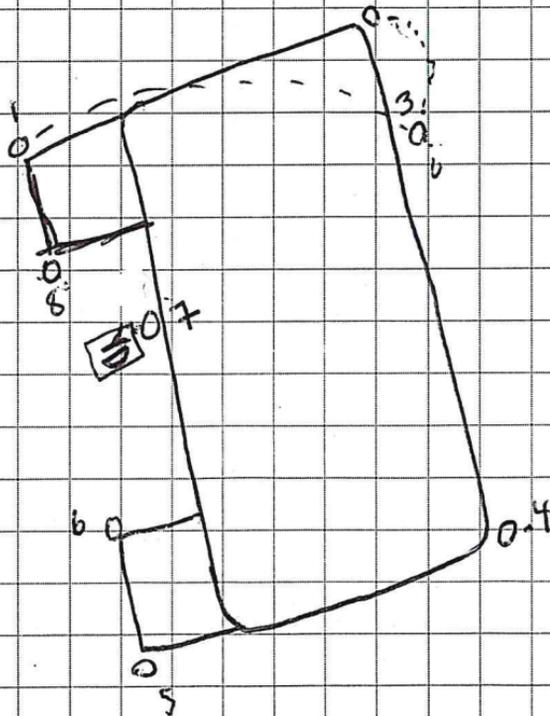
QUAIL RIDGE

Downspout 4 observed
discharging to surface

Downspout 3

is open stack,
exposed to surface,
no downspout.

Dye tested downspout 2
observed discharging on
surface (lawn).

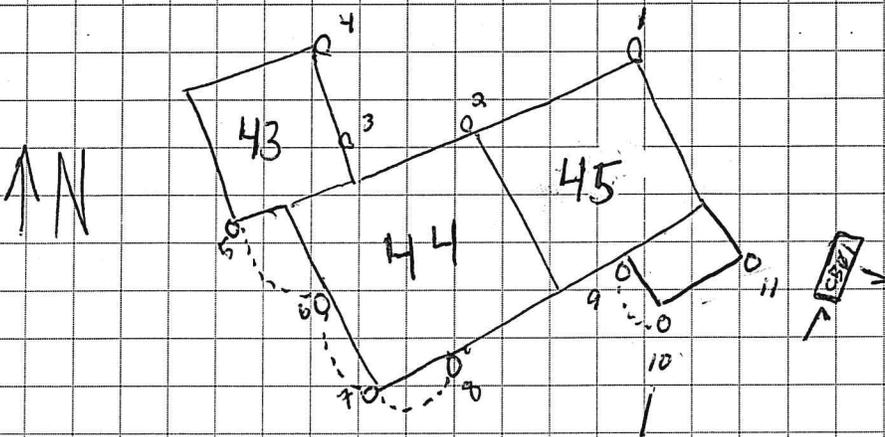
- Downspouts 1,2,3,4 observed discharging to surface
- Downspouts 5,6,7,8,9,10 connected via sound test, and visual orientation of pipes.
- Dye tested downspout 10, observed discharging to catch basin CB01.

Dye tested this downspout.
Dye seen in CB01.

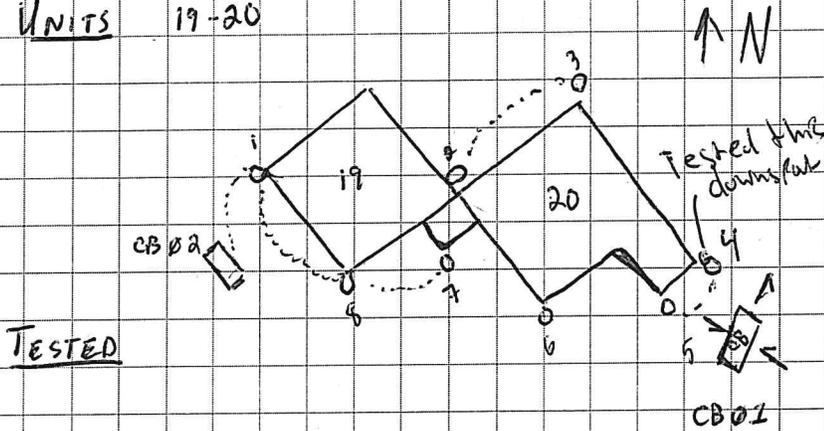
UNITS 19-20

Dye tested downspout 4, observed discharging in catch basin CB02 from the NW inlet.

Downspouts 2 & 3 and 4 & 5 are connected via sound test.

Downspouts 1, 8, 7 are connected via sound test, also connected to CB02 via sound test.

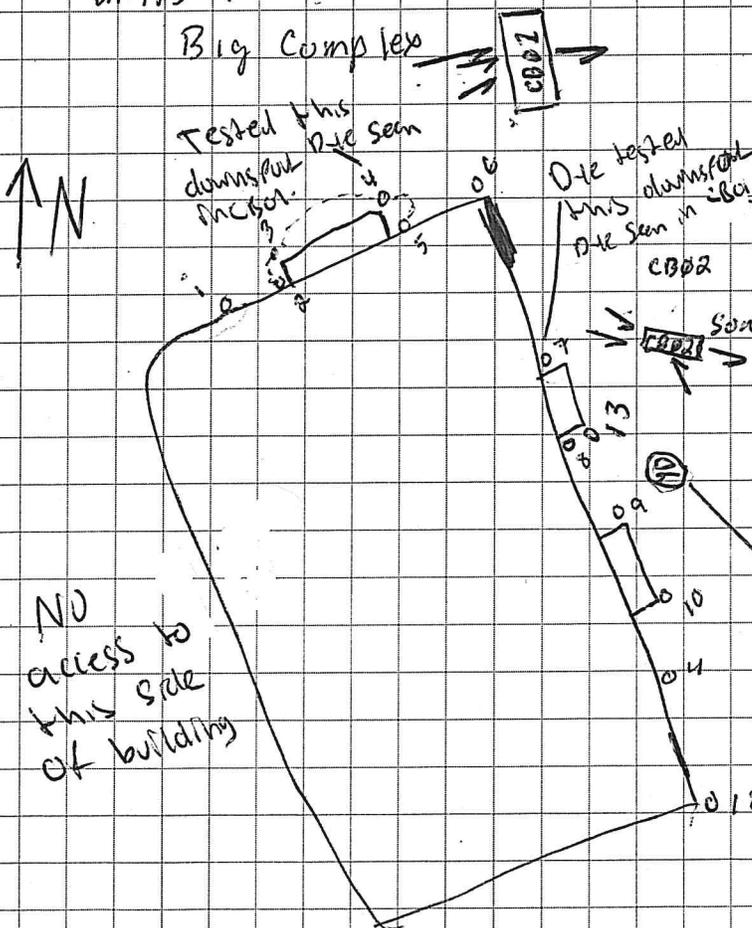
UNITS 4-12

Tested this downspout inlet. Dye seen

Dye tested this downspout Dye seen in CB02

Dye test Downspout 4, observed discharging into catch basin CB02 from smaller sized south west inlet.

Dye test downspout 7, observed discharging in CB01 from south west inlet.

Dye tested Yard Drain, observed discharging into CB02

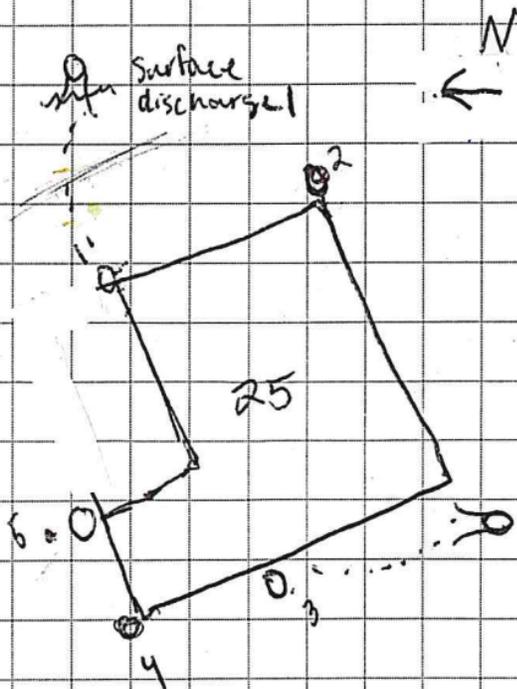
Dye from DS 4 seen here.

Dye tested this downspout.
Dye seen at surface discharge 2.

Downspout 5 discharges to surface.

Dye tested downspout 4, observed discharging at surface discharge 2.

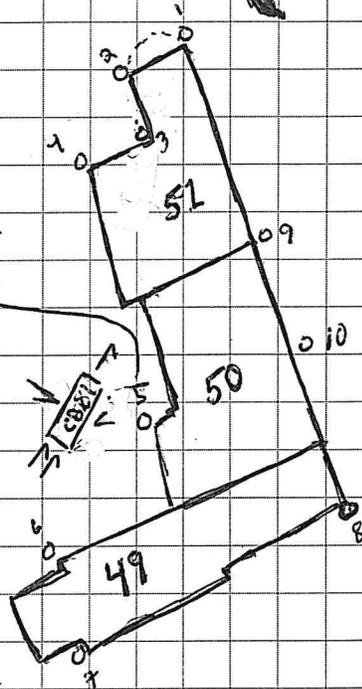
Tested
this downspout
dye seen
in
CB01.

Pipe opening
Downspout 2, 3, 9, 10
discharging to surface

Dye tested downspout 4
observed discharging to
surface, at Pipe opening 1

downspout 5,
observed discharging into
storm drain CB01

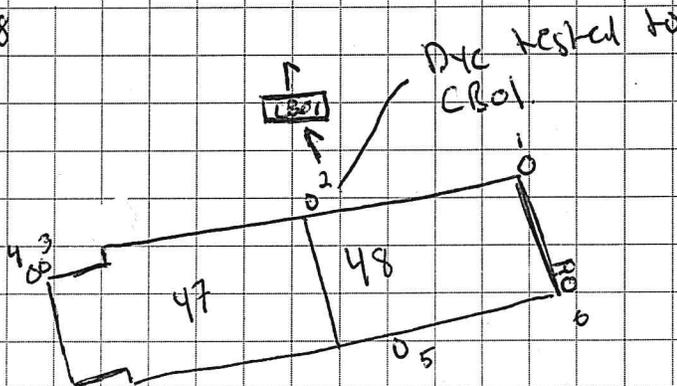
Dye tested to
CB01

Dye tested downspout 2,
observed discharging to
drain catch basin CB01

Downspouts 1, 3, 4, 5, 6
observed discharging to
surface

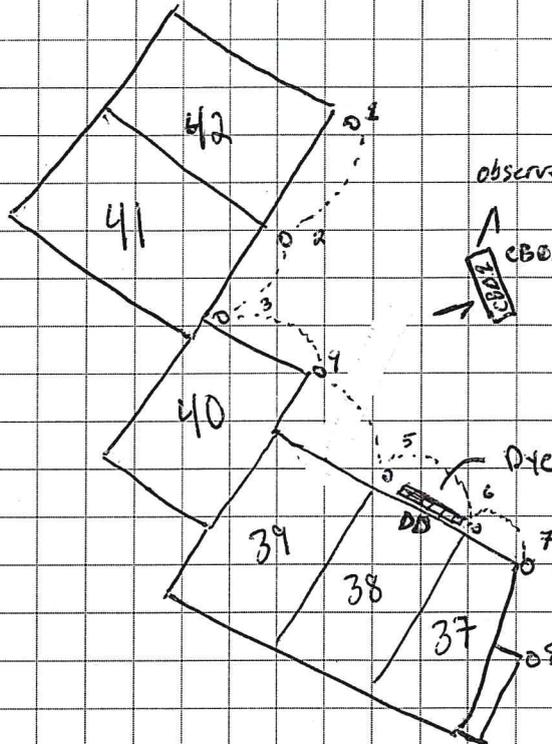
→ Downspouts 1, 2, 3, 4, 5, 6, 7, 8 are connected via sound test

→ Dye tested downspout 7, observed discharging to drain catch basin CB01.

→ Dye tested DD in front of Unit #38 garage bays, observed discharging into CB01

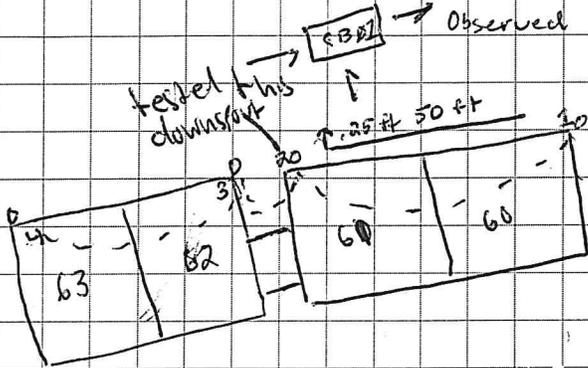
UNIT 60-61

Dye test downspout 2, observed discharging in drain catch basin #1

Observed downspout 1, 2, 3, 4 connected by sound test.

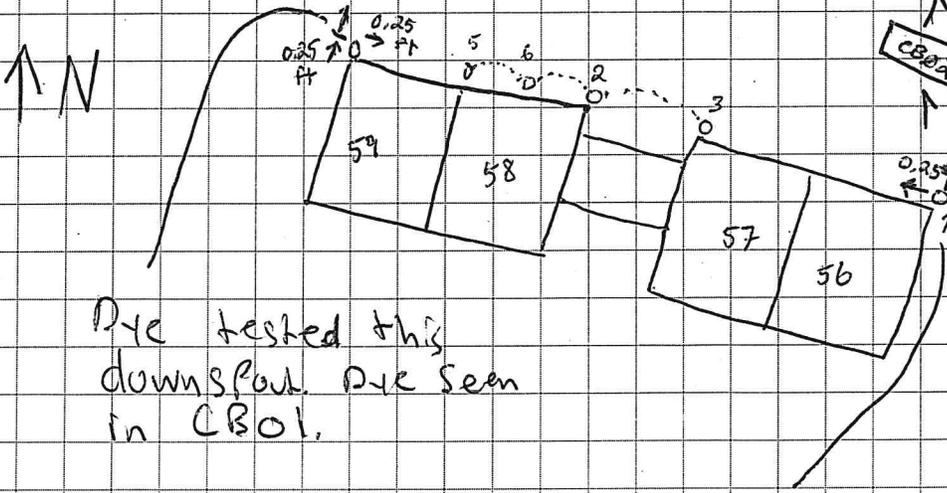
56-59

Downspouts 56, 2, 3 are connected by sound test. 1, 4 are independent

Dye tested this downspout. Dye seen in CB#1.

Dye tested downspout 1, observed discharging into drain catch basin #1 at the end of prospect st.

Dye test downspout 4, observed discharging in CB#2

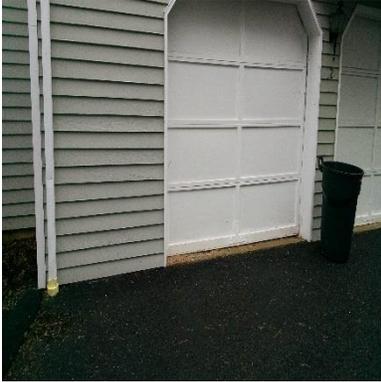
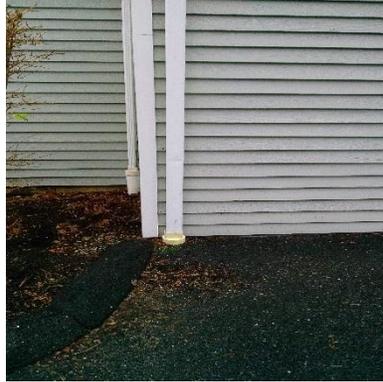
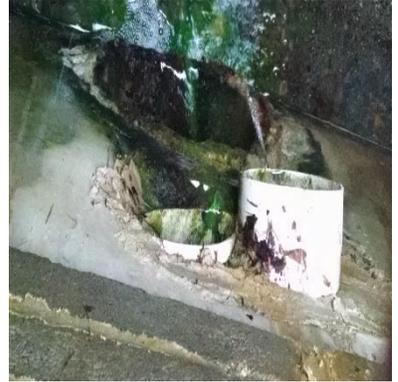
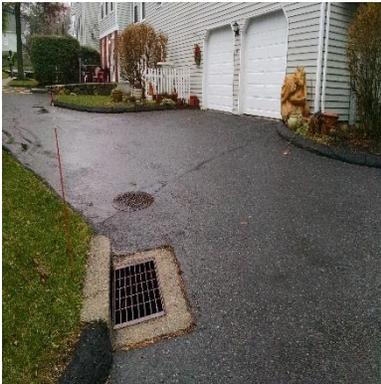
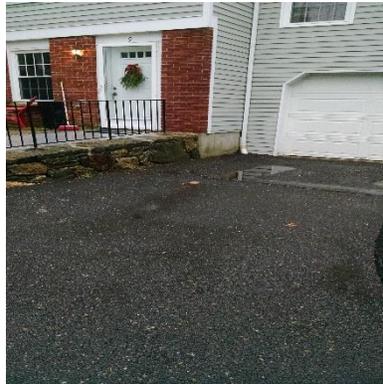
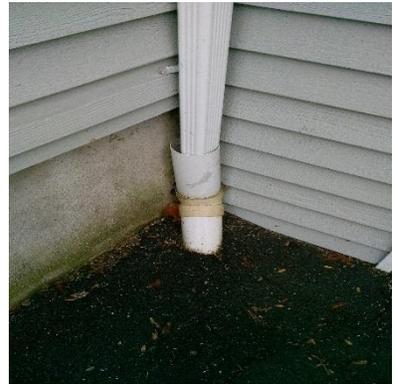
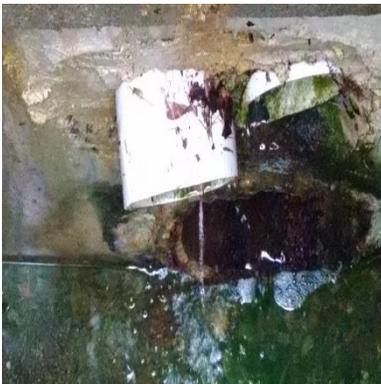
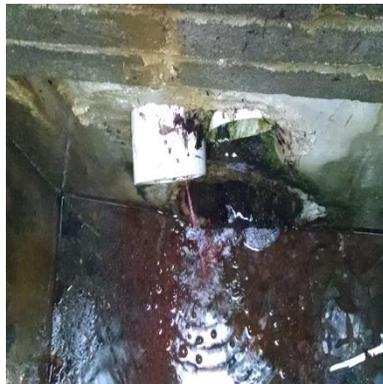
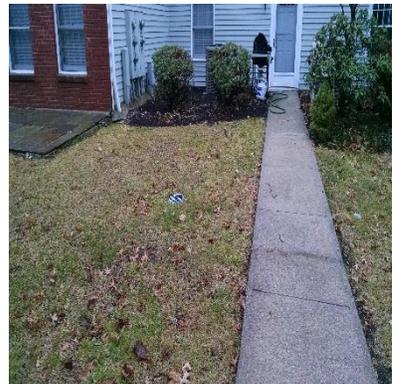
Dye tested this downspout. Discharges to surface.

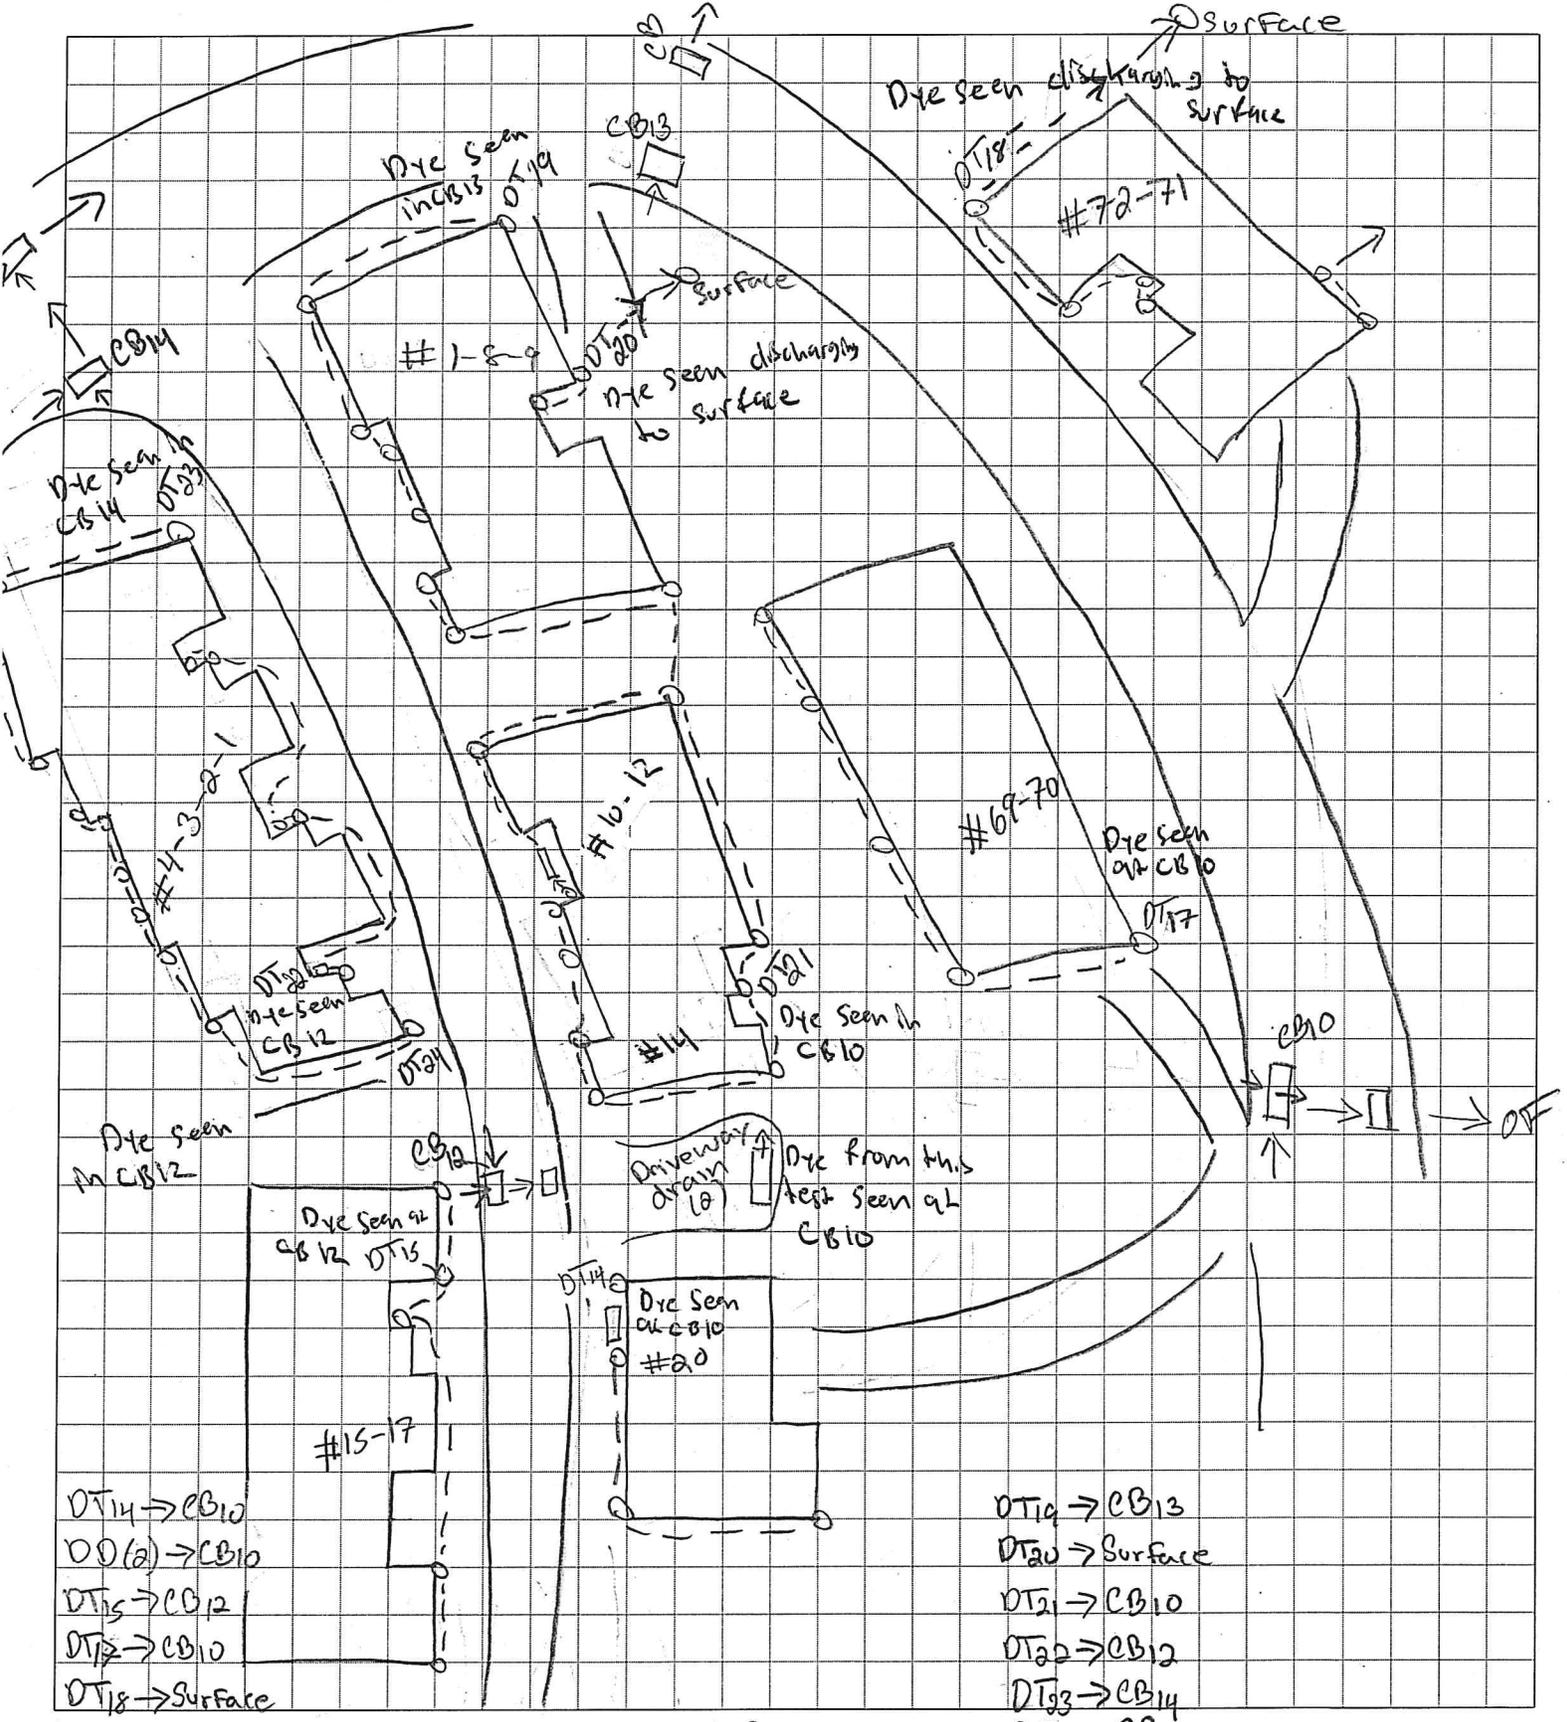
Sewer Manhole ID: 199

Drain Manhole ID: CB

Dye Observed: Yes

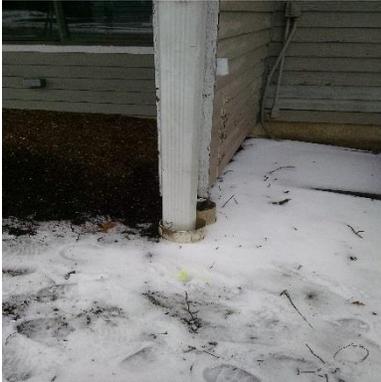
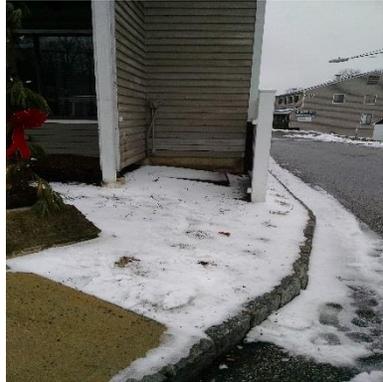
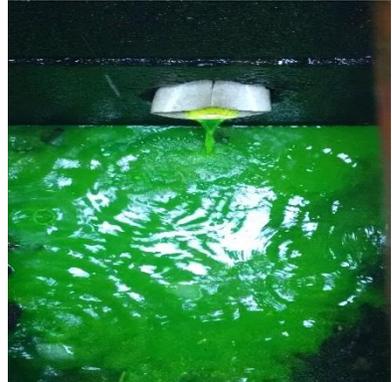
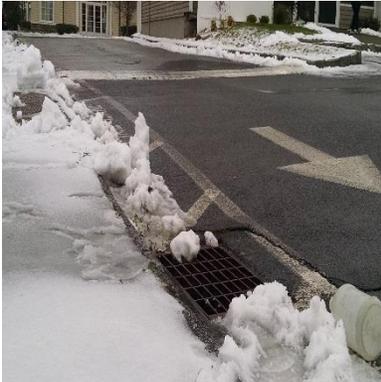
Downspout 0.5' S of NE corner and 0.5' from wall (downspout 4 from sketch). Dye was observed in a CB1, NW of the building.

Dye tested downspout 4,
observed discharges in CBI
from SE inlet.

Dye tested
this downspout.
Dye seen in
CBI.

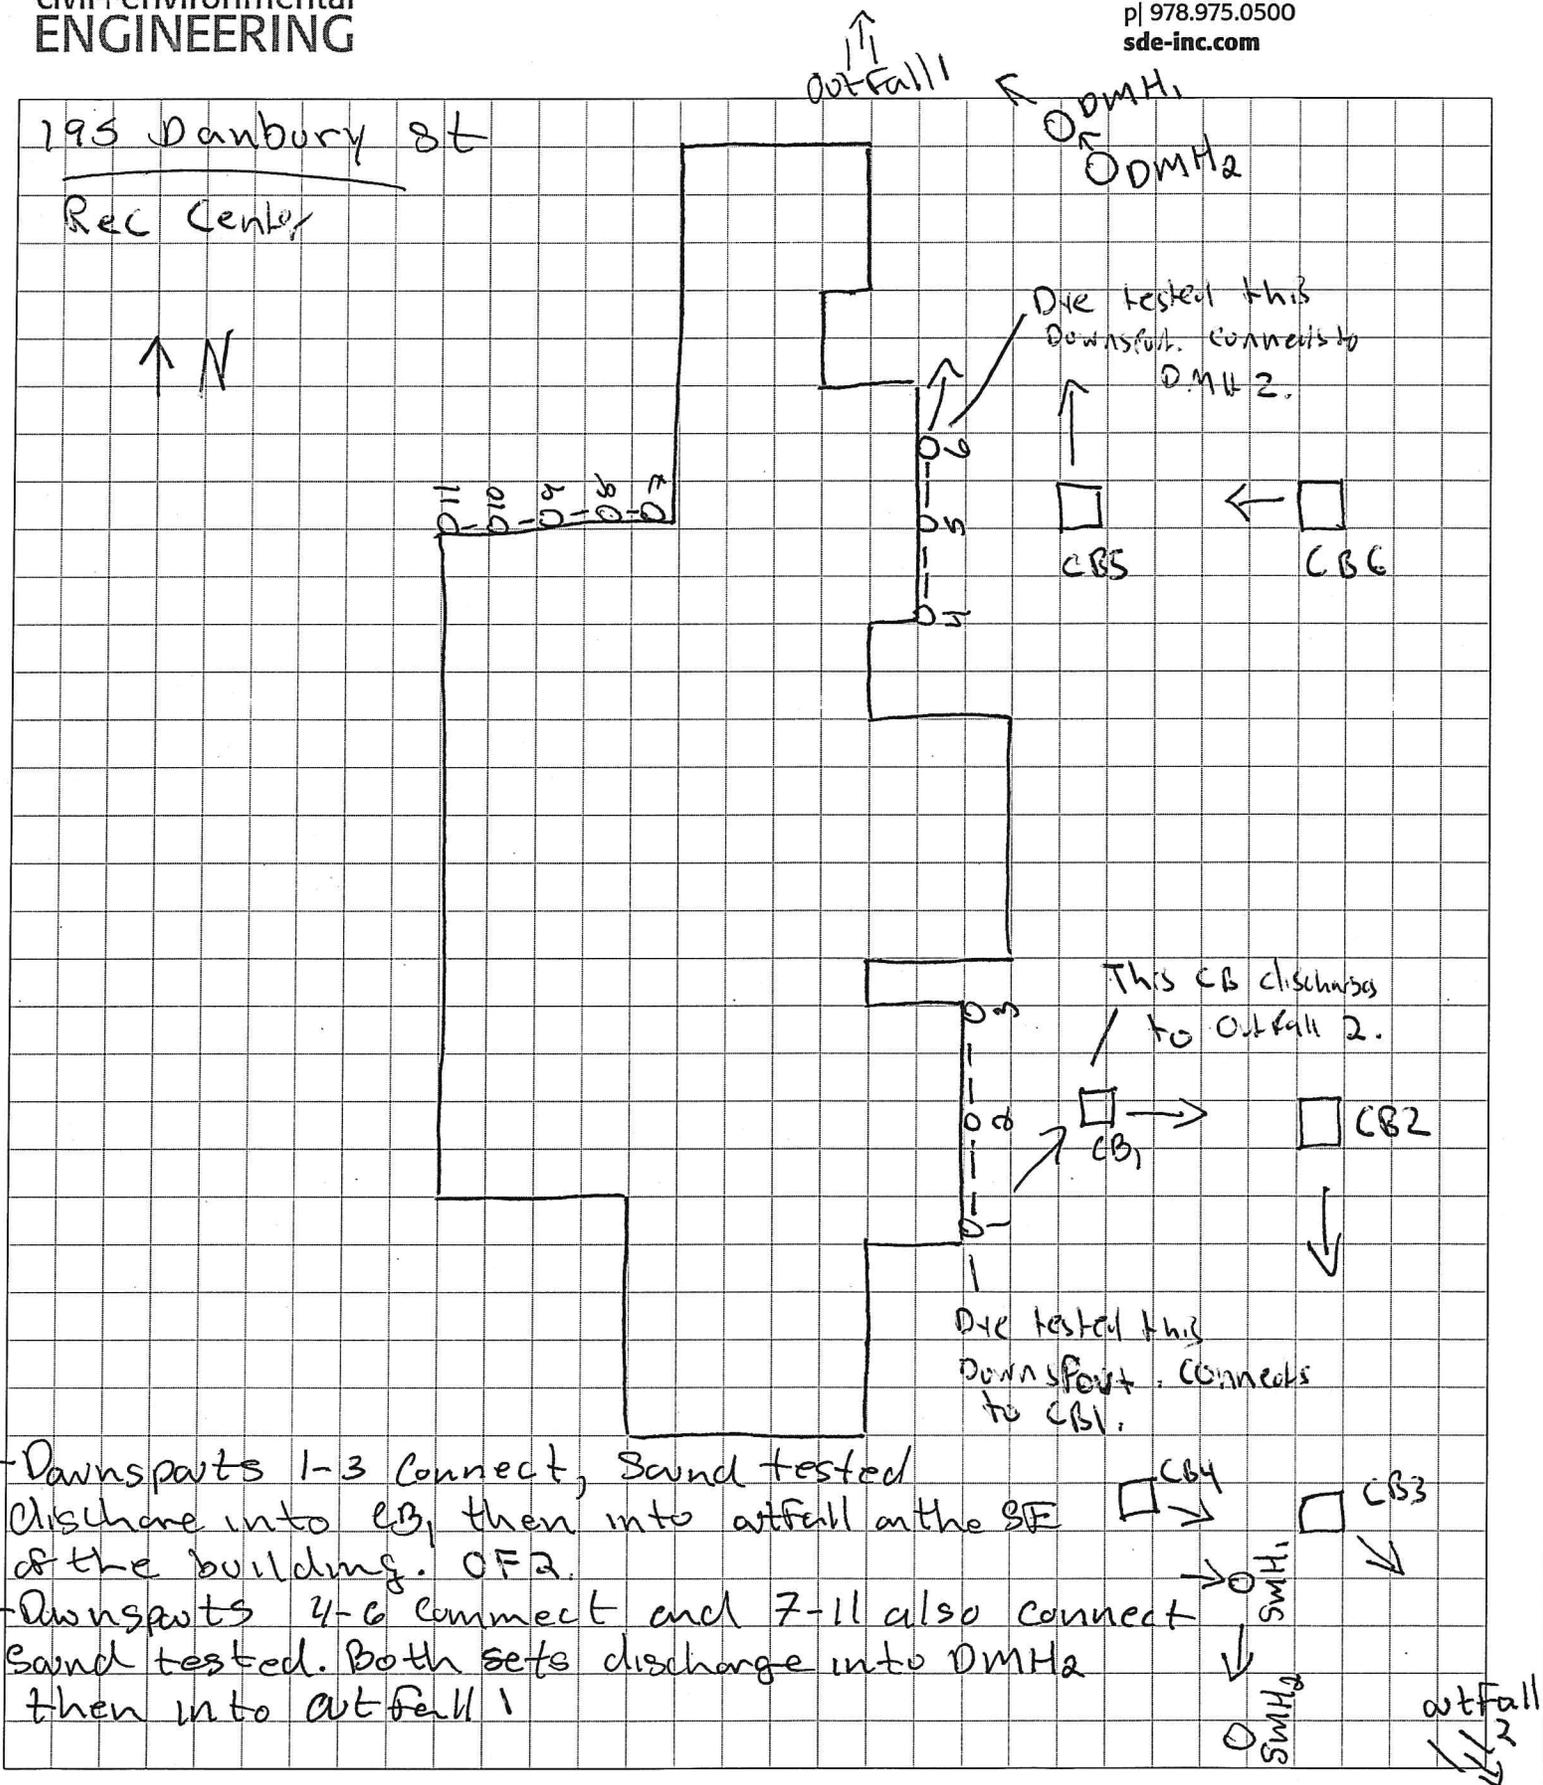
Downspouts on the North part of the building discharged into DMH2 from sketch. Crew also located outfall behind the building where DMH1 and DMH2 discharge

- Downspouts 1-3 connect, sound tested discharge into CB₁ then into outfall at the SE of the building. OF₂.
- Downspouts 4-6 connect and 7-11 also connect sound tested. Both sets discharge into DMH₂ then into outfall 1

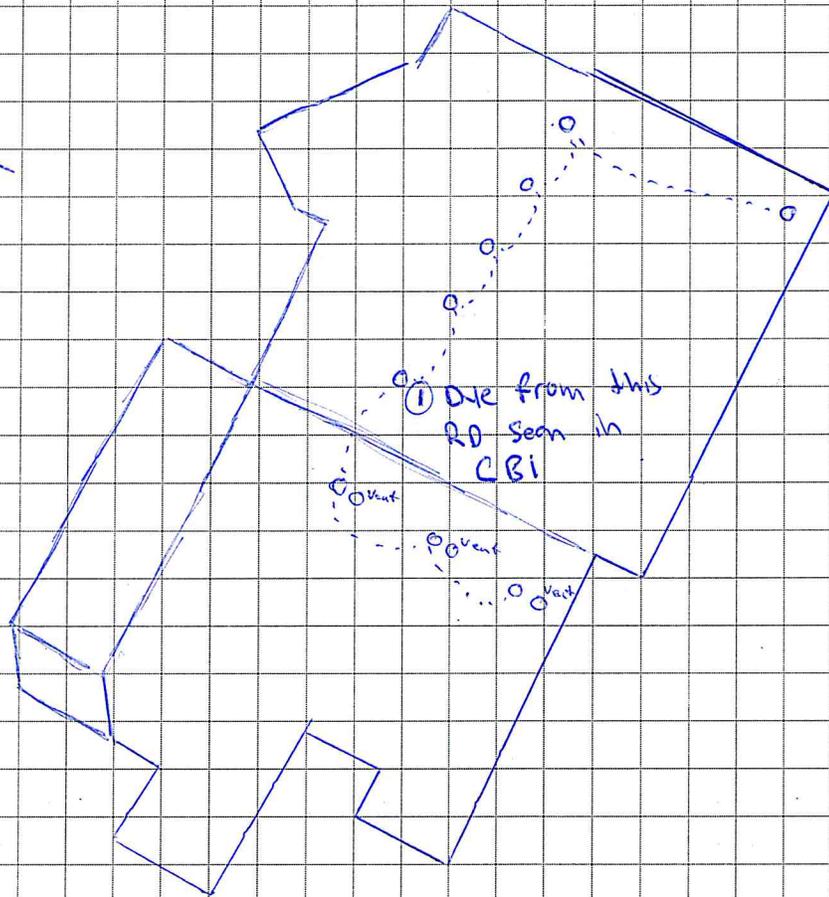
Copps Hill Road

Tested roof Drain 60' from West edge and 180' from North edge of building on sketch as RD1. Dye was observed in a storm manhole behind Stop & Shop and then in a catch basin upstream labelled as CB1 on sketch and at outfall to stream North of Stop & Shop.

Notes: All roof drains sound tested positive for connections to dyed roof drain marked as ①.

Tested roof drains dye was observed in a catch basin NW of building, and at the stormwater outfall to the NE.

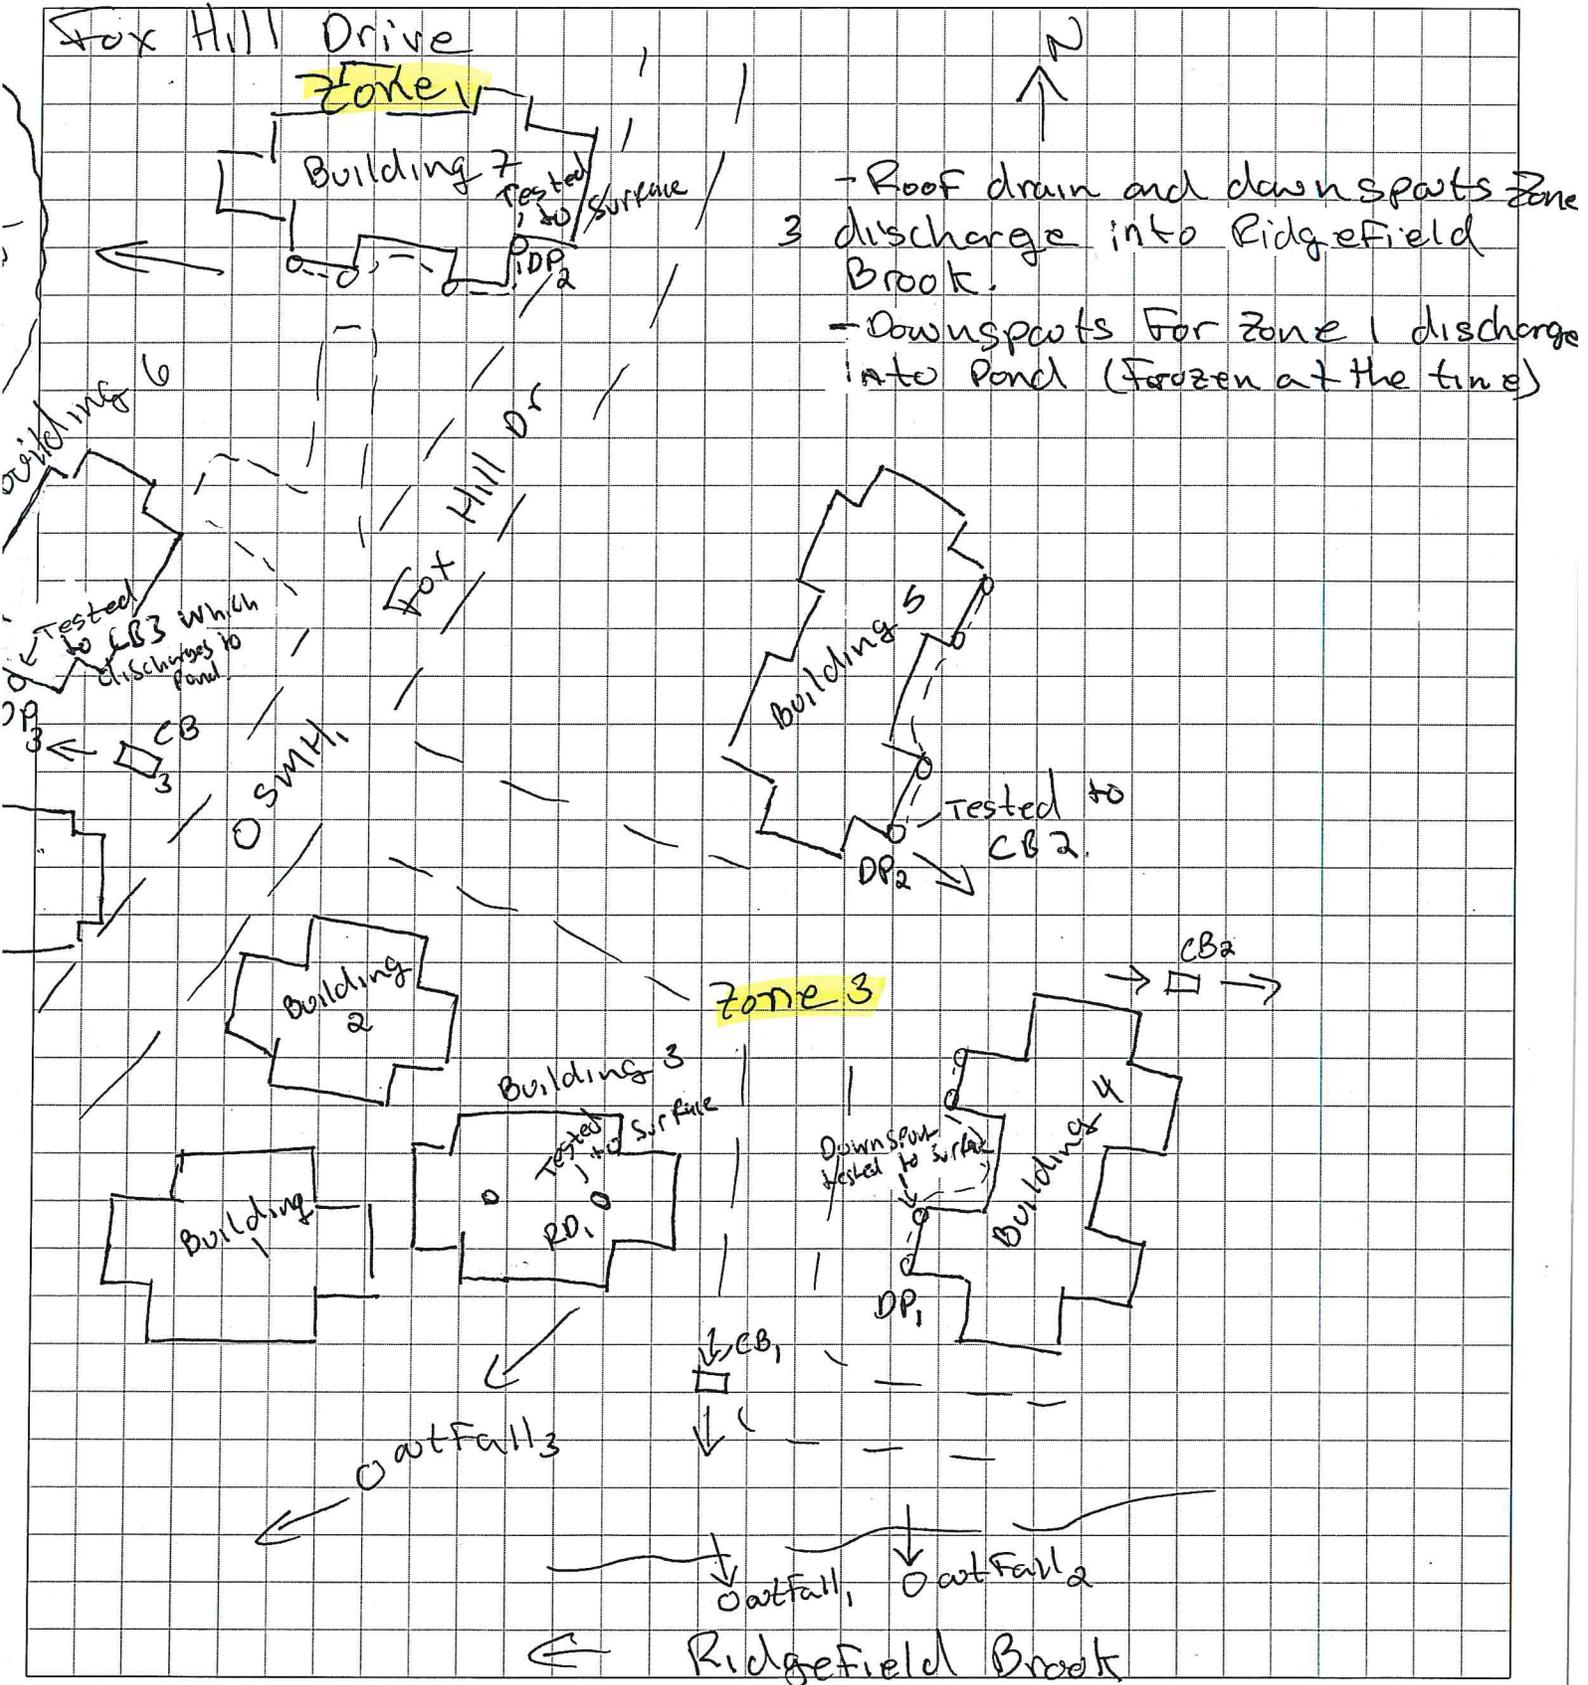
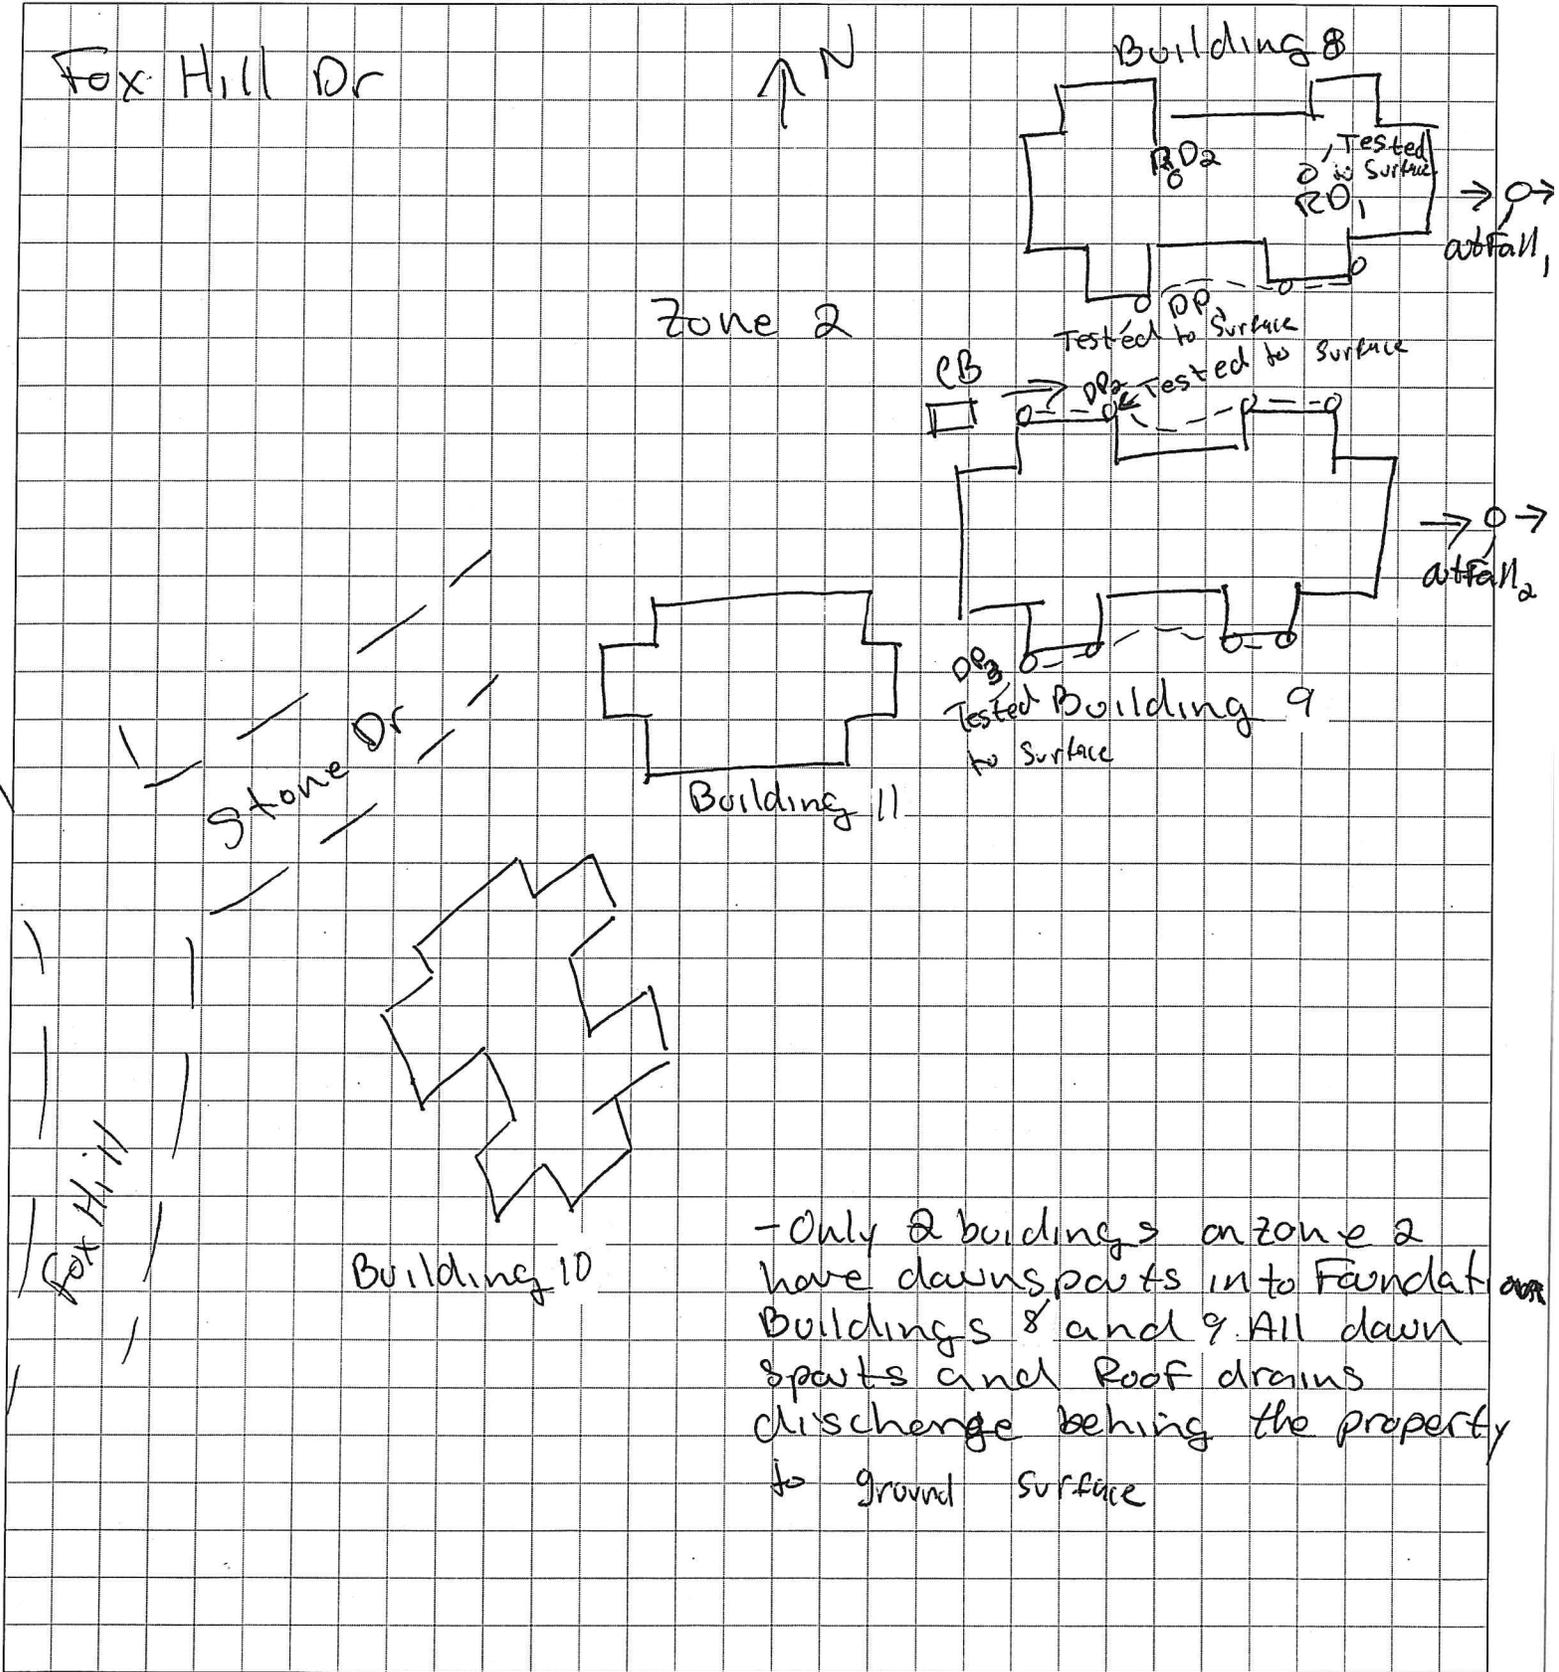
Downspout (DP3) discharges to surface behind the building.

- Only 2 buildings on zone 2 have downspouts into Foundation Buildings 8 and 9. All downspouts and roof drains discharge behind the property to ground surface

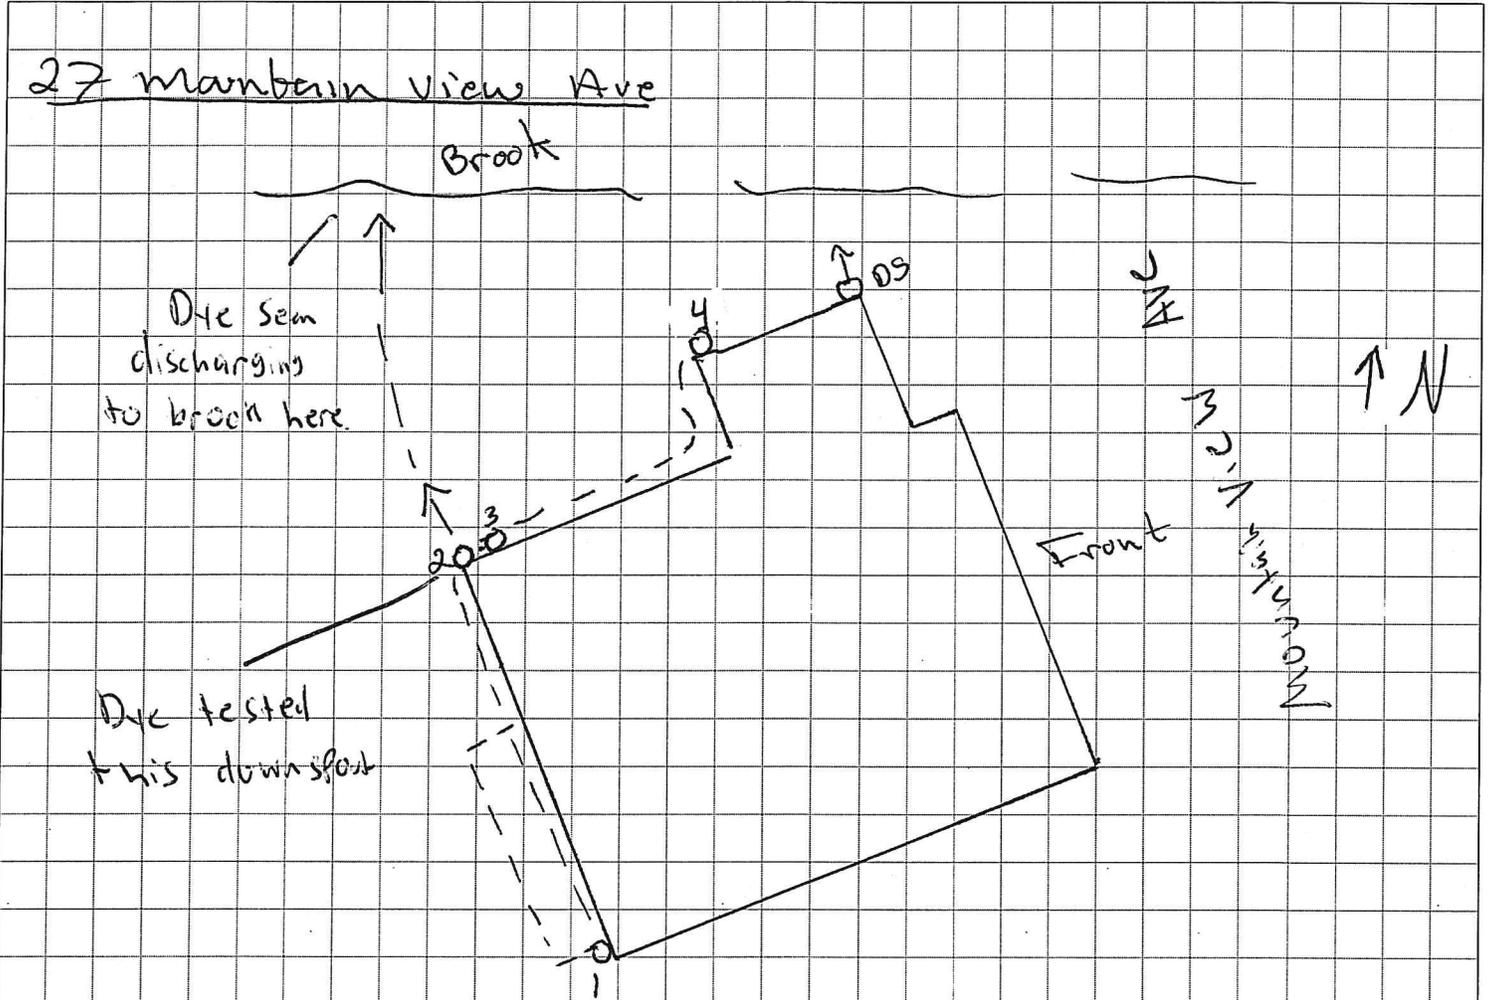
Tested downspout 2 from sketch. Downspouts discharge into brook beside house.

- Downspouts 1-4 connect, sand tested
- Downspouts discharge into brook.

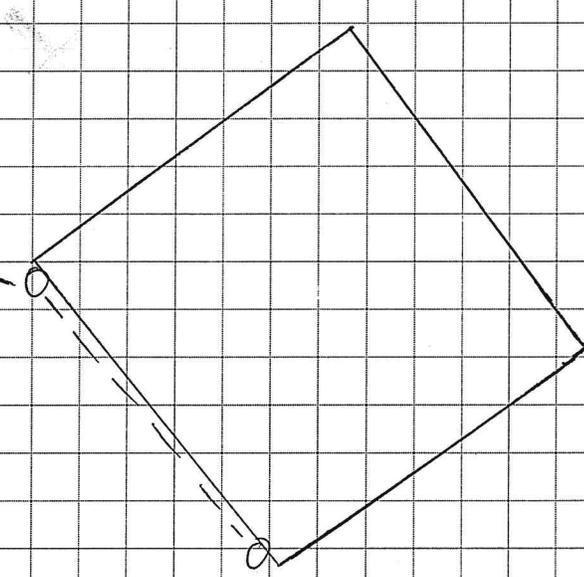
Roberts Ln

tested this
downspout

- Front of the house downspouts connected
- Downspouts discharge into brook behind the property
