Technical Memorandum

To	Ridgefield WPCA	Page	1 of 22
CC	C. Fisher, J. O'Brien, J. Pennell		
Subject	Town of Ridgefield, CT Phase 2 Wastewater Facilities Plan Technical Memorandum No. 1 – Dyed Water Testing and Tracing		
From	Jon Pearson/Alberto Angles		
Date	October 27, 2016

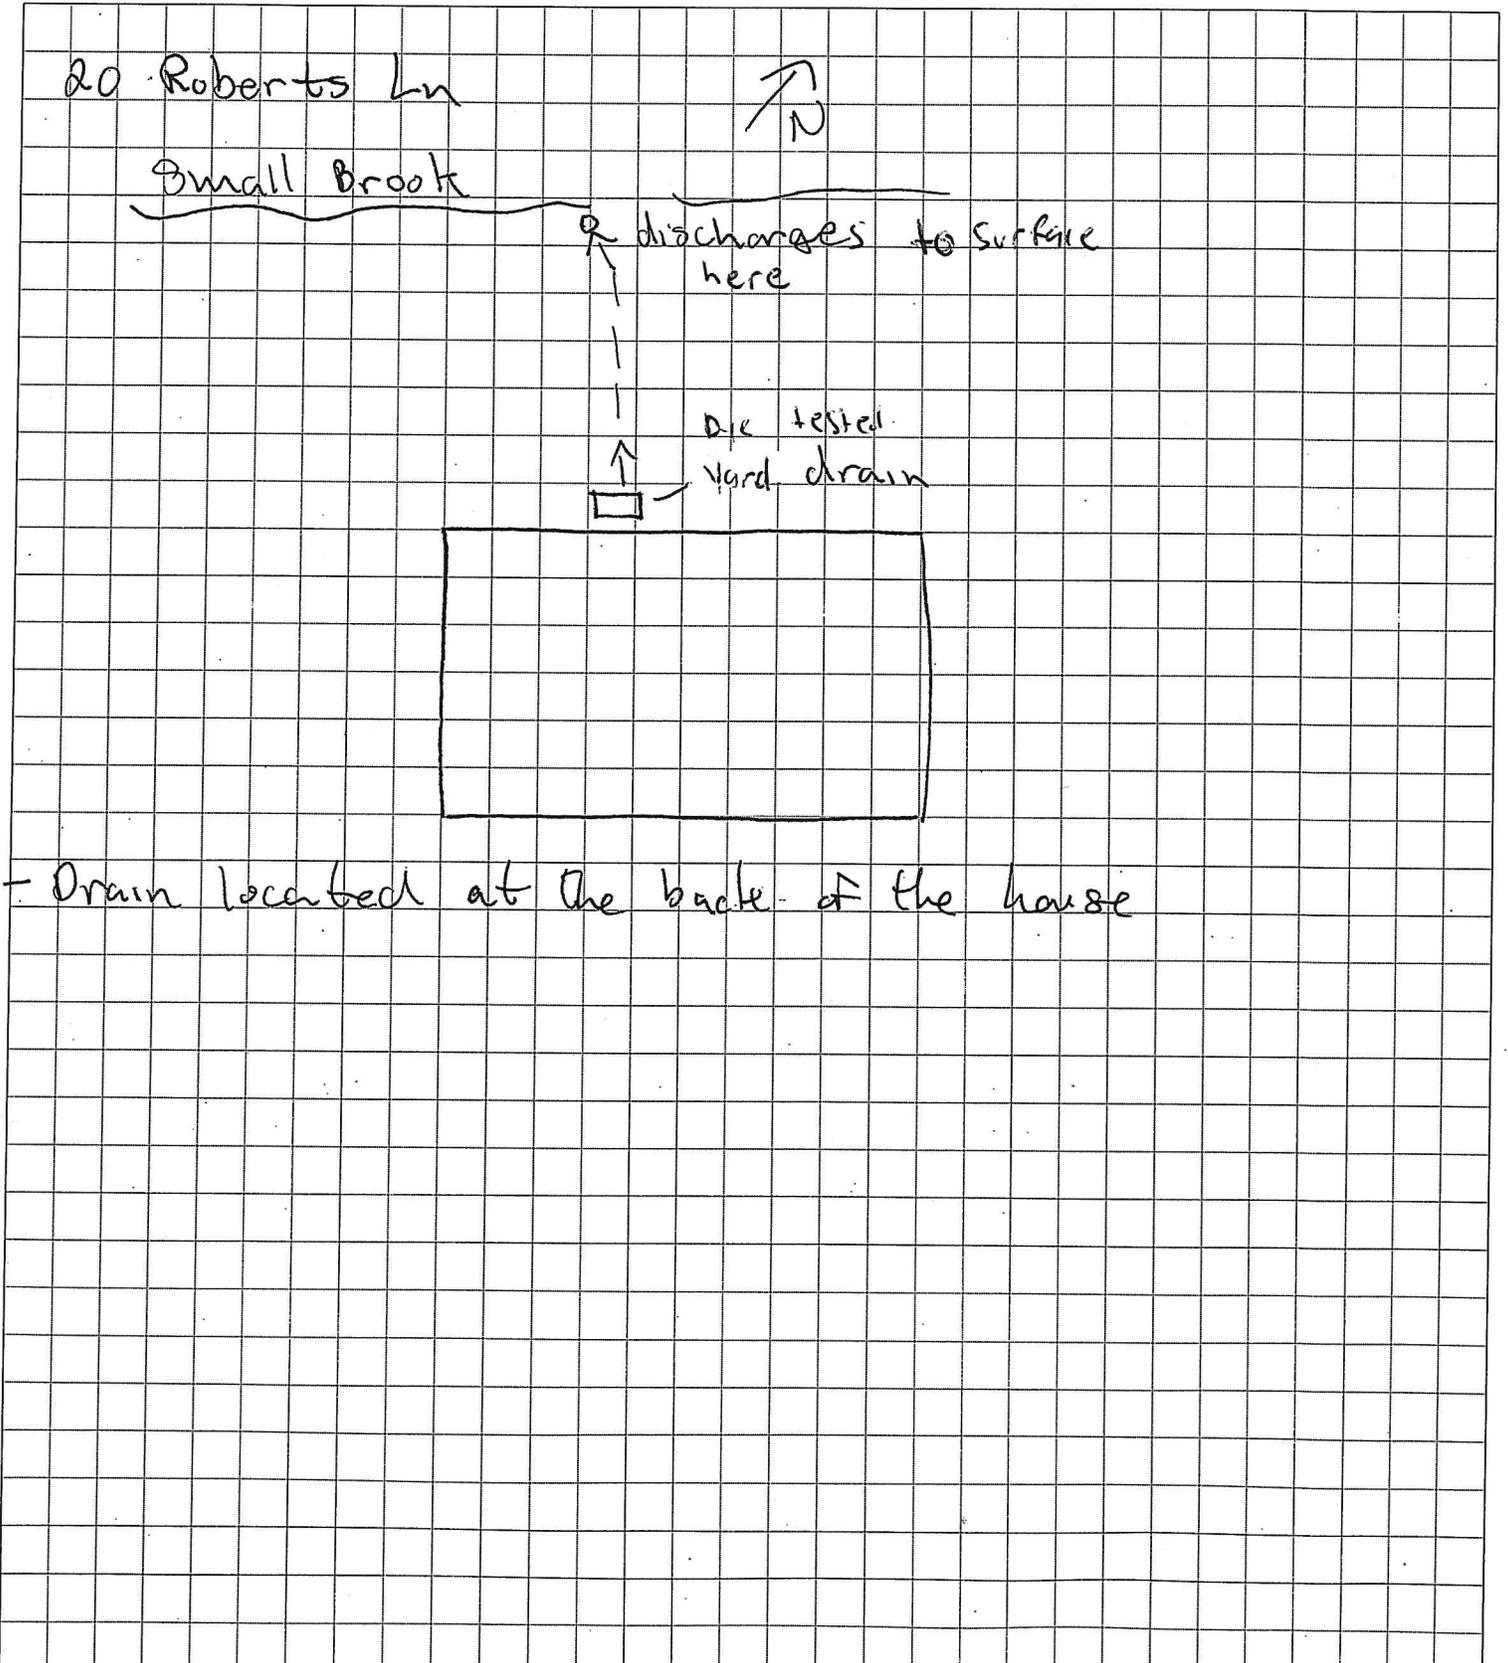
Dye seen discharging to small brook behind the building.

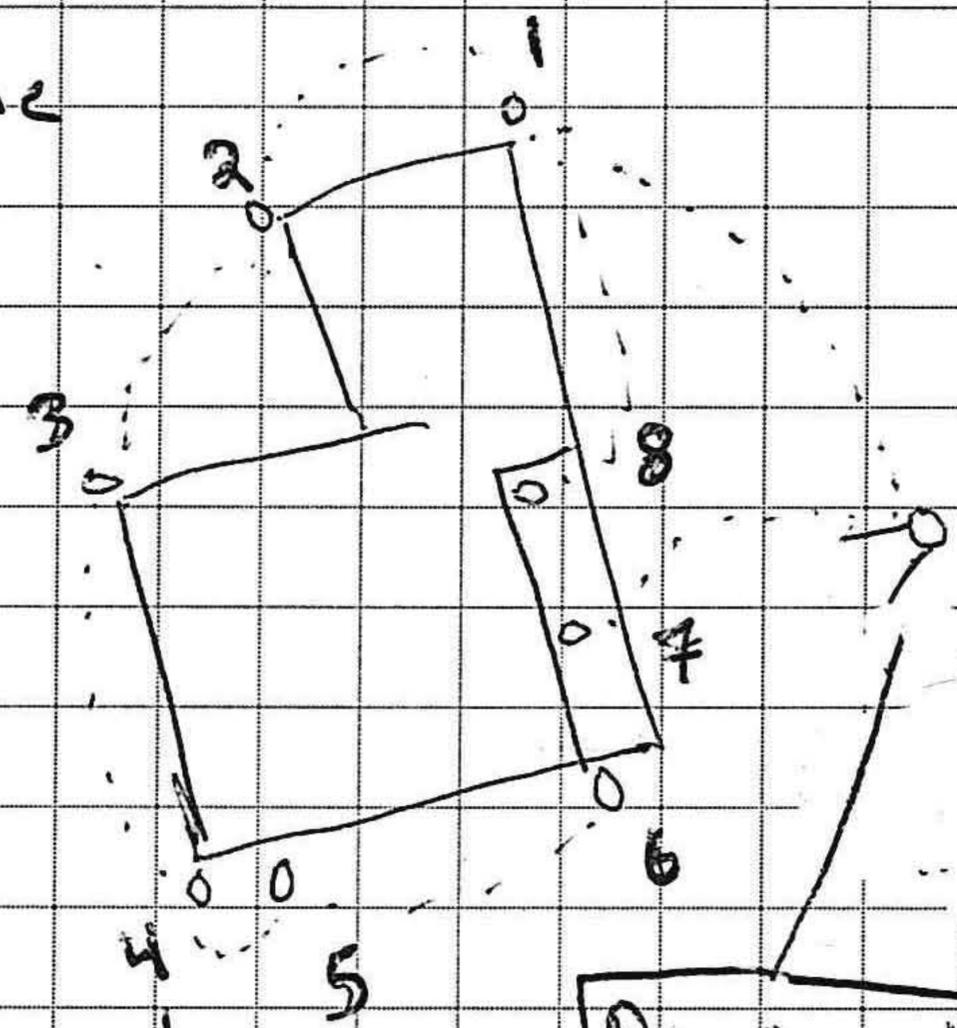
ROBERTS

Dye tested downspout 0.25' E of NW corner and 0.25' from wall (downspout 4 from sketch). Dye observed discharging from PVC pipe in back yard to into small brook.

Dye tested this downspout

Dye seen discharging to surface here

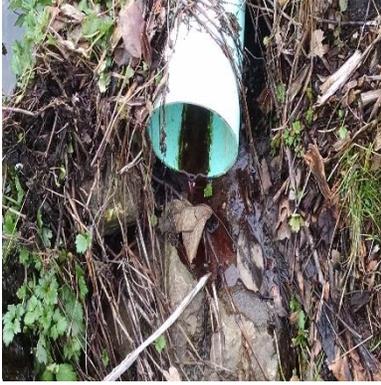
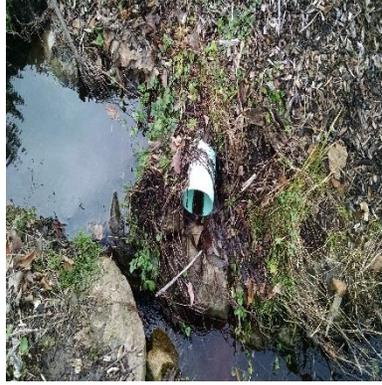
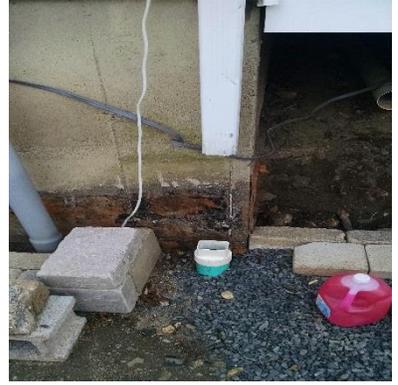
Dye tested downspout 4 observed discharging to surface on edge of stream.

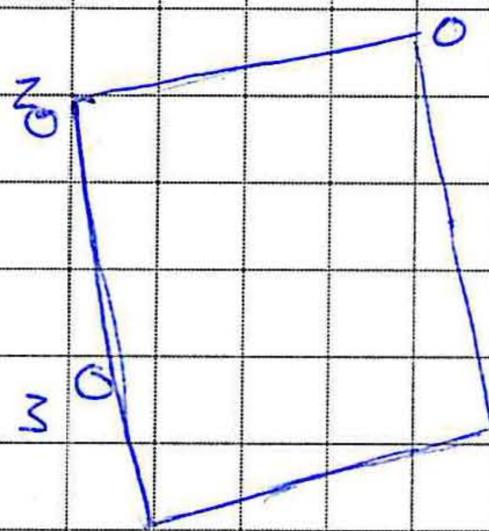
6 Rochembeau Ave

o all downspouts observed discharging to surface.

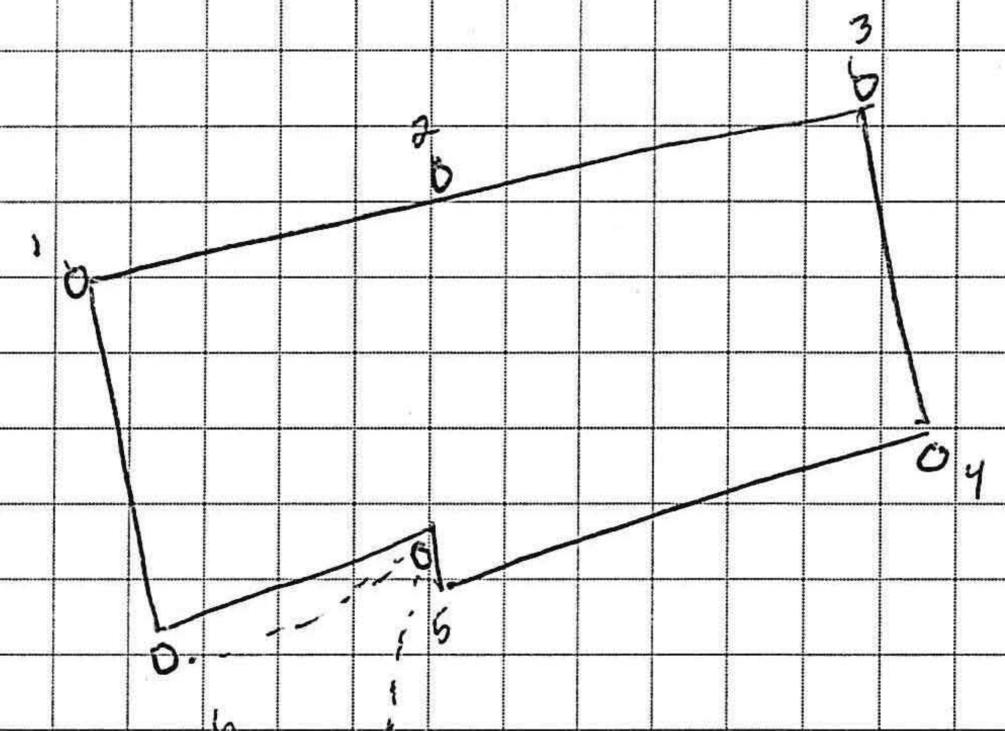
Inlets to driveway drain sound tested to house.
Dye tested driveway drain, CB01 confirmed in next catch basin CB02, behind 2 WASHINGTON. CB02 discharges into Stream

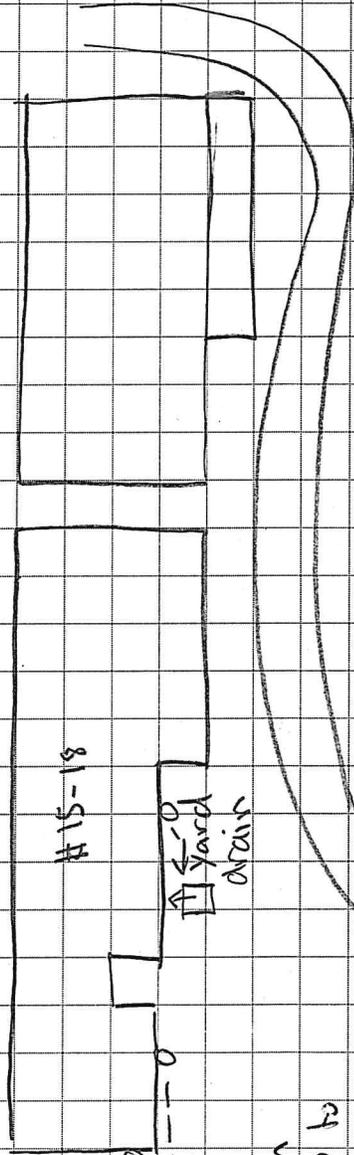
Dye seen discharging to surface from DF5

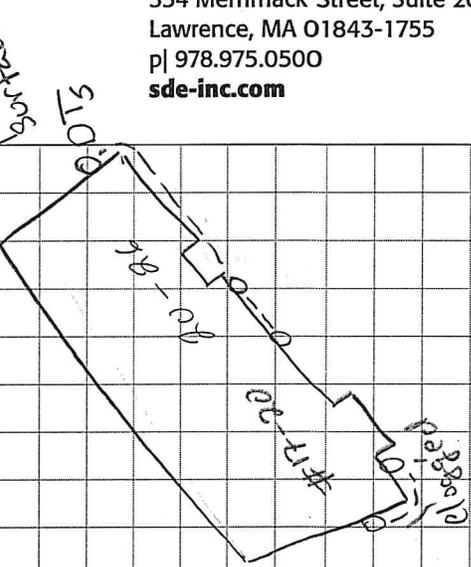
Dye from DT5 seen at surface

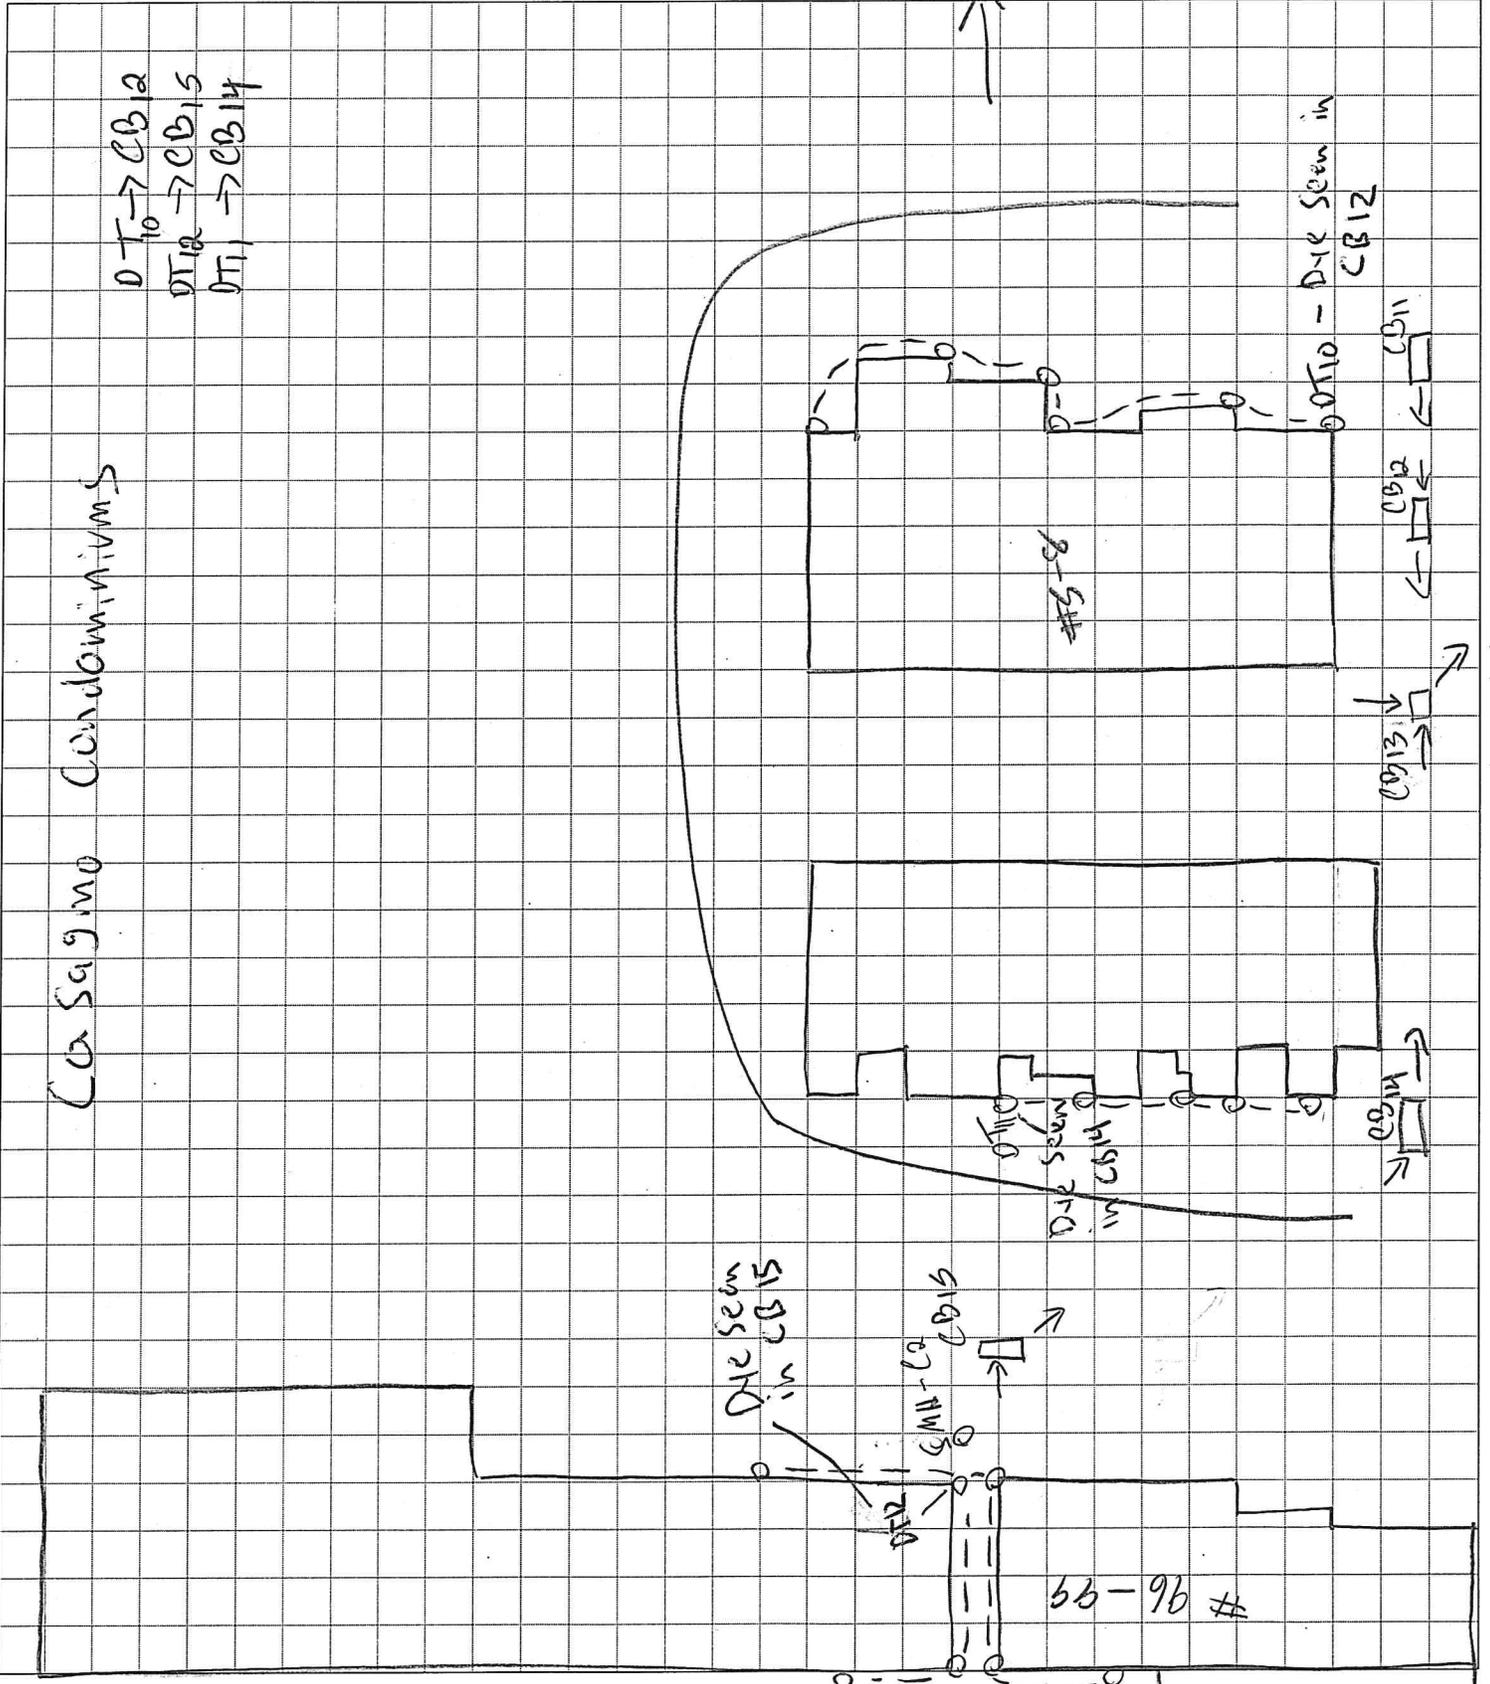
DT₁₀ → CB12
DT₁₂ → CB15
DT₁₁ → CB14

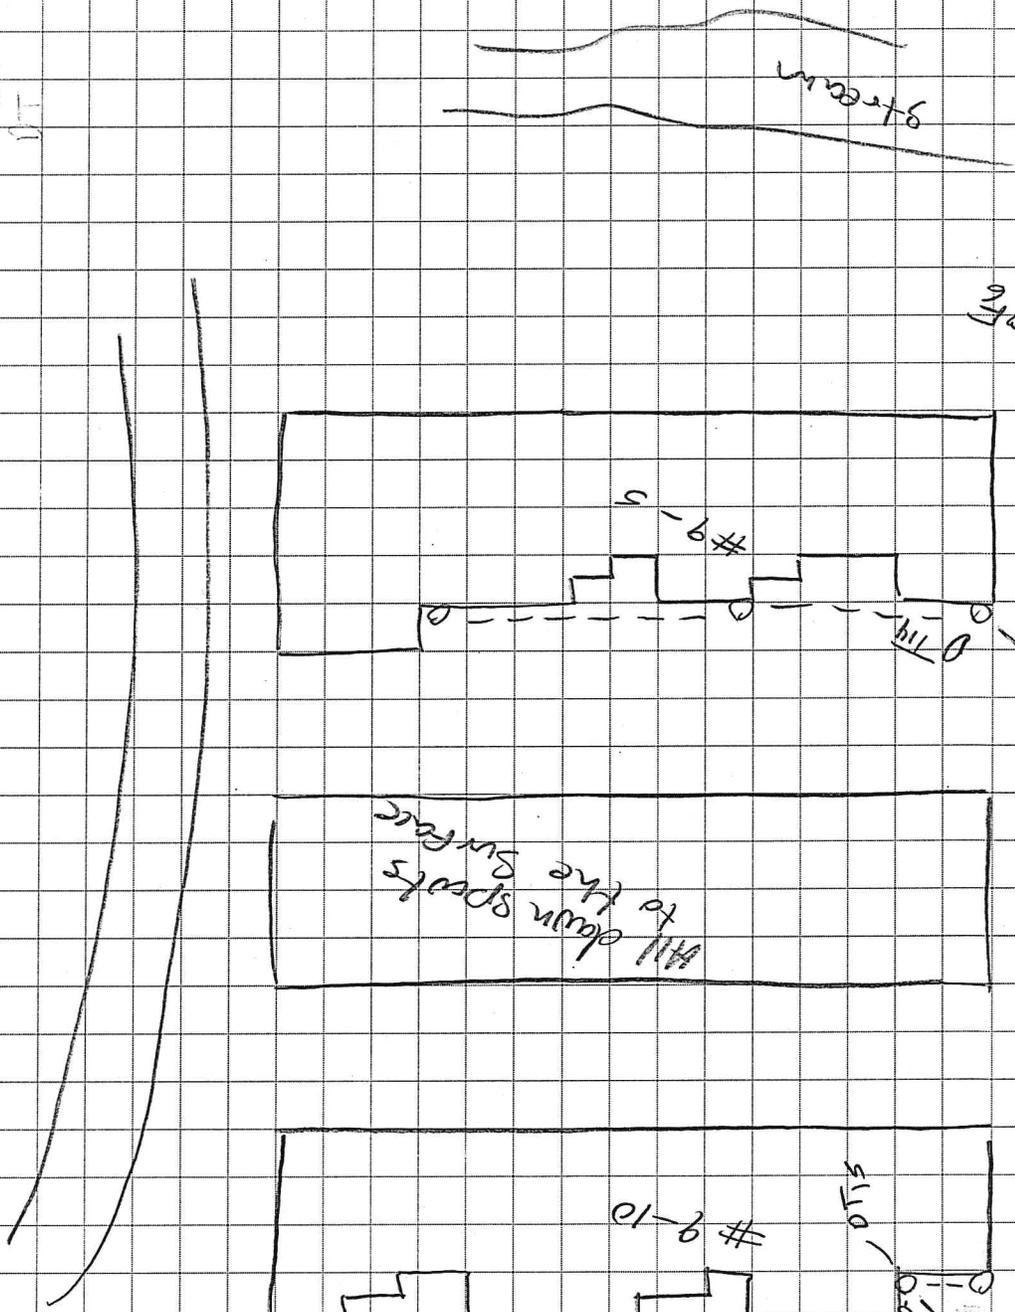
Dye Test
DT14 → Surface (OF6)
DT15 → Surface (OF7)

Dye Seen discharging to Surface from OF6

Dye Seen discharging to Surface from OF7

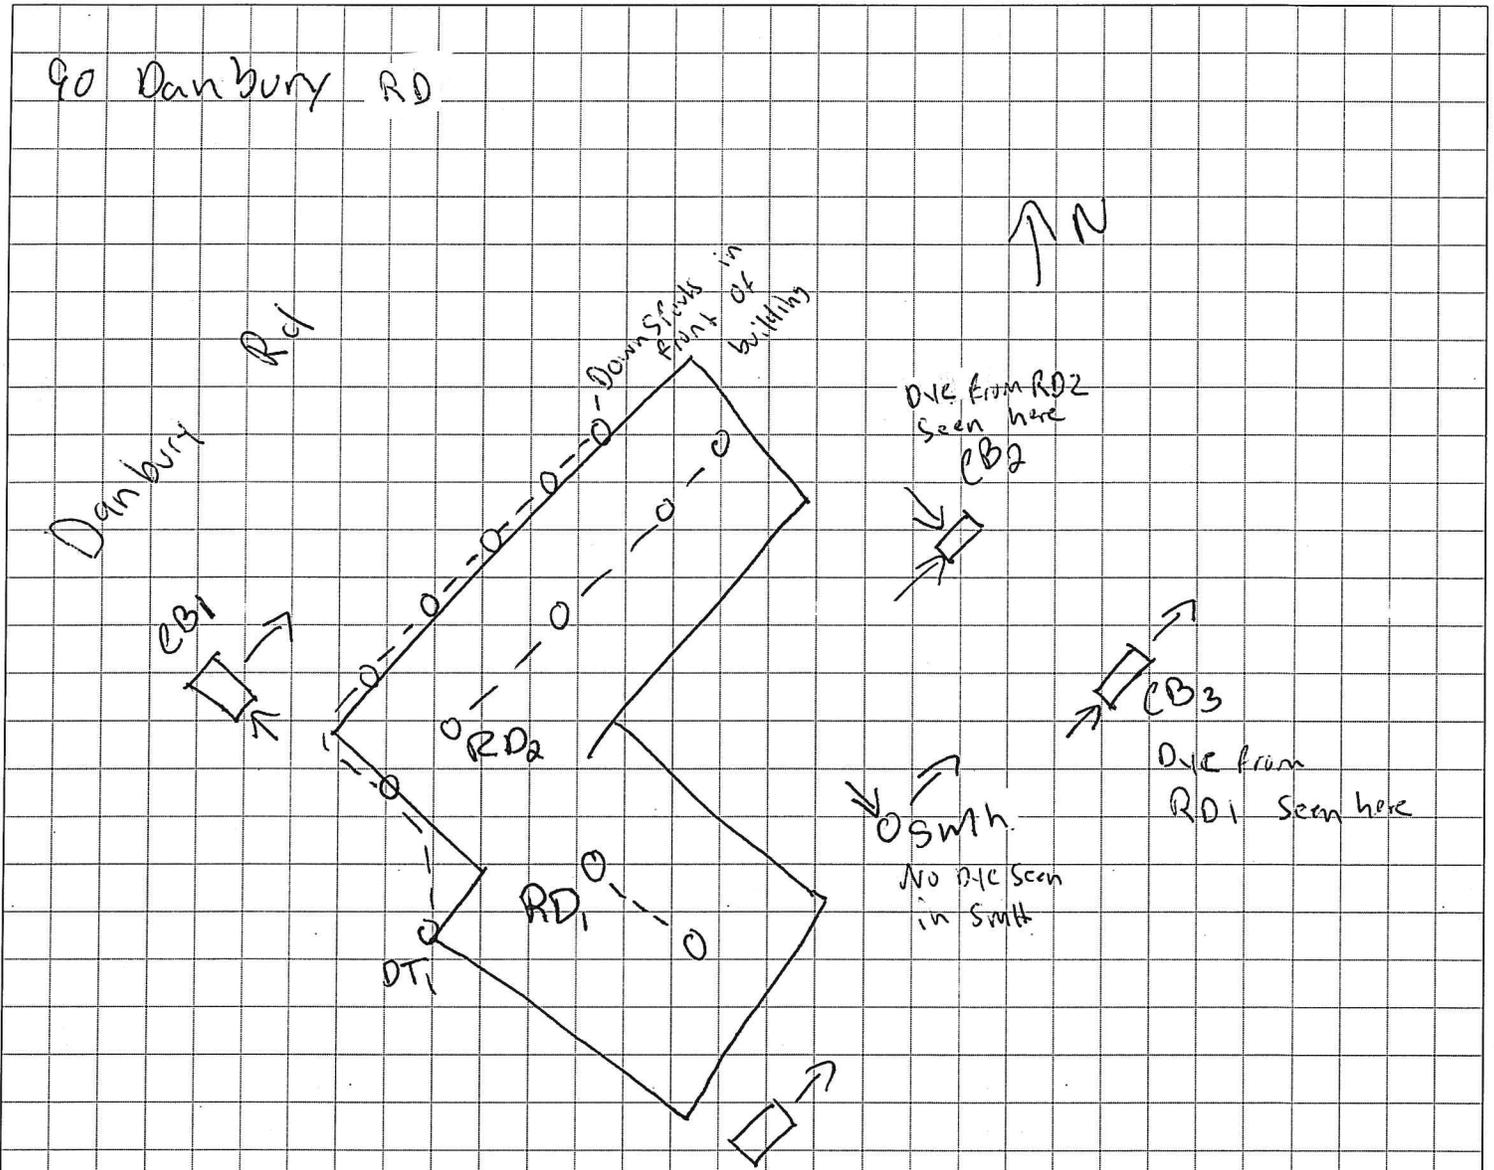
Tested downspouts in front of the building. Catch basin located in the parking lot in front of the building.

* All downspouts connect and discharge into CB1

* RD1 set discharges into catchbasin CB3

* RD2 set discharges into catchbasin CB2

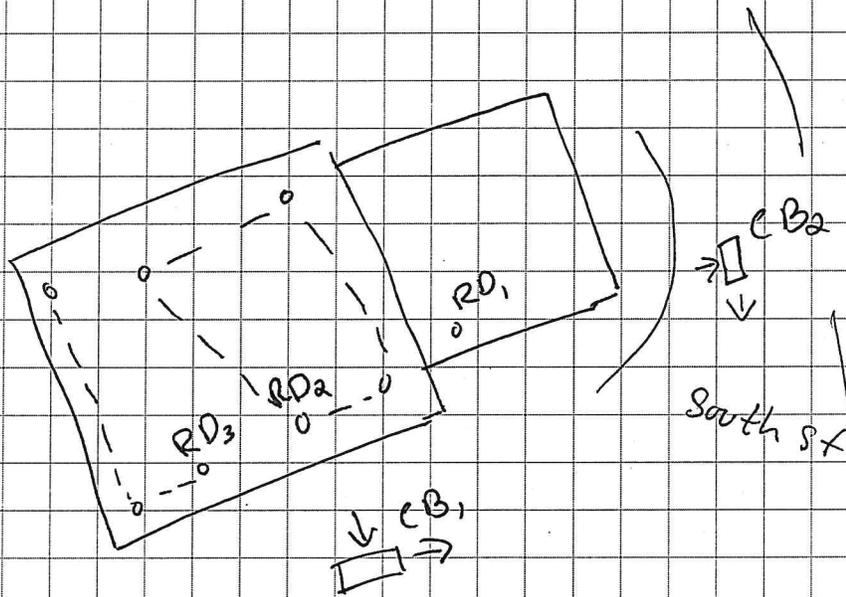
10 South St

Roof drain discharges into catch basin located in the parking lot.

↓ outfall
DIR from RD3 seen here

- Roof Drain (RD₃) discharges to Surface (outfall)
- Roof Drain (RD₂) discharge into catch basin (CB₁)
- Roof Drain (RD₁) discharge into catch basin (CB₂)

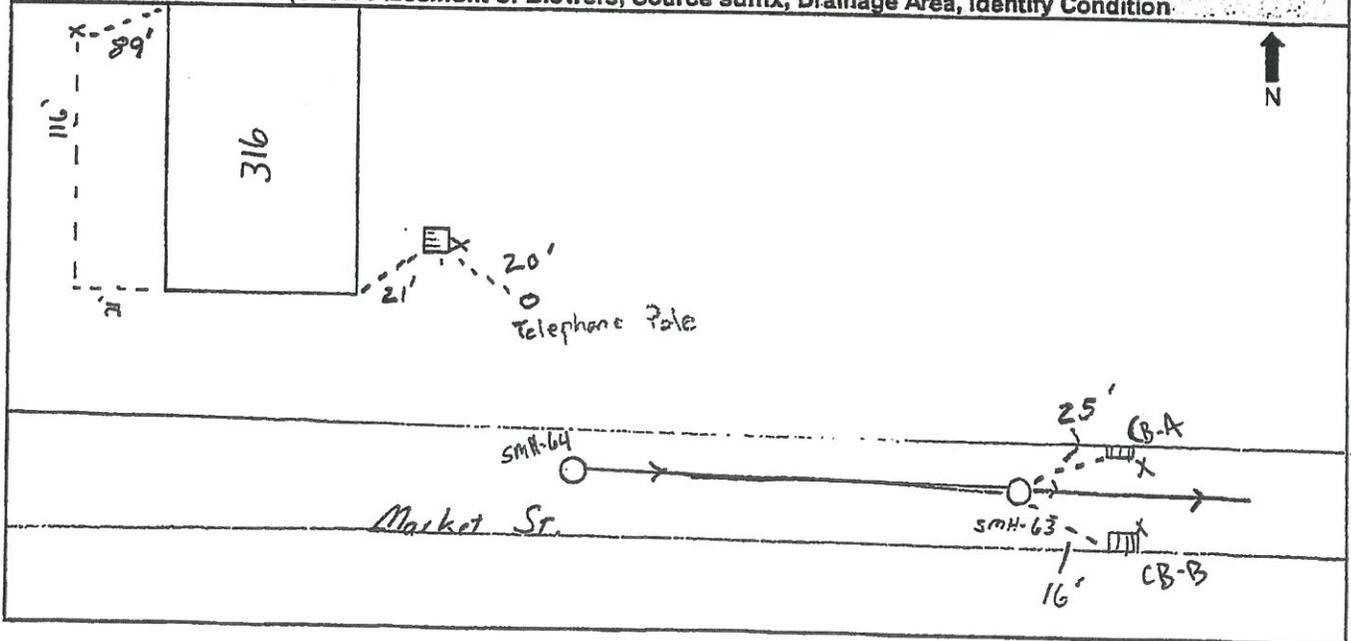
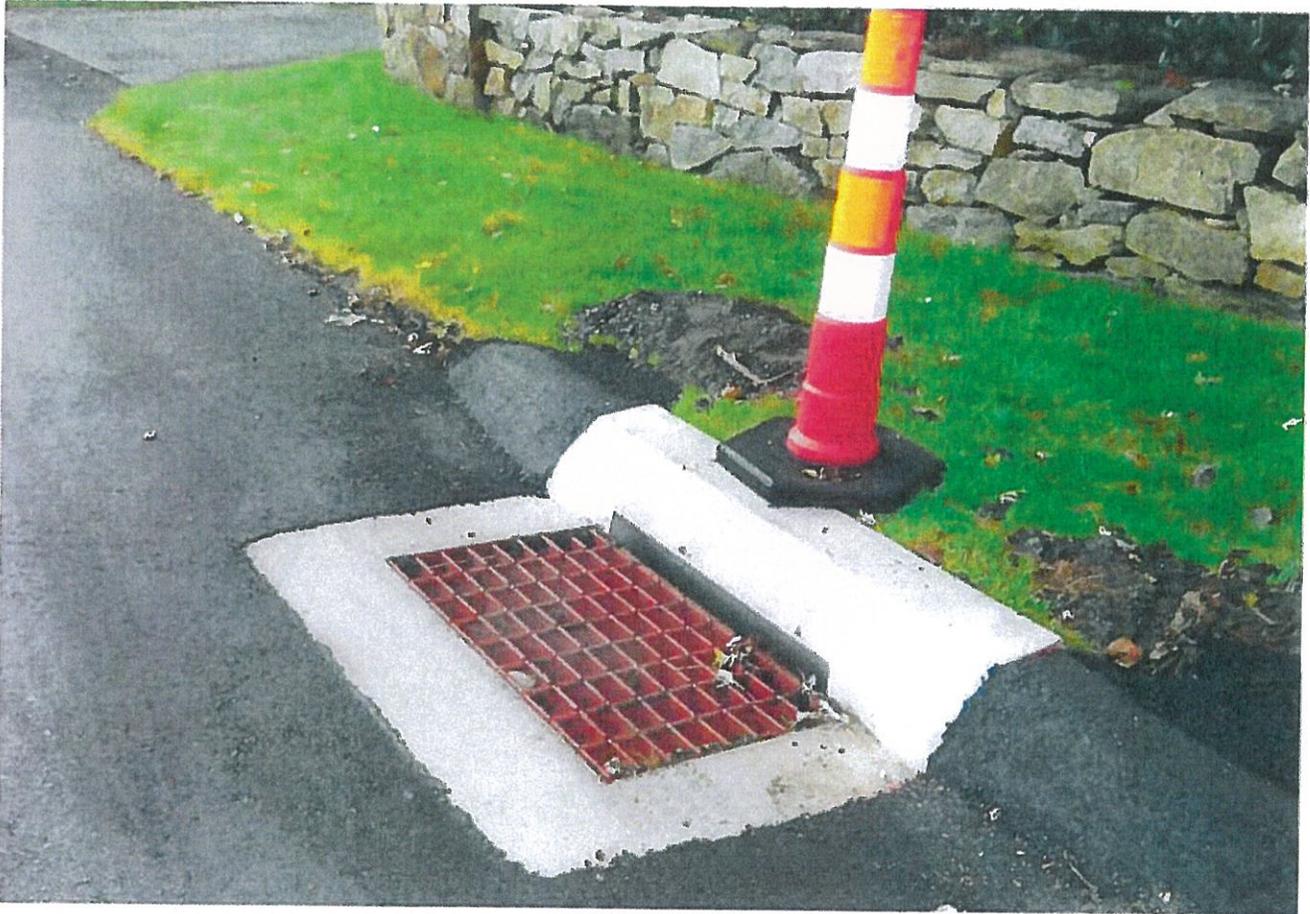
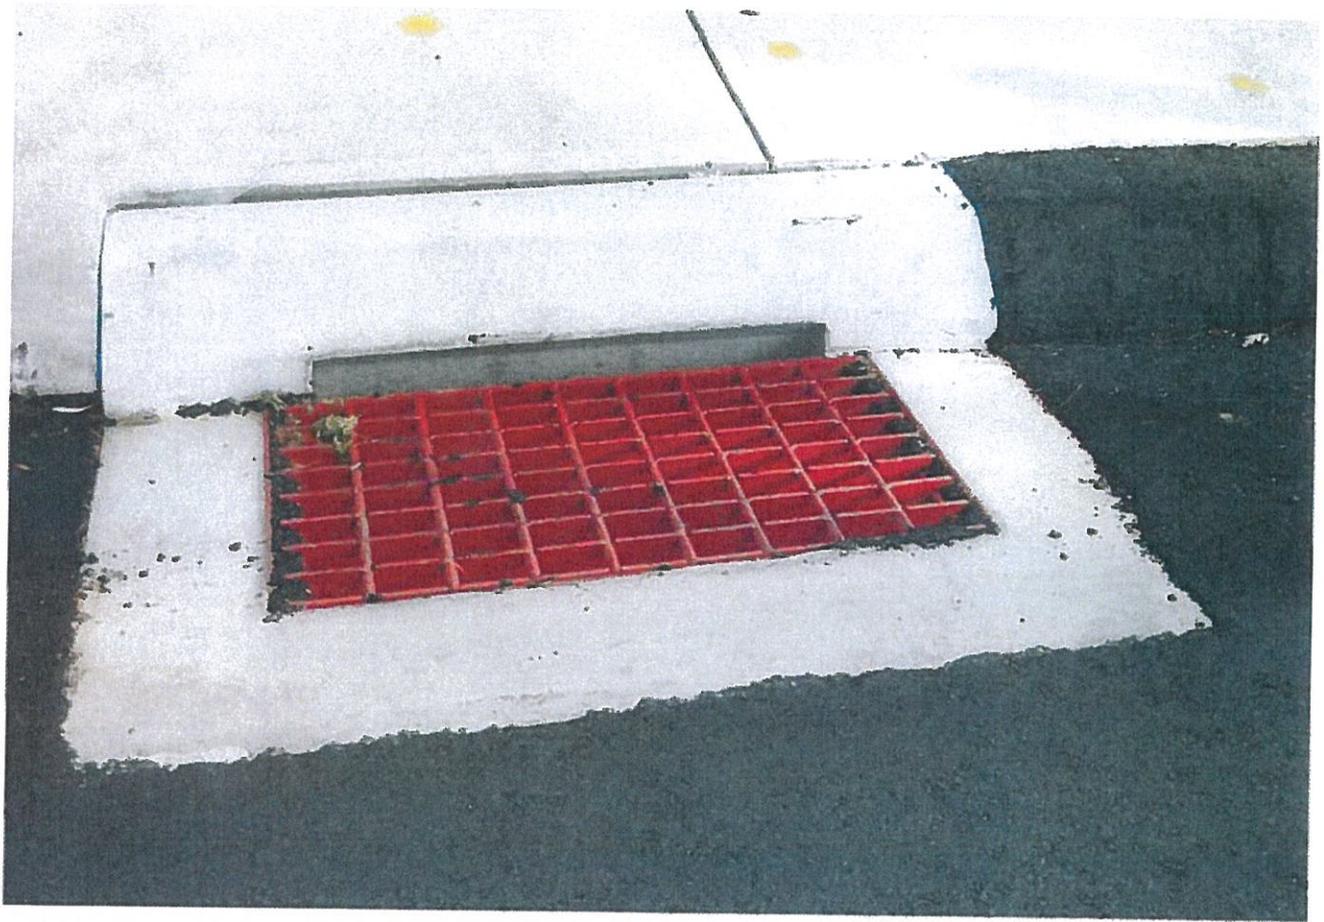
Project Market St @ SMH-63

Sanitary Line was televised from SMH-63 Down stream while the storm drain was plugged and flooded with dye. The drain crosses the Sanitary. Two leaks had been found.

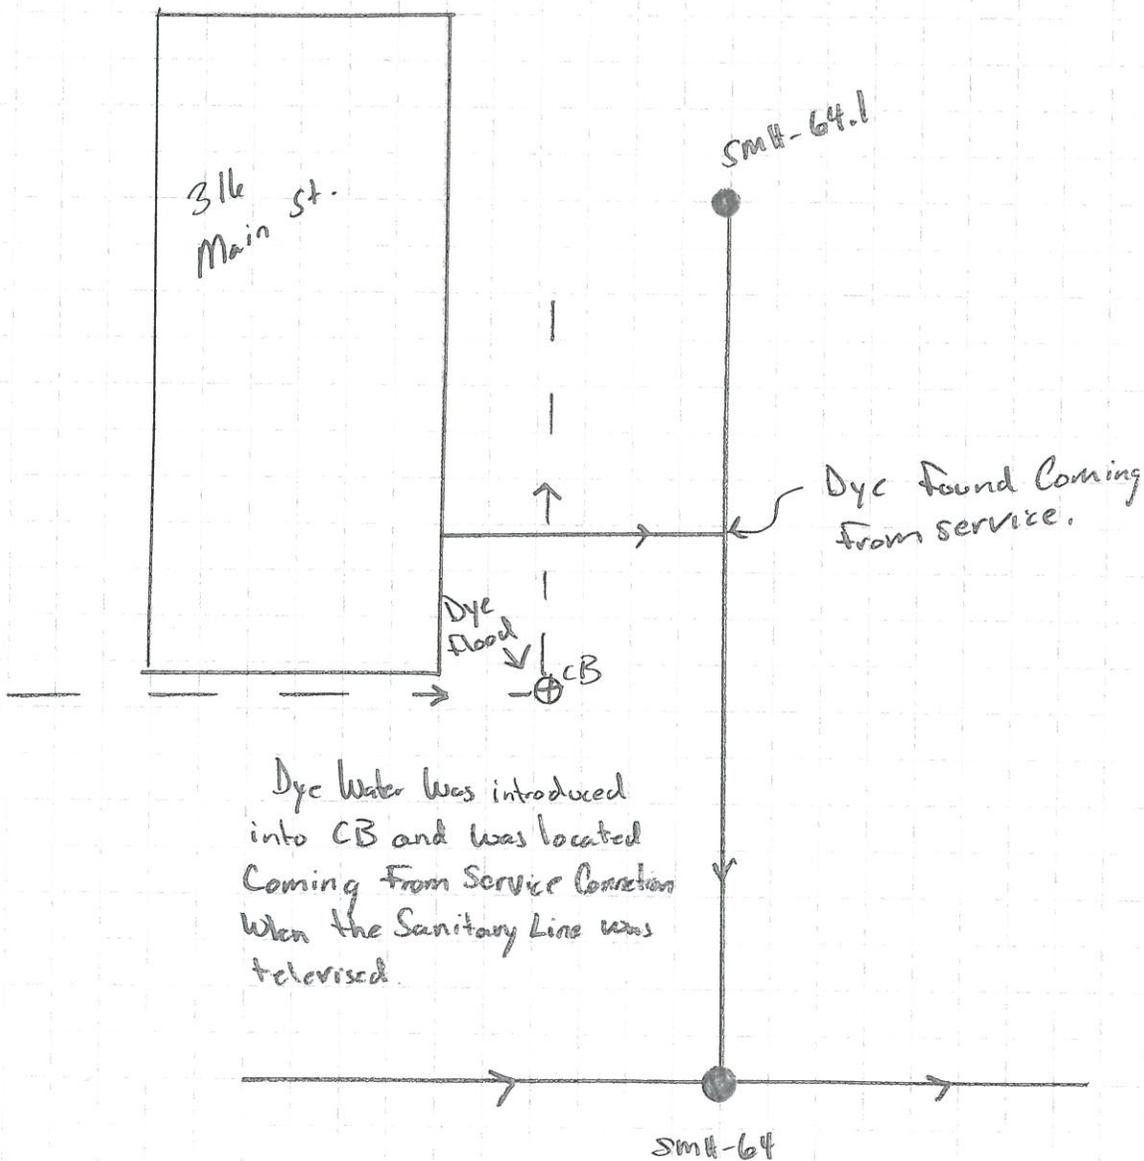
Project 316 Main St.

Dye Water Was introduced into CB and was located Coming From Service Connection When the Sanitary Line was televisised.

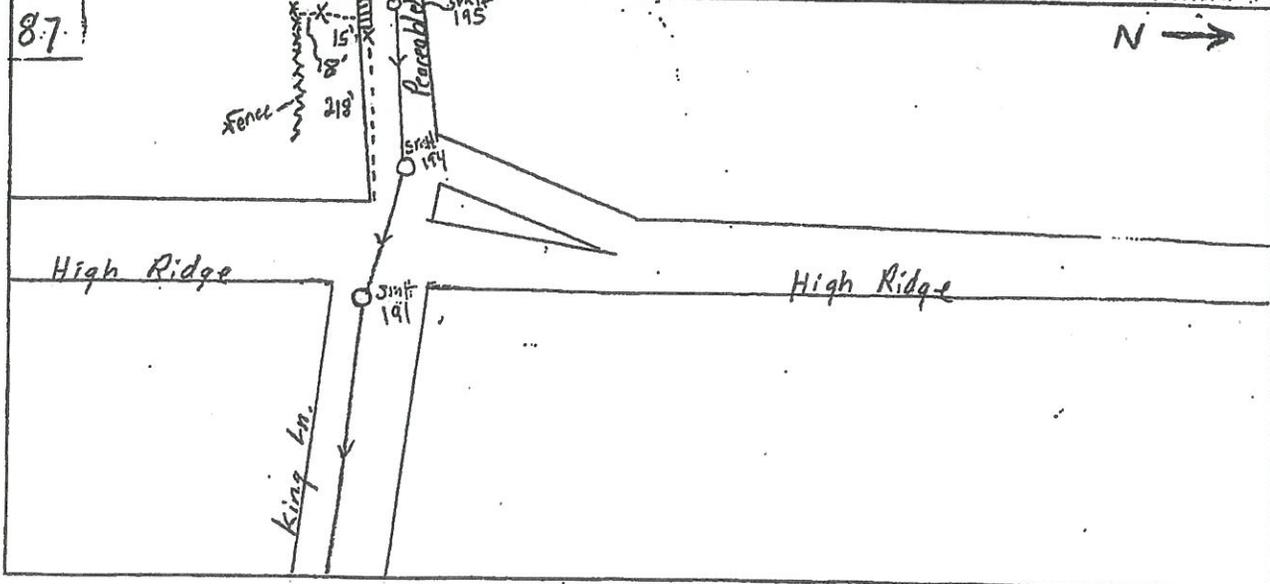
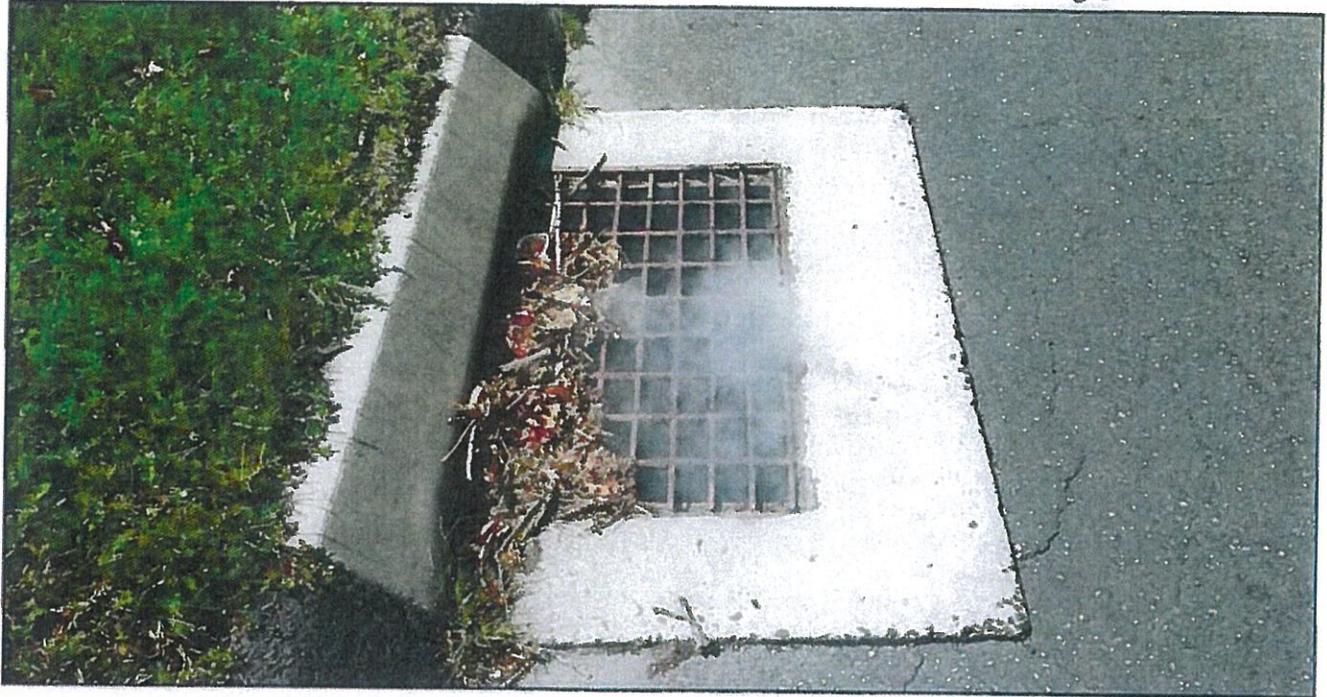
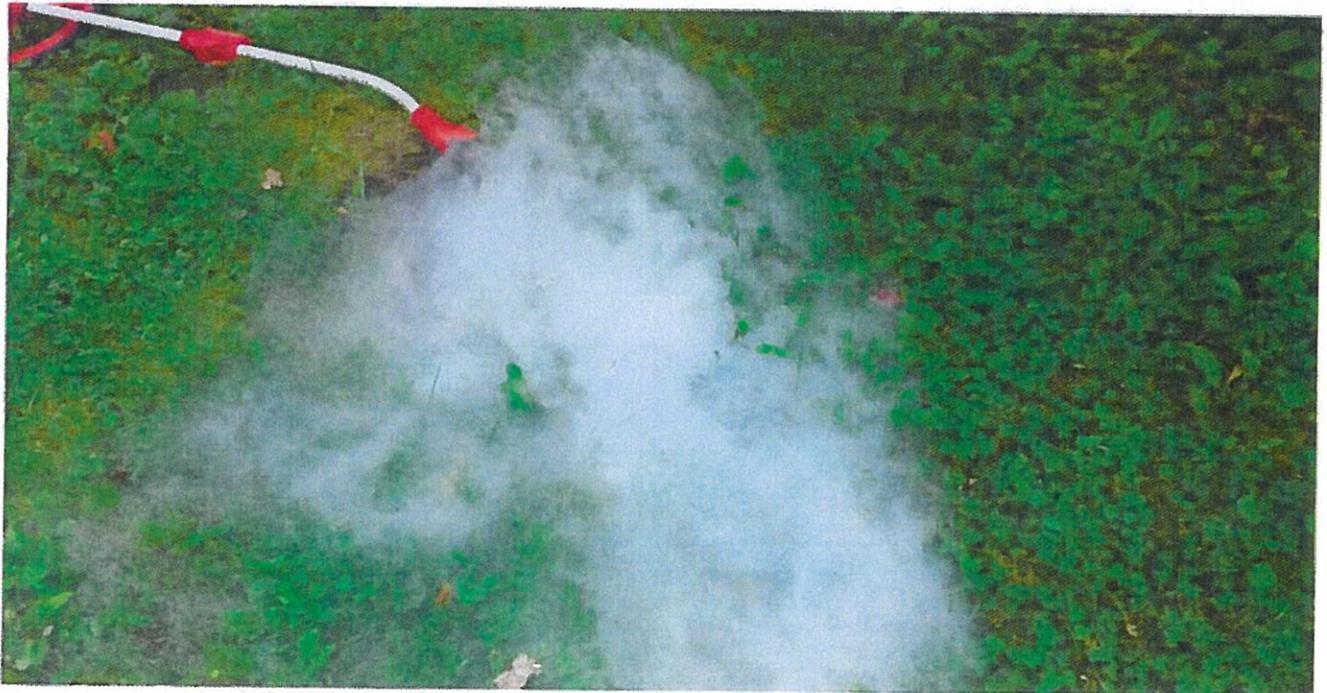
Project 87 High Ridge

Outgoing Line in CB-1 was plugged and the Drain Line was flooded upto CB-2, we also Plugged 6" Sideline into CB-2 and Flooded through hole in ground that Smoked - No dye was found.

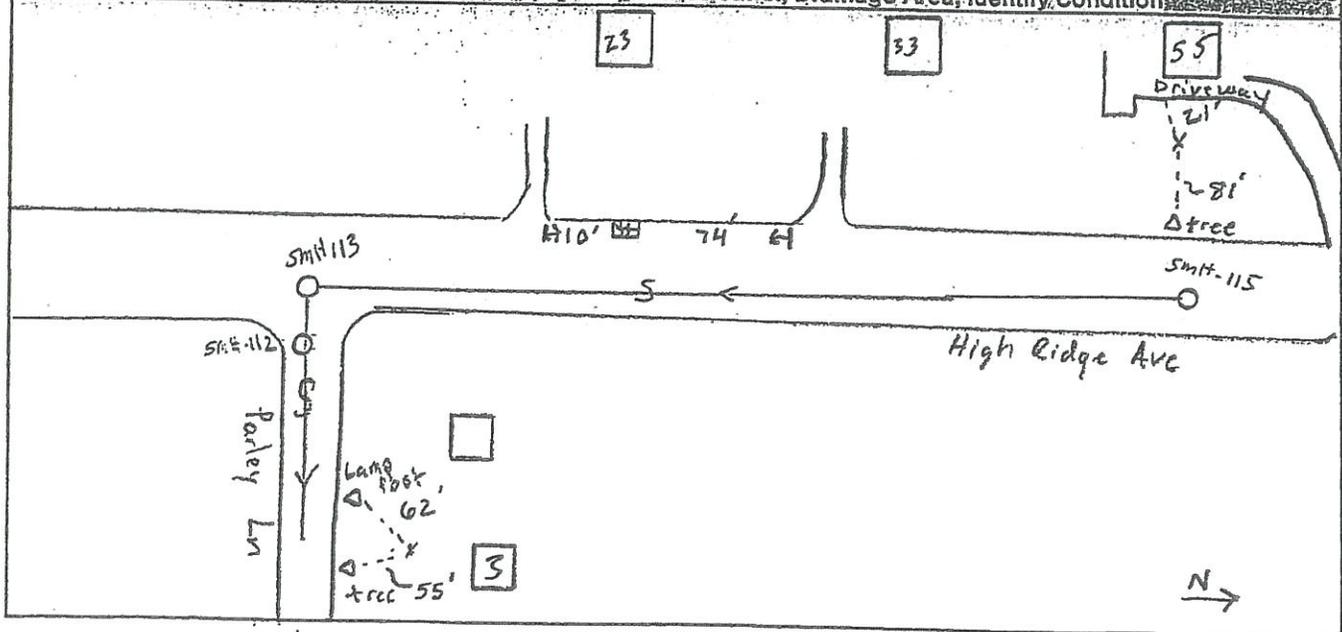
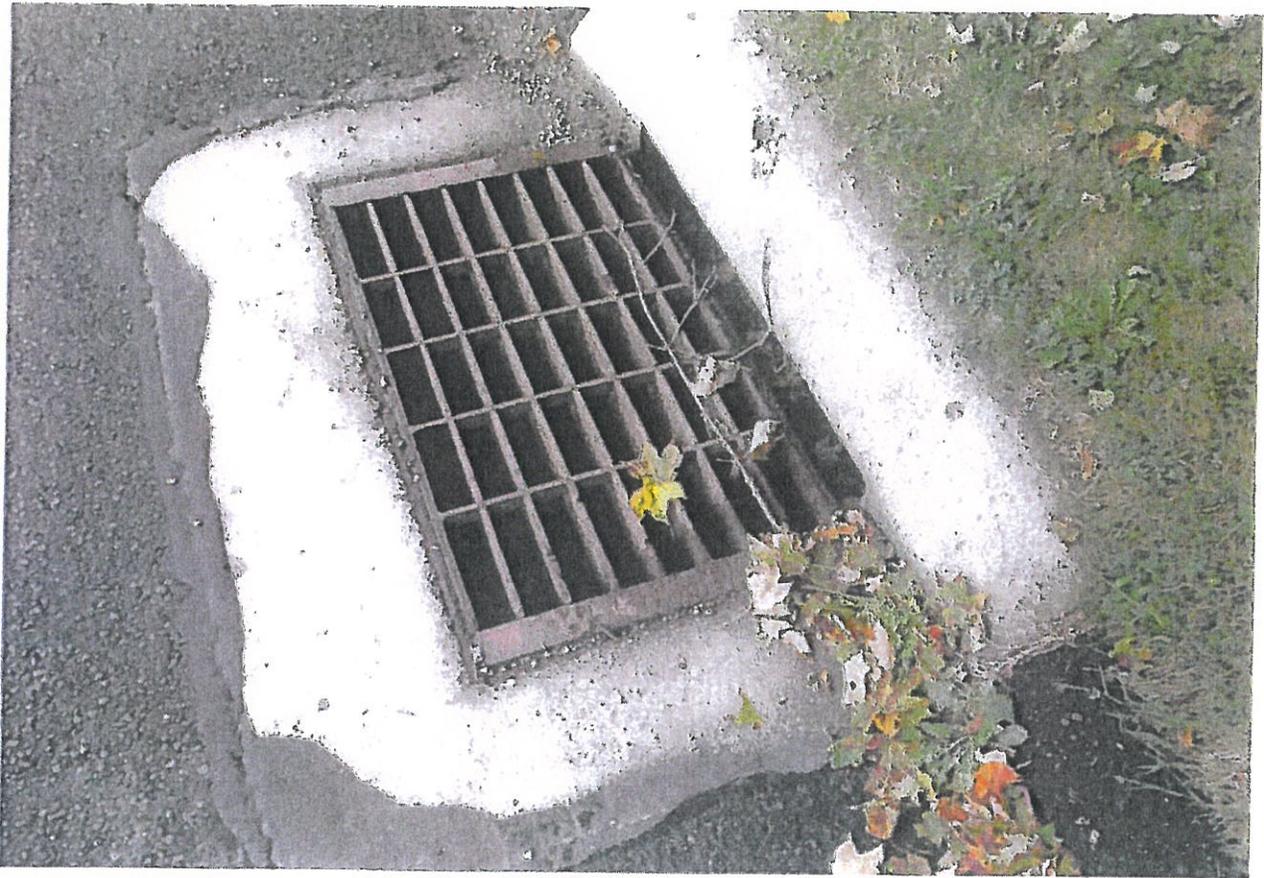
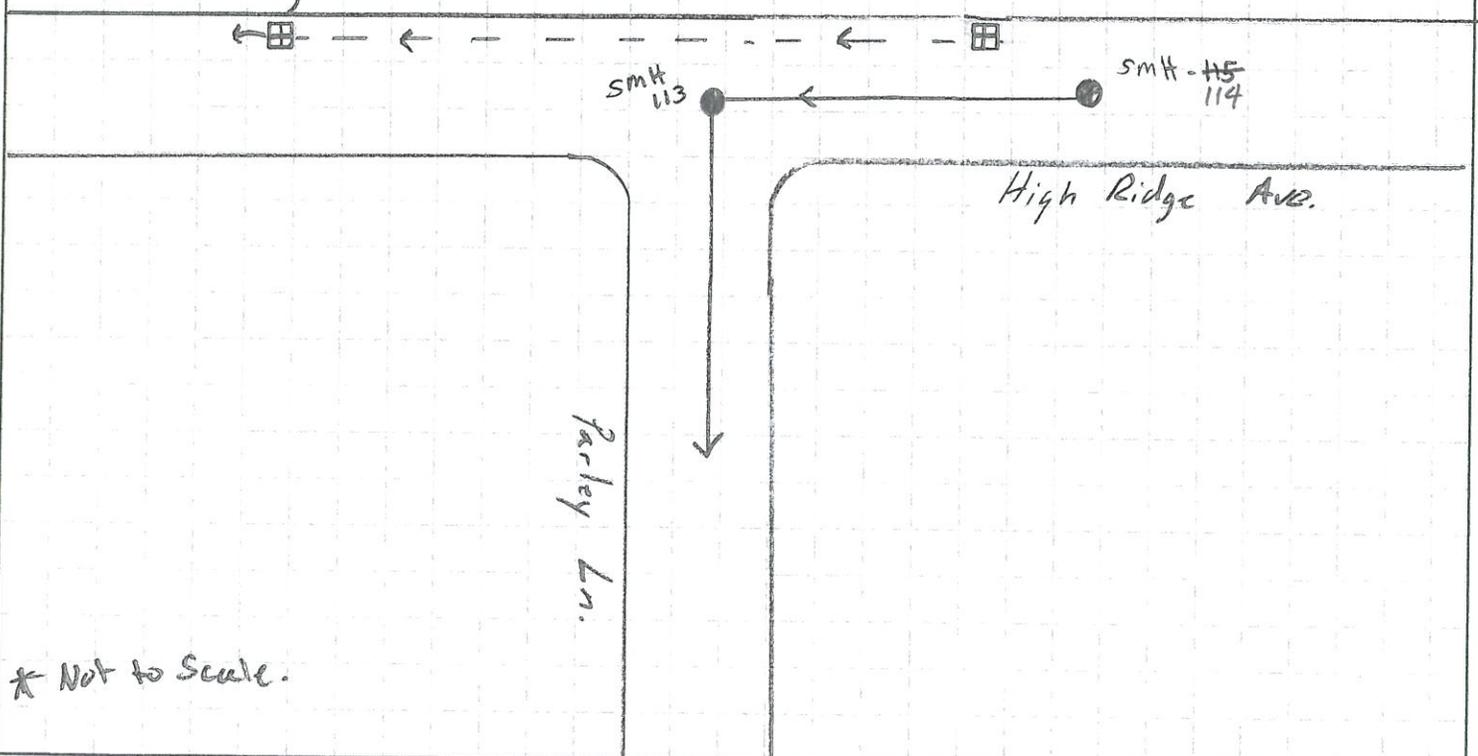
Project 23 High Ridge Ave

Drain Line was flooded with Dye water
During the flood, dye was observed entering
SMH-113 at the Pipe Connection of incoming
Line from behind the Liner, it appeared to
have not sealed correctly.

Incoming drain line
plugged and upstream
line flooded with
Dye Water.
