Technical Memorandum

To	Ridgefield WPCA	Page	1 of 22
CC	C. Fisher, J. O'Brien, J. Pennell		
Subject	Town of Ridgefield, CT Phase 2 Wastewater Facilities Plan Technical Memorandum No. 1 – Dyed Water Testing and Tracing		
From	Jon Pearson/Alberto Angles		
Date	October 27, 2016

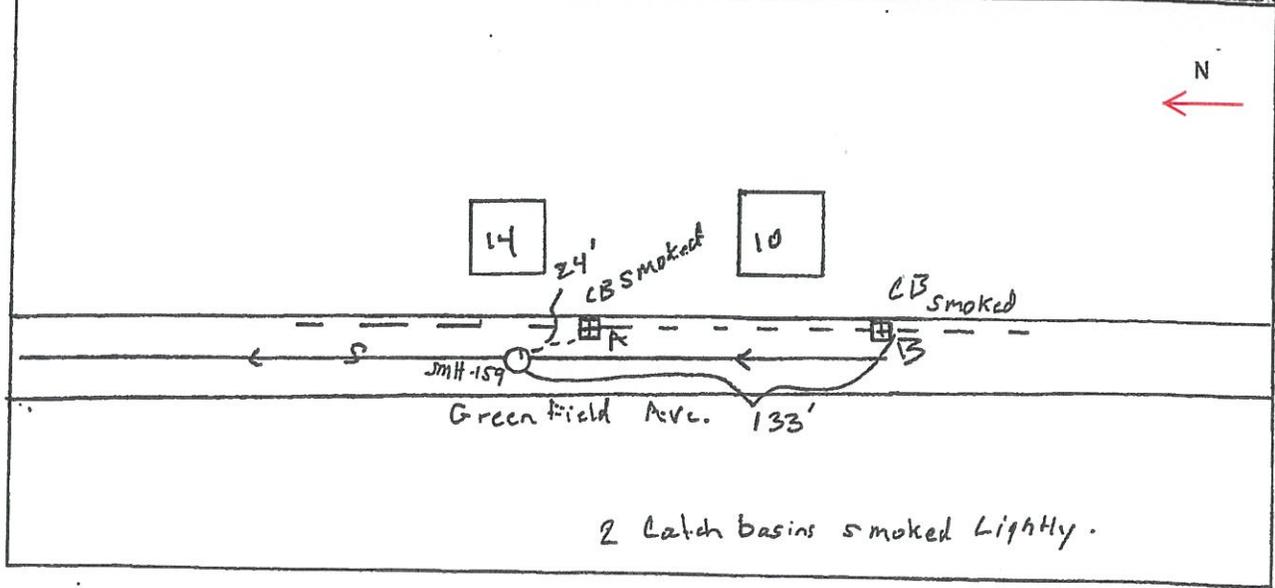
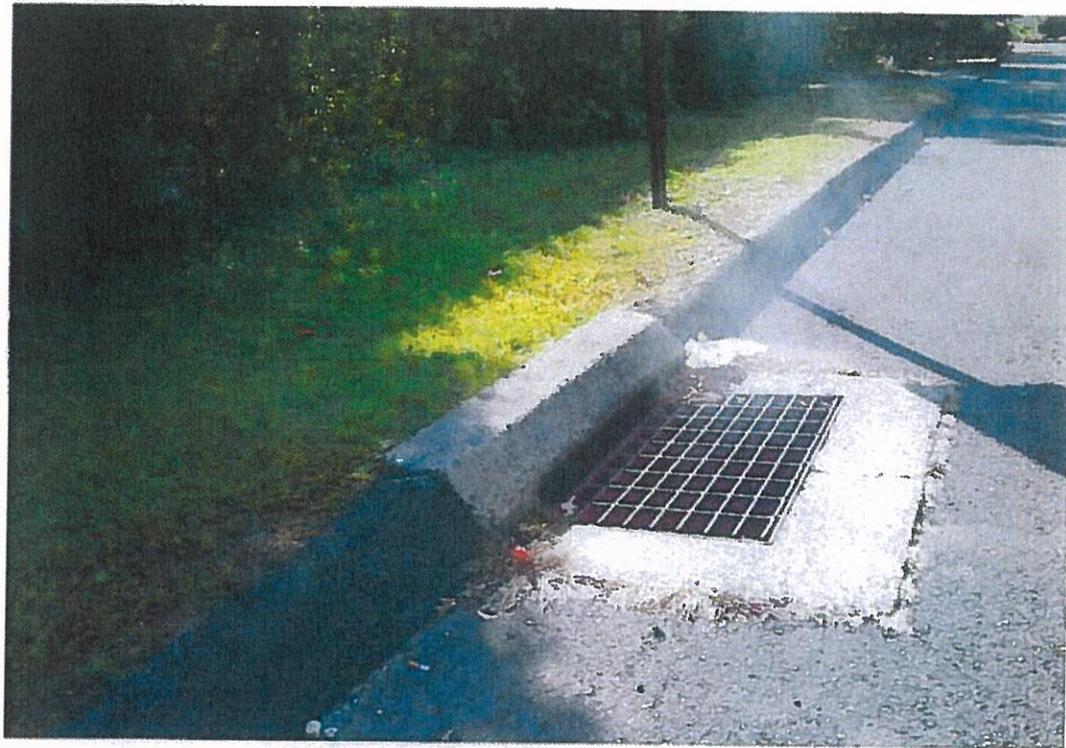
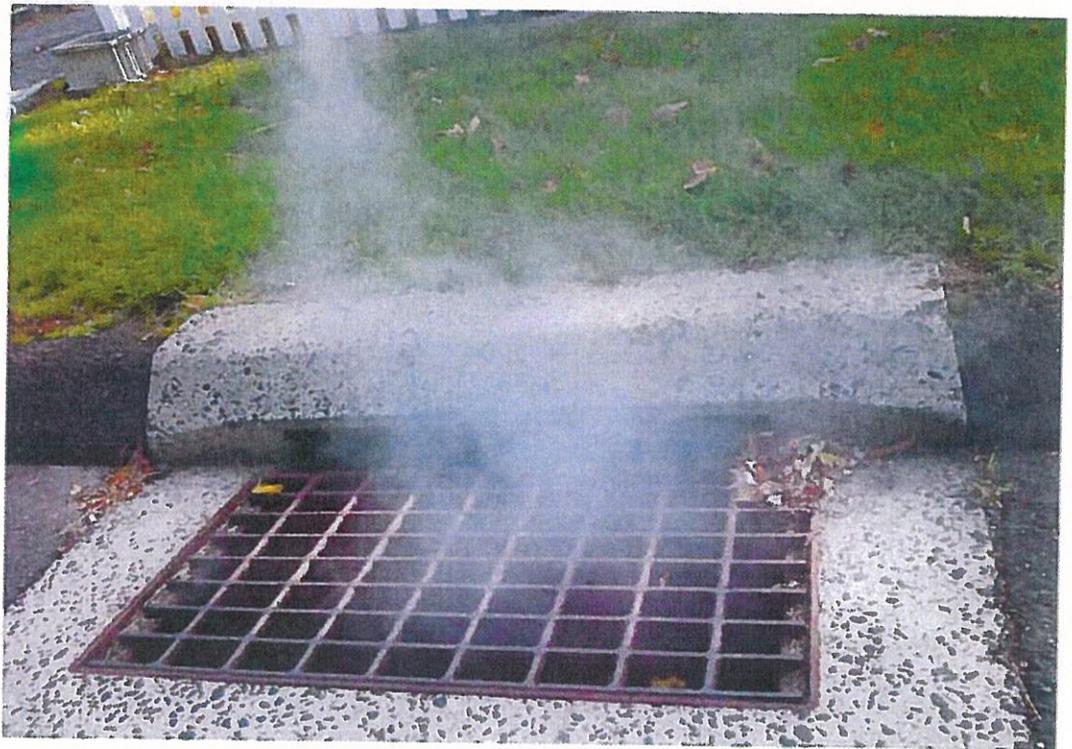
Date 7/15/16 Project 10 Greenfield Ave Initial SS

We plugged the incoming line of CB-1 and dye flooded the Drain Line
we then televised the Sanitary Sewer Line upstream of SMH-159
and a leak was found at a service Connection.

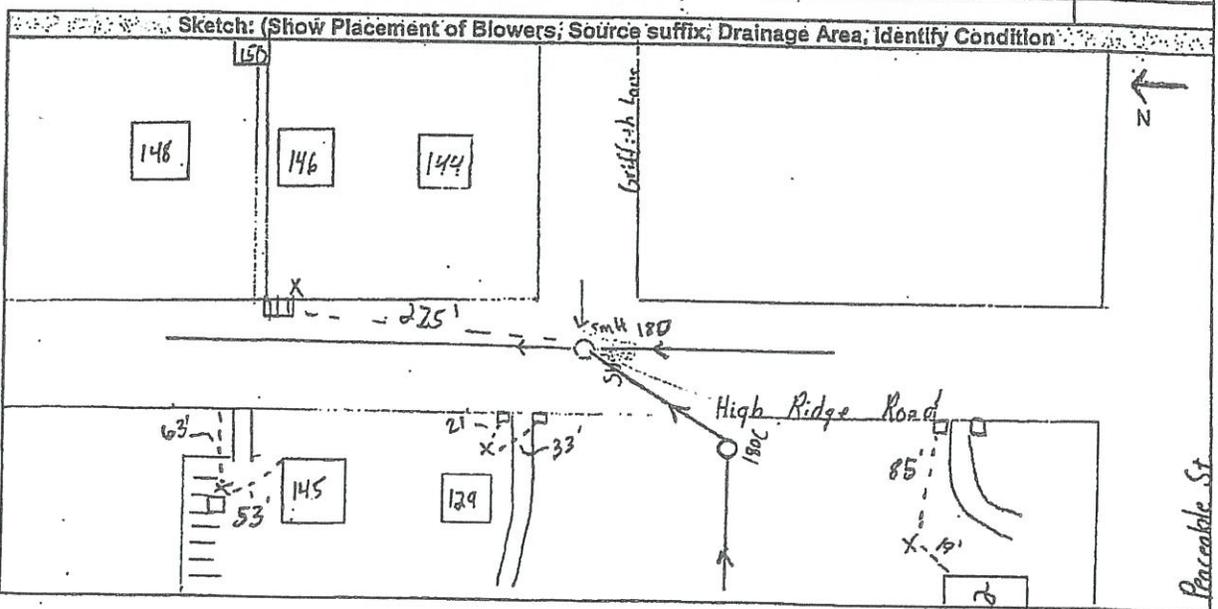
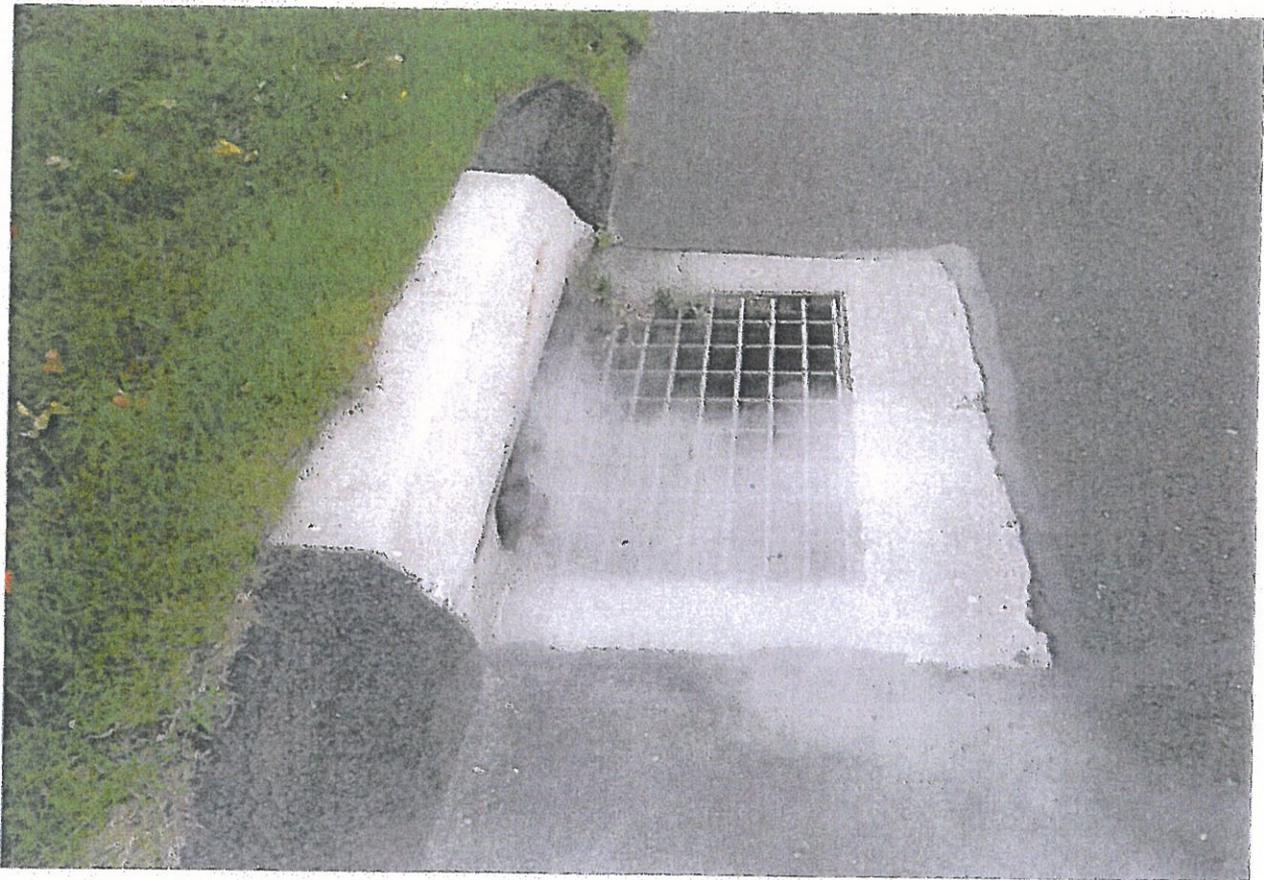
Project CB @ 150 High Ridge Rd-

CB-1 Incoming Line was Plugged and line was flooded, the Corrugated pipe was so deteriorated it wouldn't hold water, we then Plugged CB-2 and flooded upstream to CB-3, the Sanitary sewer was televised and no dye was found.

CB-2 is the Structure that Smoked, It is possible the defect is Between CB-1 and CB-2, but not being able to flood pipe due to deteriorated pipe hindered results.

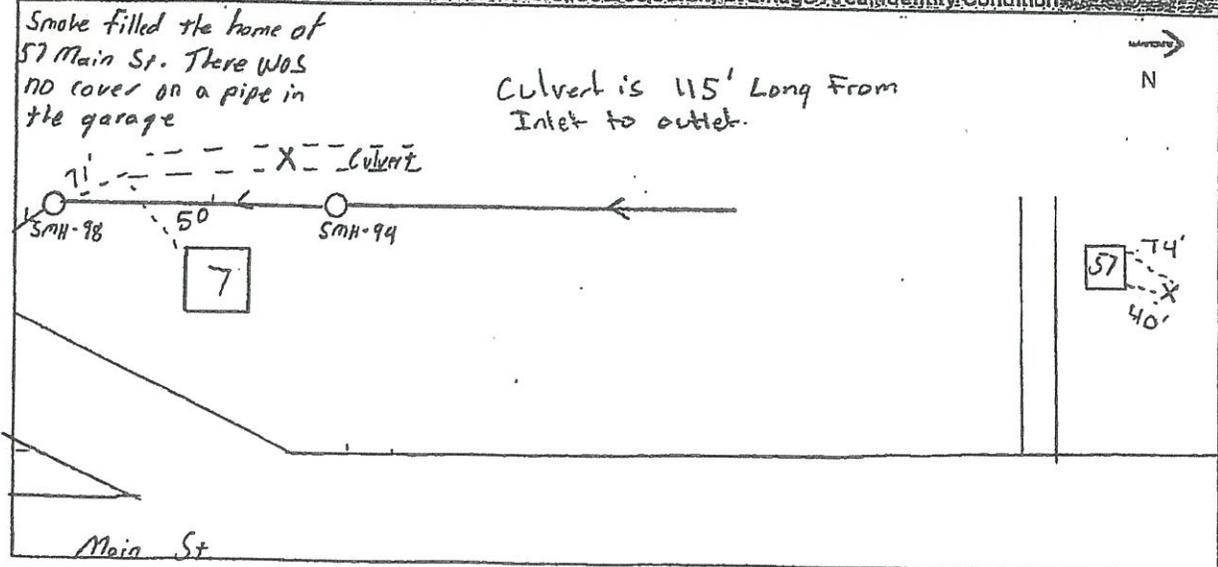
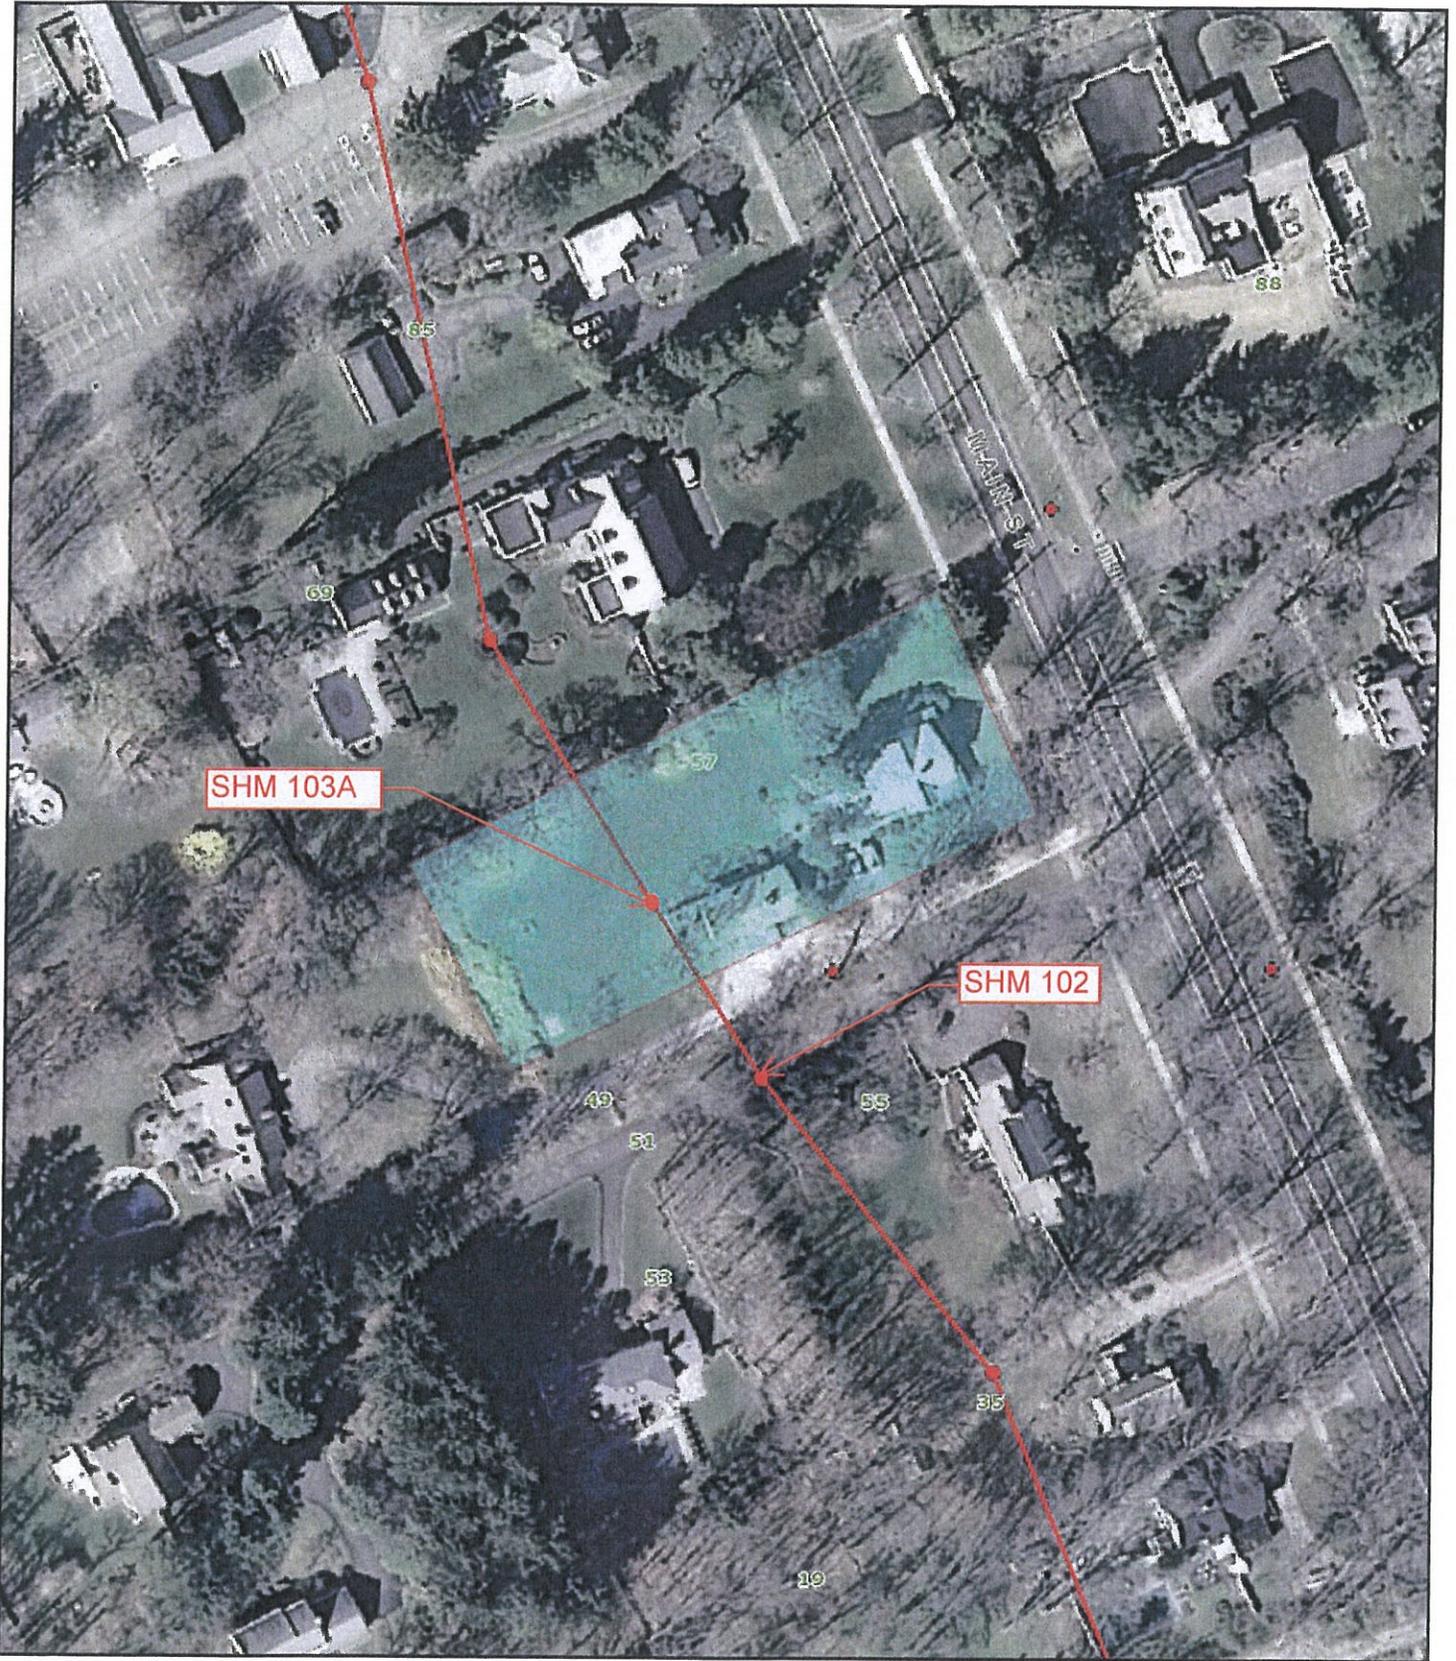
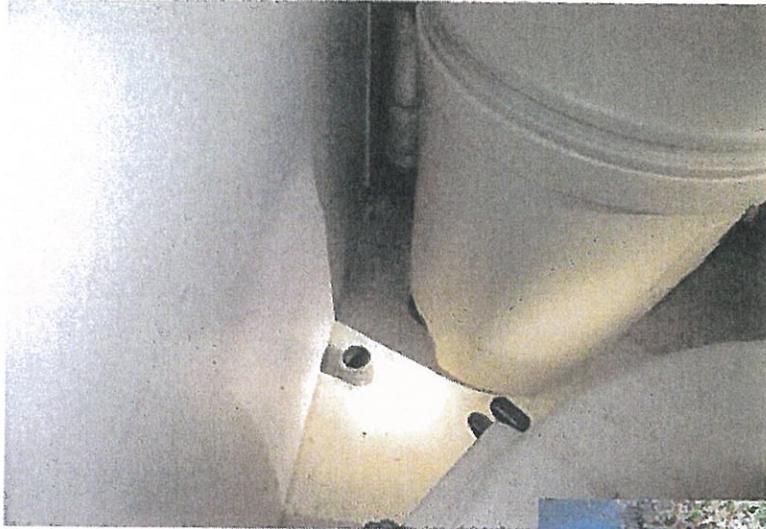
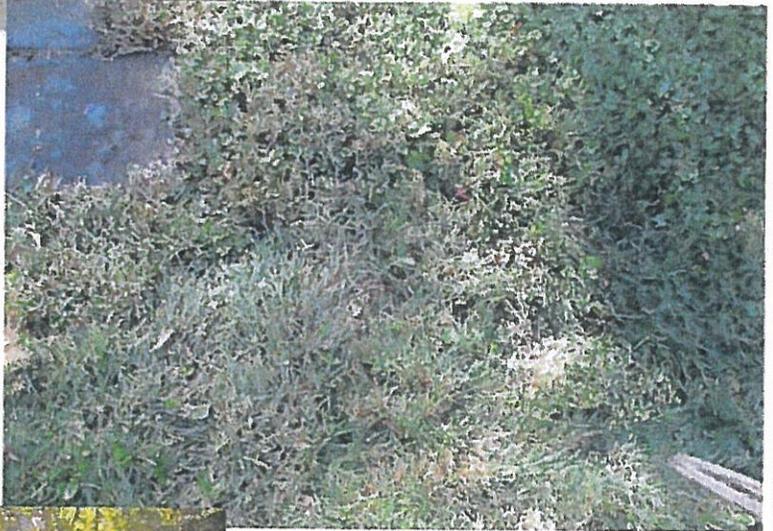
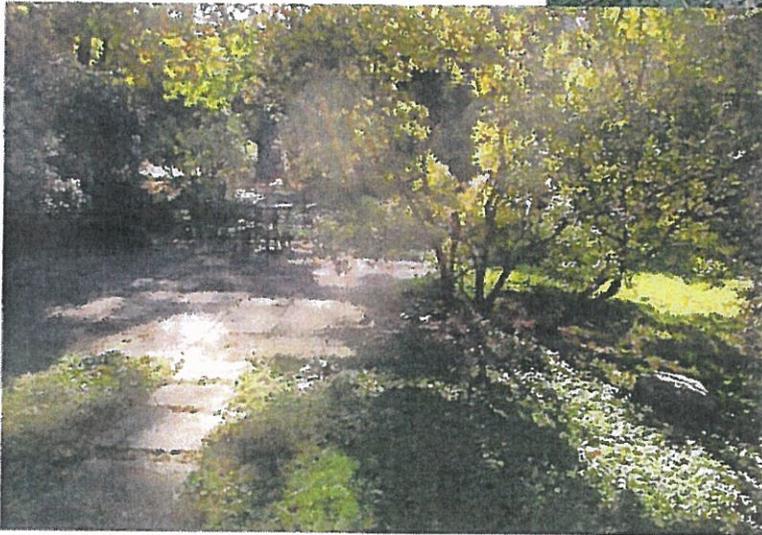
Source 67 - 57 Main Street

Dye water was introduced to the area that smoked behind 57 Main st. The sewer was televised from SMH-102 upstream and dye water was observed coming out of a service connection at 135'

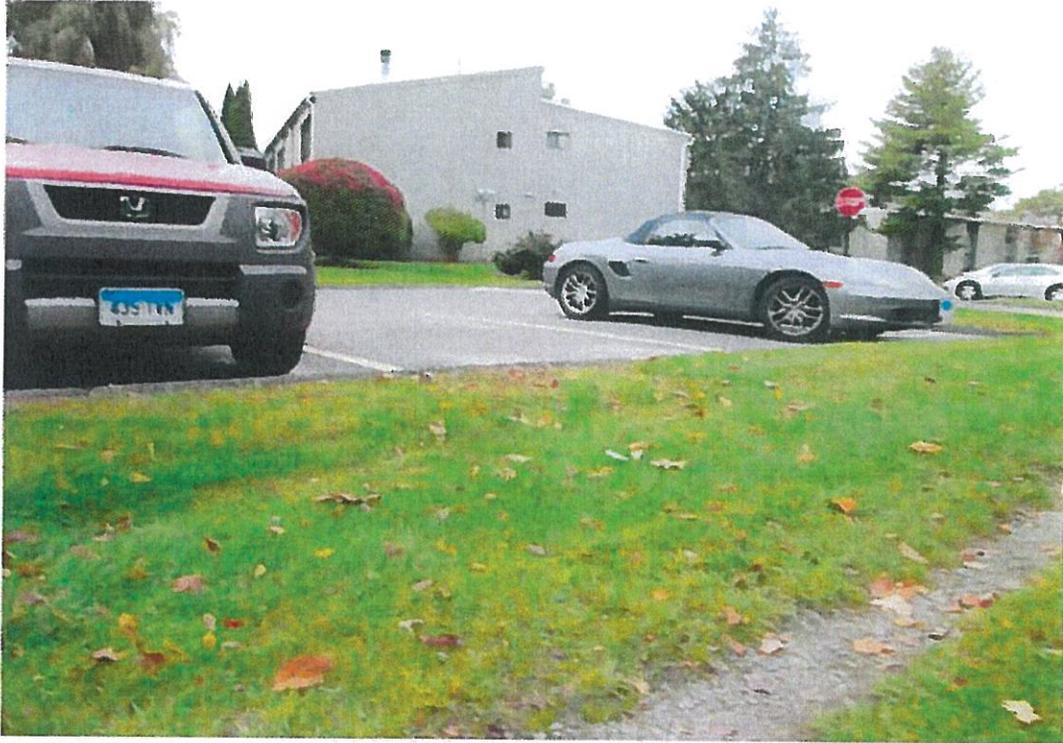
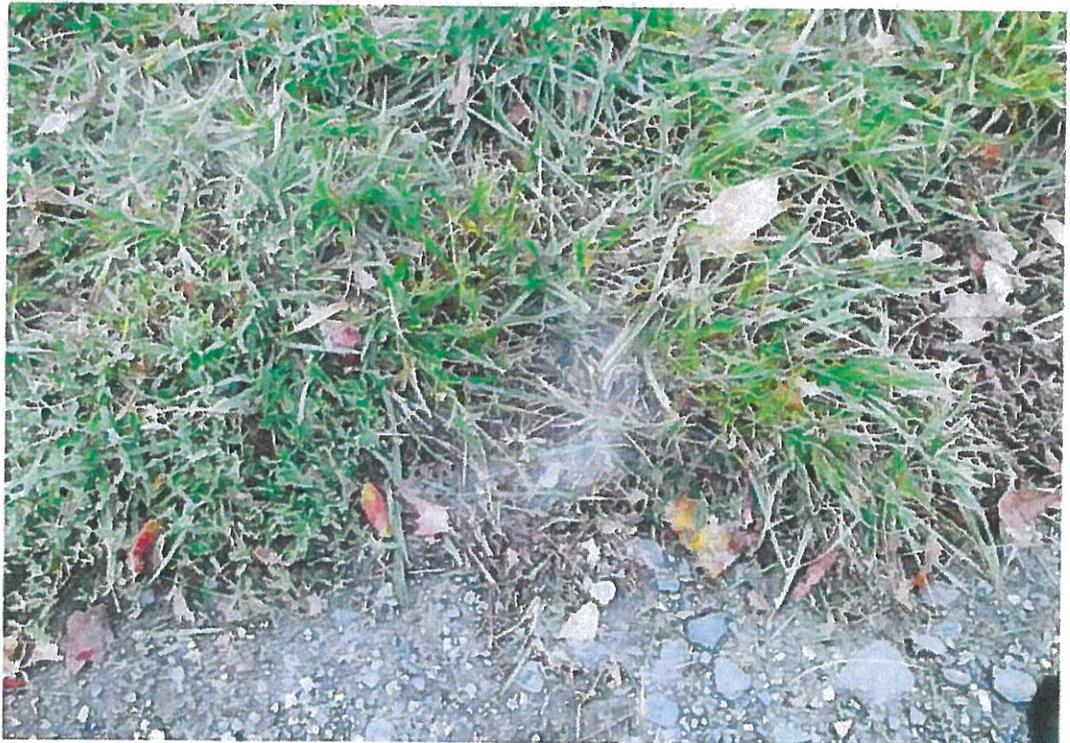
Project Grove St. Dye Flood

Dye was introduced onto walking path and a Pool was created. No Dye was visible after a 30-45 minute test. SMH-116 was observed.

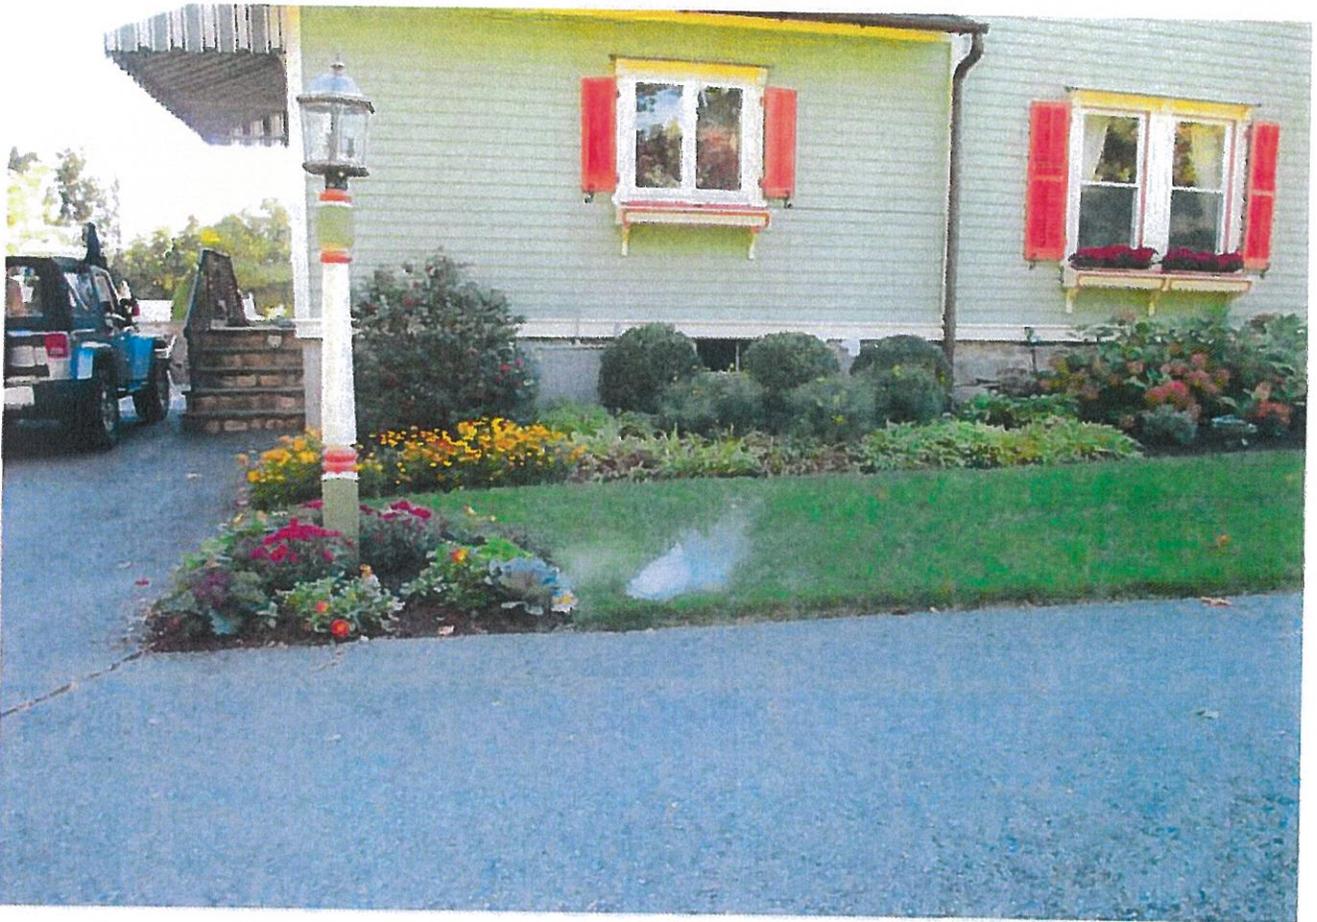
Project 34 Catoonah St.

Defect at 34 Catoonah St. had been repaired prior to doing dye Flood. The defect was caused by a contractor that installed a gas line and punctured a 2" Ejector Pump Line. A dye flood was performed to confirm and no dye was found in the Sanitary Sewer.
