Technical Memorandum

To	Ridgefield WPCA	Page	1 of 9
CC	C. Fisher, J. O'Brien, M. Burke, J. Pennell		
Subject	Town of Ridgefield, CT Phase 2 Wastewater Facilities Plan Technical Memorandum No. 2 – Internal CCTV Inspection of Selected Mainline Sewers and Lateral Service Connections		
From	Jon Pearson/Alberto Angles		
Date	November 17, 2016

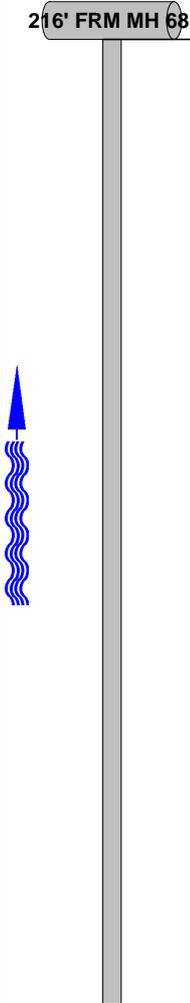
216' FRM MH 68 0.00 ATC Tee Connection, at 02 o'clock, 4, 4, Remark: LAT AT 216' FRM U/S MH 68

63.00 MSA Survey Abandoned, Remark: EOC
